Inspections: Damaged Pole Report

Service Request 26-00470139 Sector: \_\_\_\_\_ Gateway: \_\_\_\_\_ Primary: \_\_\_\_\_

Location on Service Request: 2010 E. Monument St

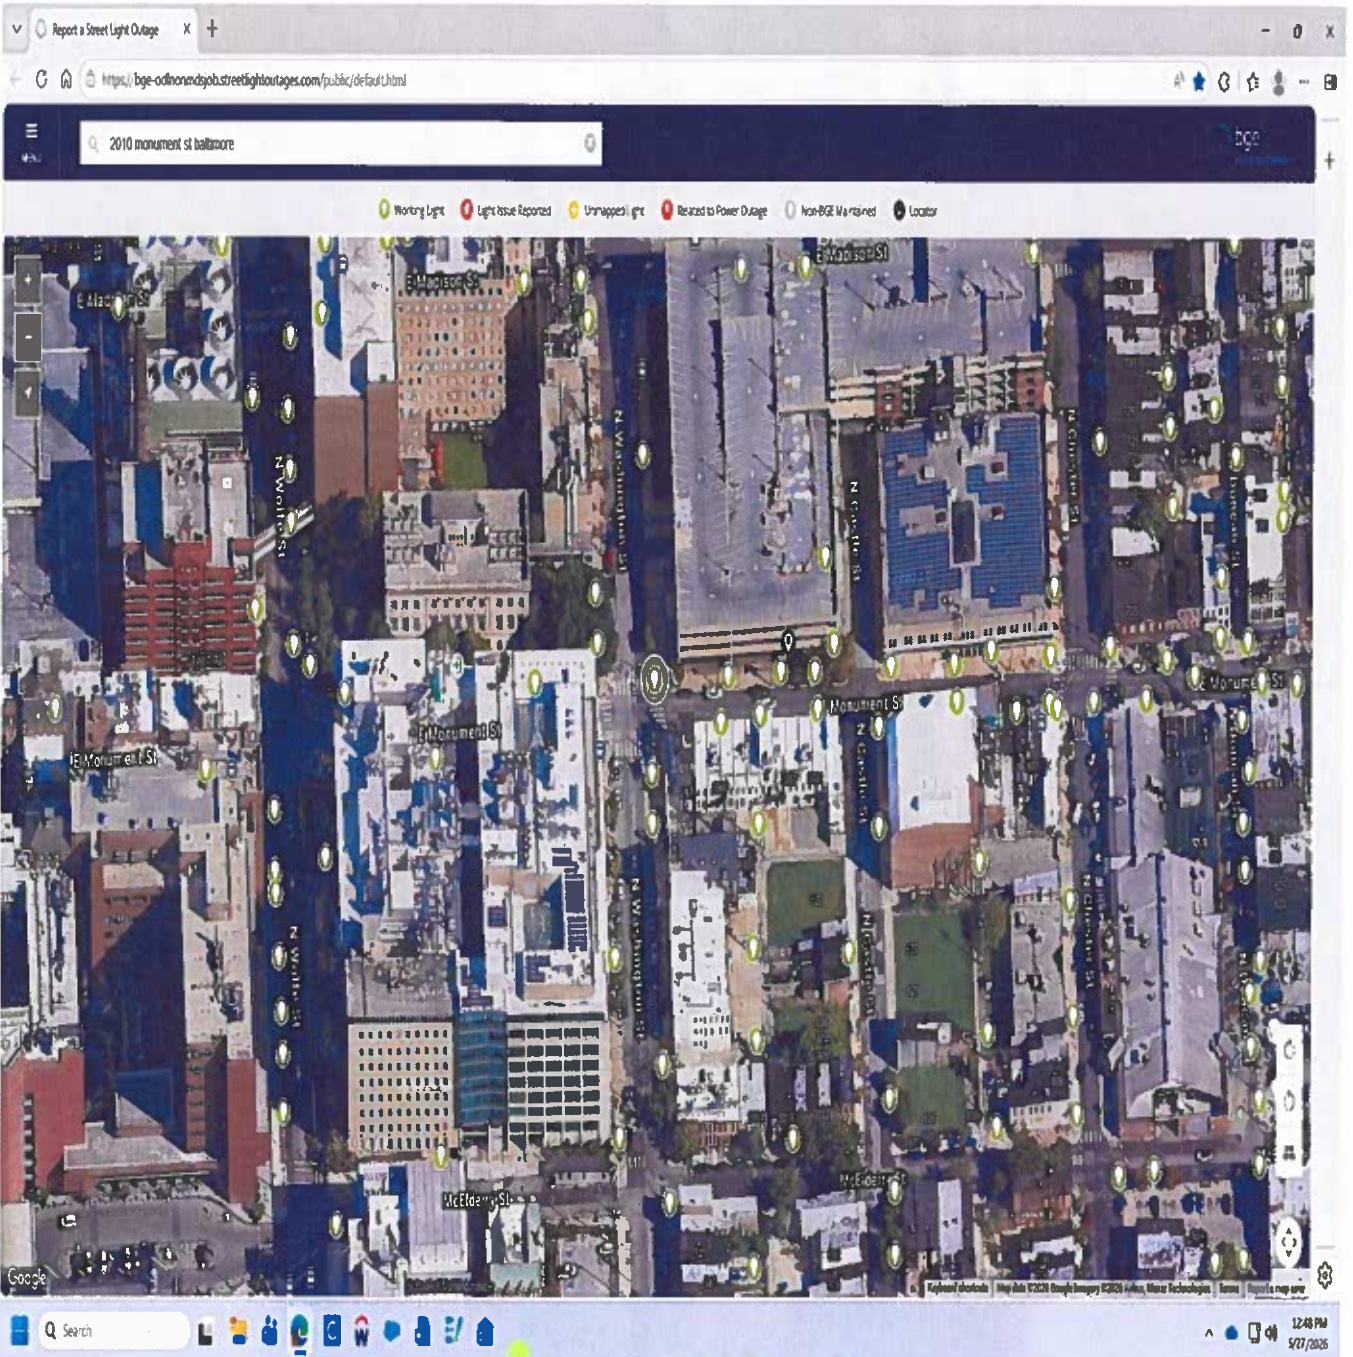
Missing ☒

Home Island pole  
Acorn  
Fixture
