# Inspections: Damaged Pole Report

Service Request: 26-00485721 Sector: \_\_\_\_\_ Gateway: \_\_\_\_\_ Primary: \_\_\_\_\_

Location on Service Request: 5400 Relcrest Rd

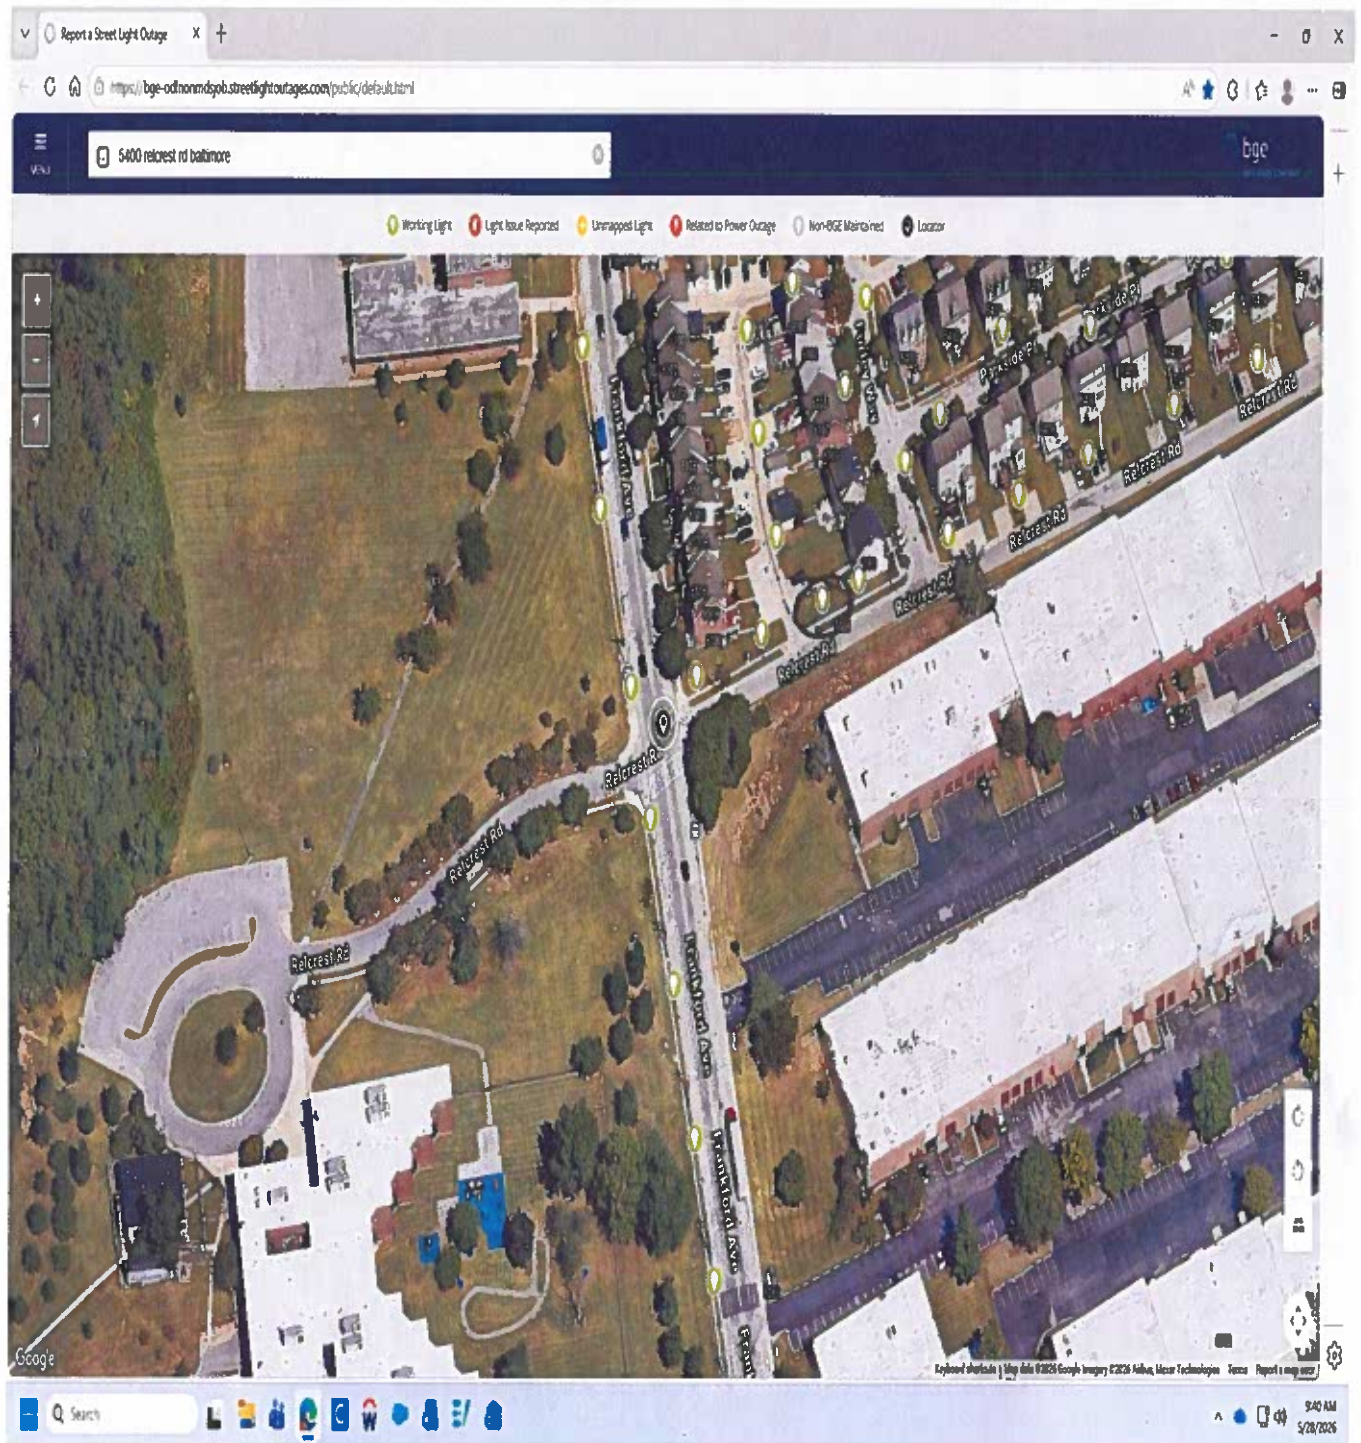
Deteriorated ☒  
Missing ☒  
Damaged \_\_\_\_\_  
Arm/Fixture Missing \_\_\_\_\_  
Other \_\_\_\_\_

NEEDS  
new  
base

Home and  
Acorn  
Fixture
