# Inspections: Damaged Pole Report

Service Request 26-00498178 Sector \_\_\_\_\_ Gateway \_\_\_\_\_ Primary: \_\_\_\_\_

Location on Service Request: 3101 MORAVIA Rd

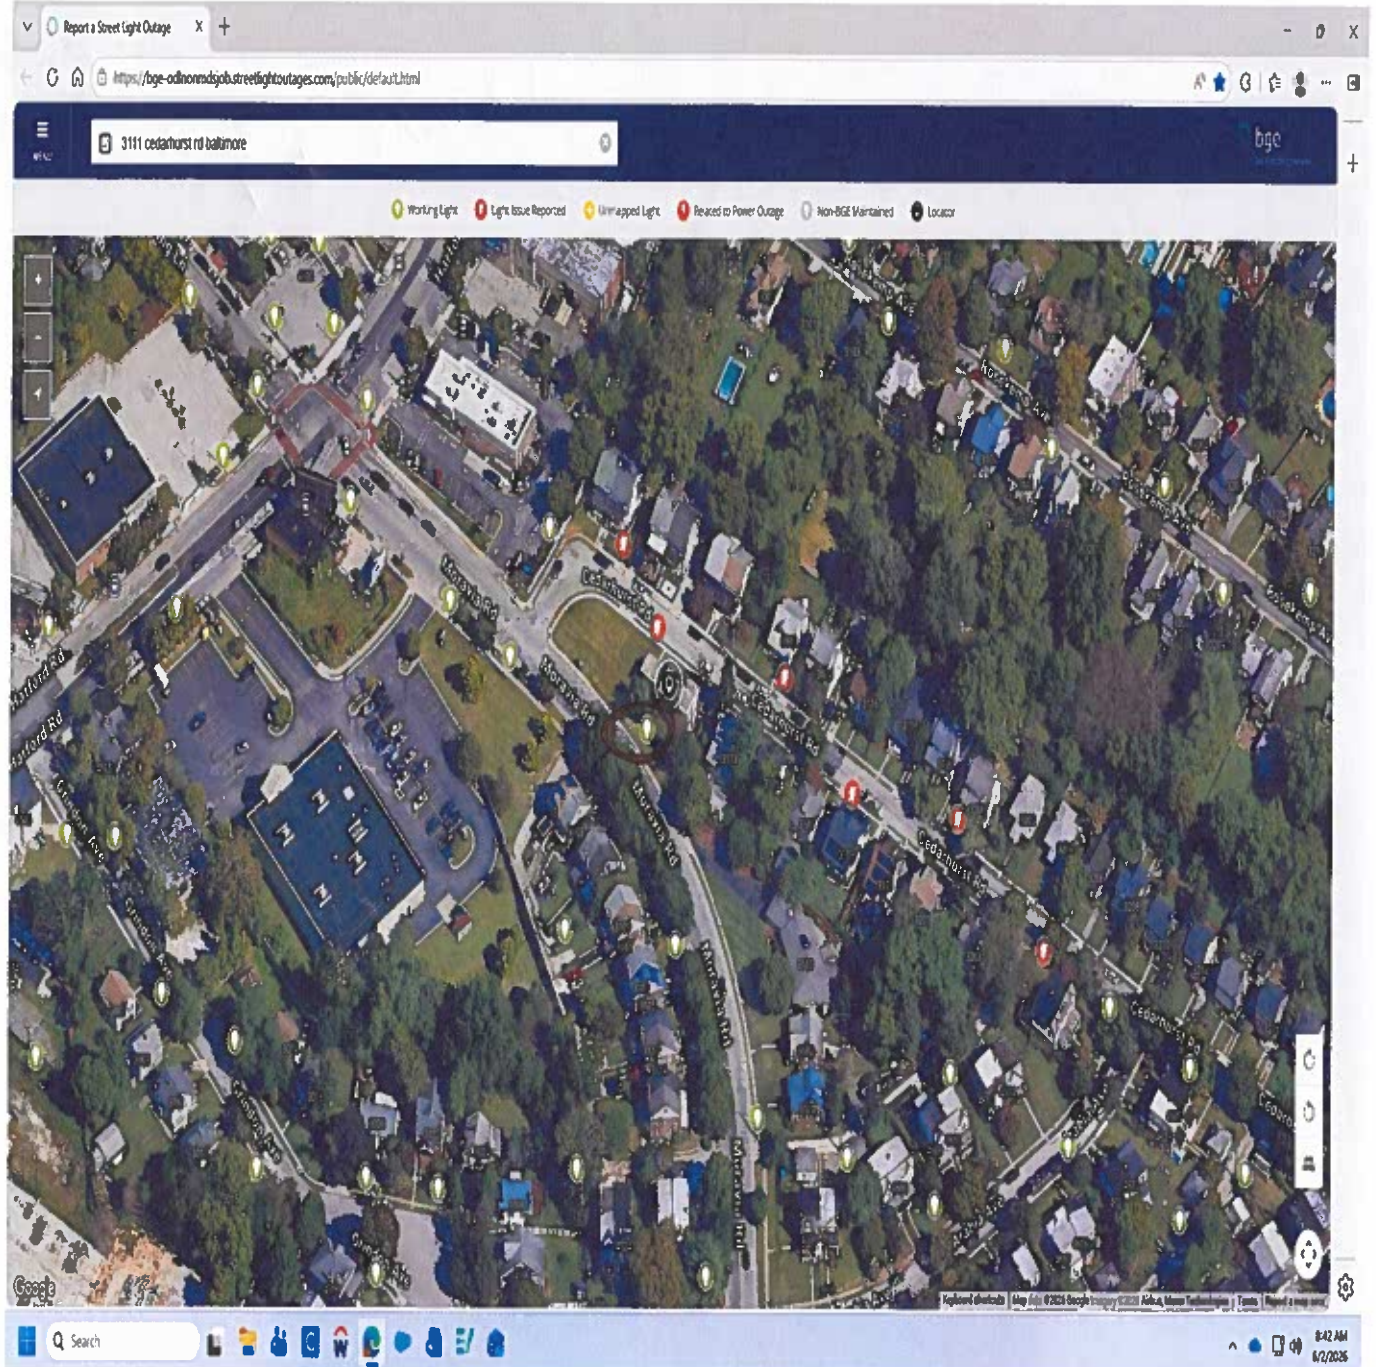
Deteriorated ☒  
Missing ☒  
Damaged \_\_\_\_\_  
Arm/Fixture Missing \_\_\_\_\_  
Other \_\_\_\_\_

**NEEDS  
New  
Base**

Damaged \_\_\_\_\_  
Missing ☒

Good ☒ Bad: \_\_\_\_\_  
Bolts ☒  
Wires ☒  
Conduit ☒

25 Foot Aluminum  
pole  
Cobra Head  
LED
