# Inspections: Damaged Pole Report

Service Request 26-00497041 Sector: \_\_\_\_\_ Gateway: \_\_\_\_\_ Primary: \_\_\_\_\_

Location on Service Request: No 64<sup>th</sup> & E. Preston St

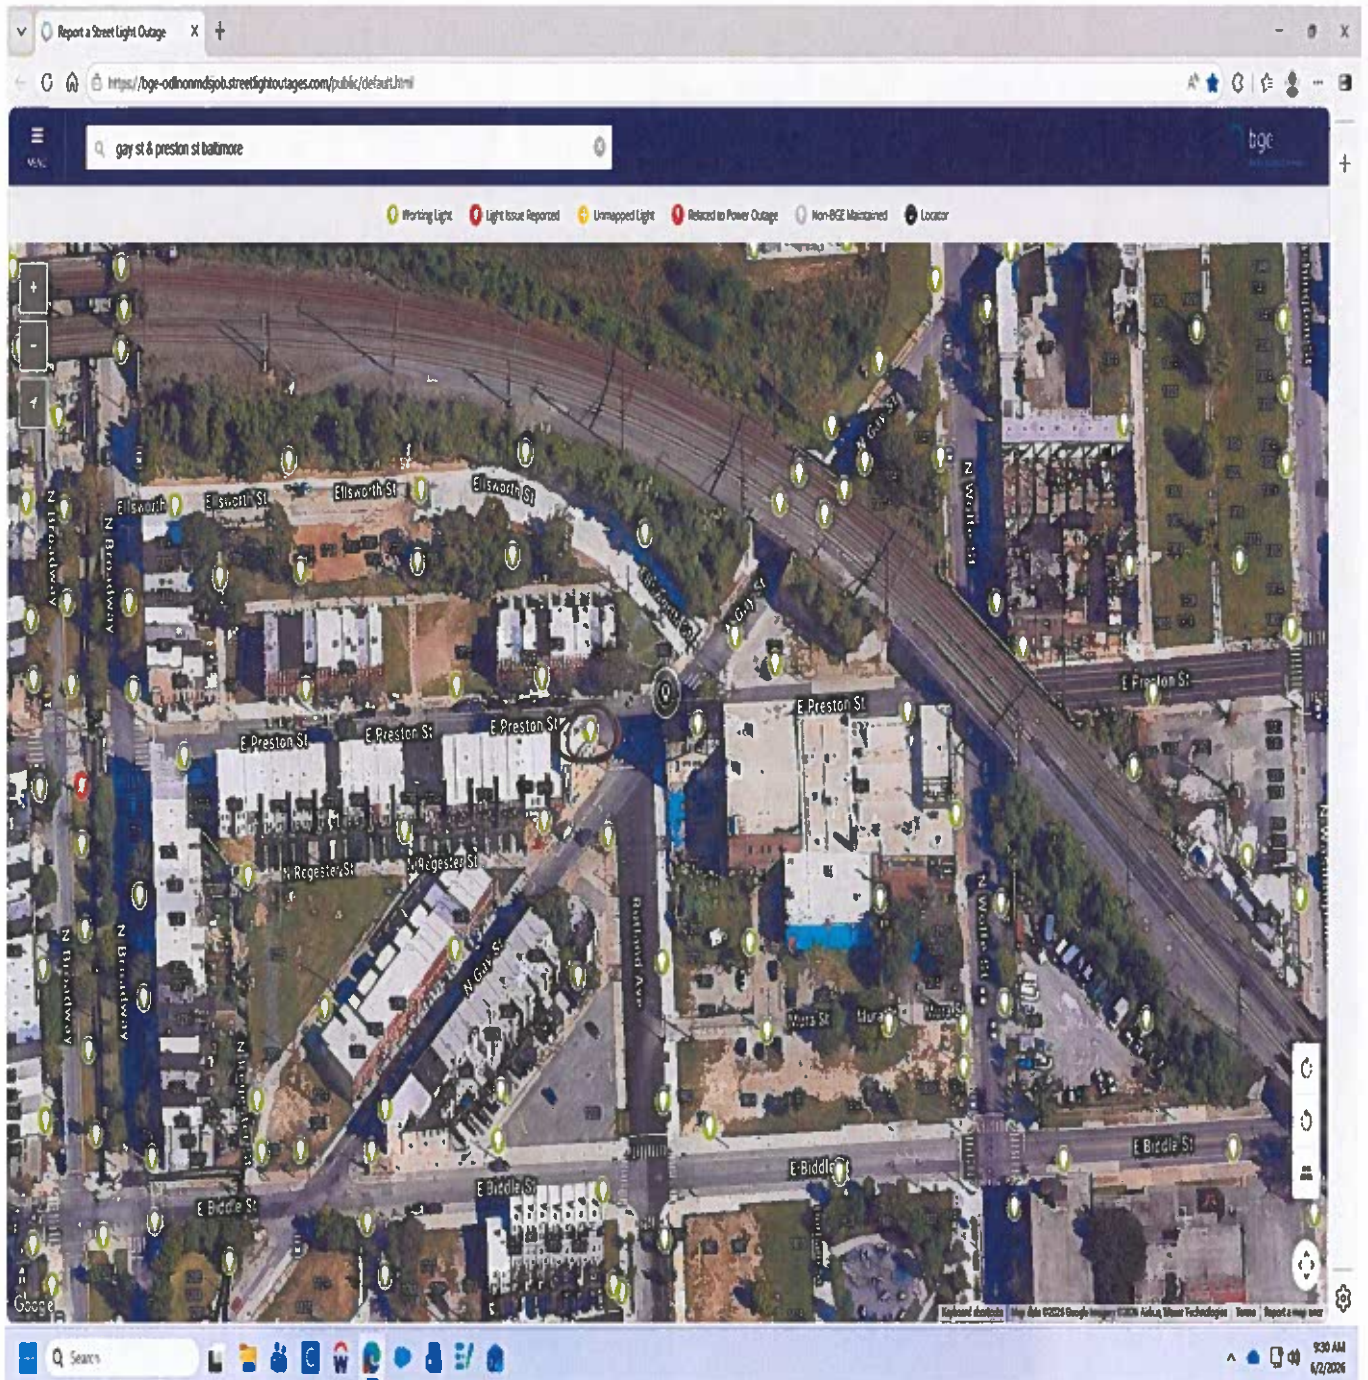
Deteriorated \_\_\_\_\_  
Missing ☒  
Damaged \_\_\_\_\_  
Arm/Fixture Missing \_\_\_\_\_  
Other \_\_\_\_\_

Damaged \_\_\_\_\_  
Missing ☒

38 Foot Alum. mono  
pole  
Cobra Head  
LED
