Inspections: Damaged Pole Report

Service Request: 26-00565562 Sector: \_\_\_\_\_ Gateway: \_\_\_\_\_ Primary: \_\_\_\_\_

Location on Service Request: 6100 Loch Raven Blvd

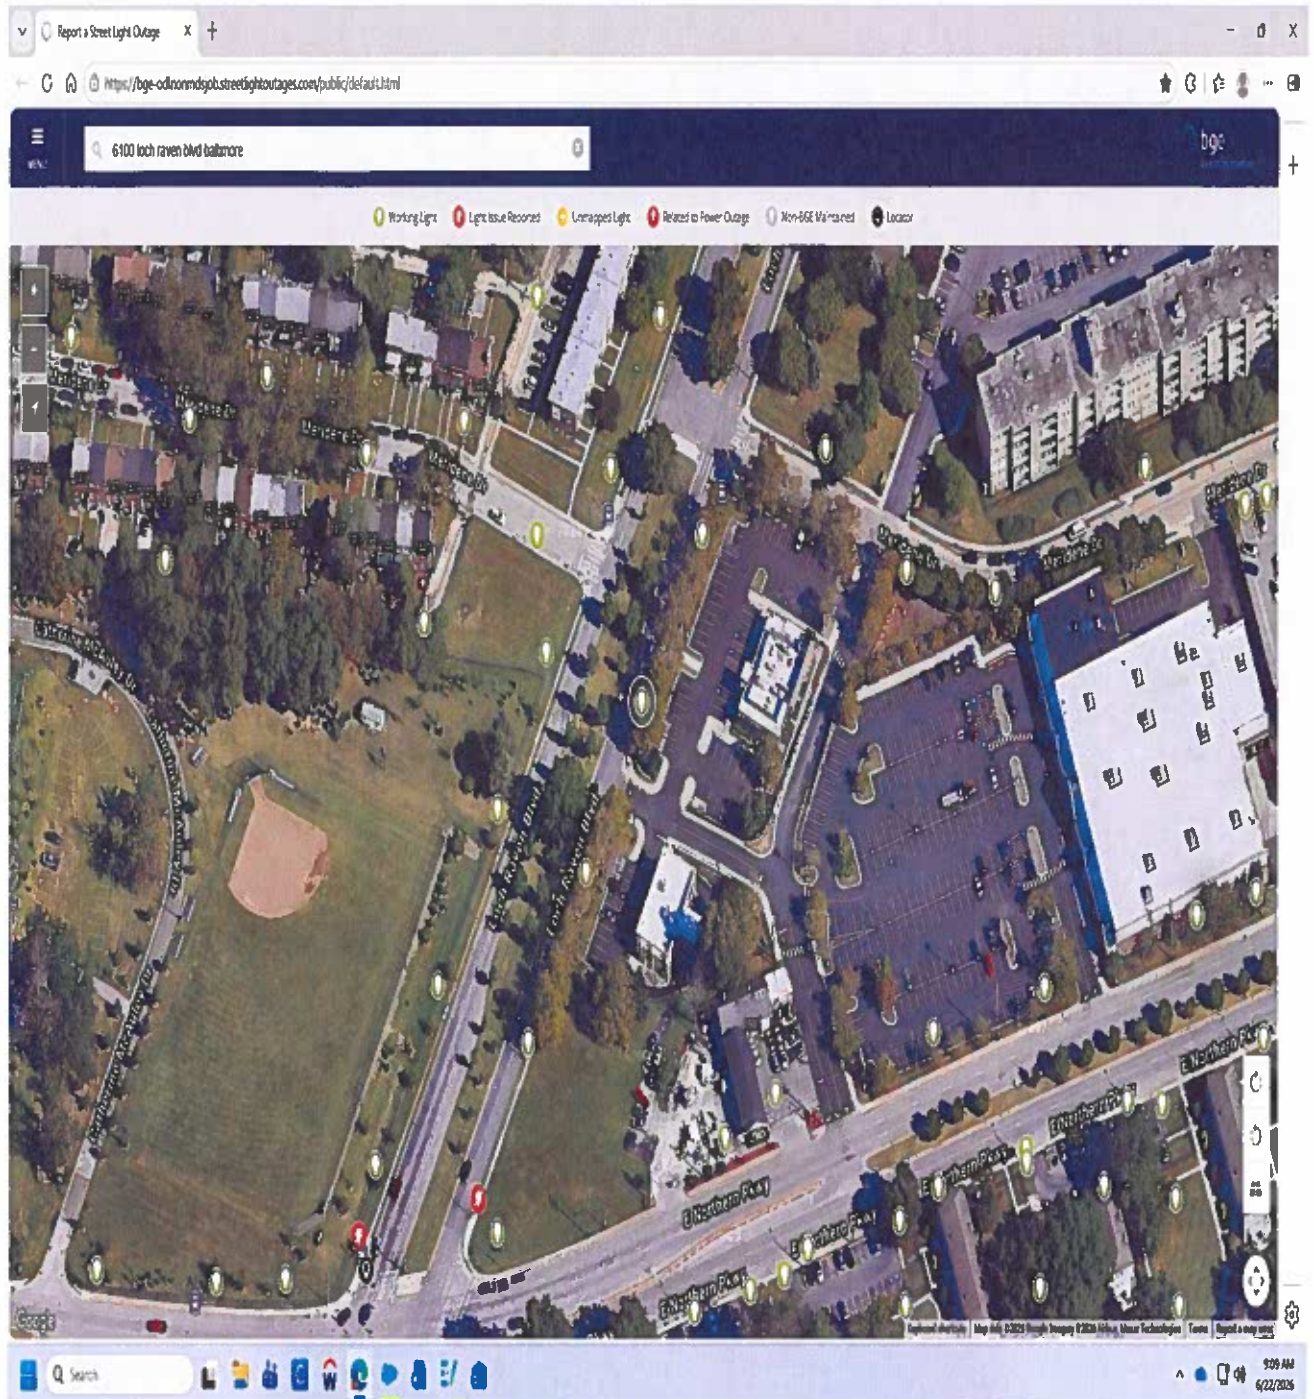
Deteriorated \_\_\_\_\_  
Missing ☒  
Damaged \_\_\_\_\_  
Arm/Fixture Missing \_\_\_\_\_  
Other \_\_\_\_\_

NEEDS  
New  
Pedestal  
Base

30 Foot Aluminum pole  
Cobra Head  
LED
