# Inspections: Damaged Pole Report

Service Request: 26-00563619 Sector: \_\_\_\_\_ Gateway: \_\_\_\_\_ Primary: \_\_\_\_\_

Location on Service Request: 2901 Fleetwood Ave

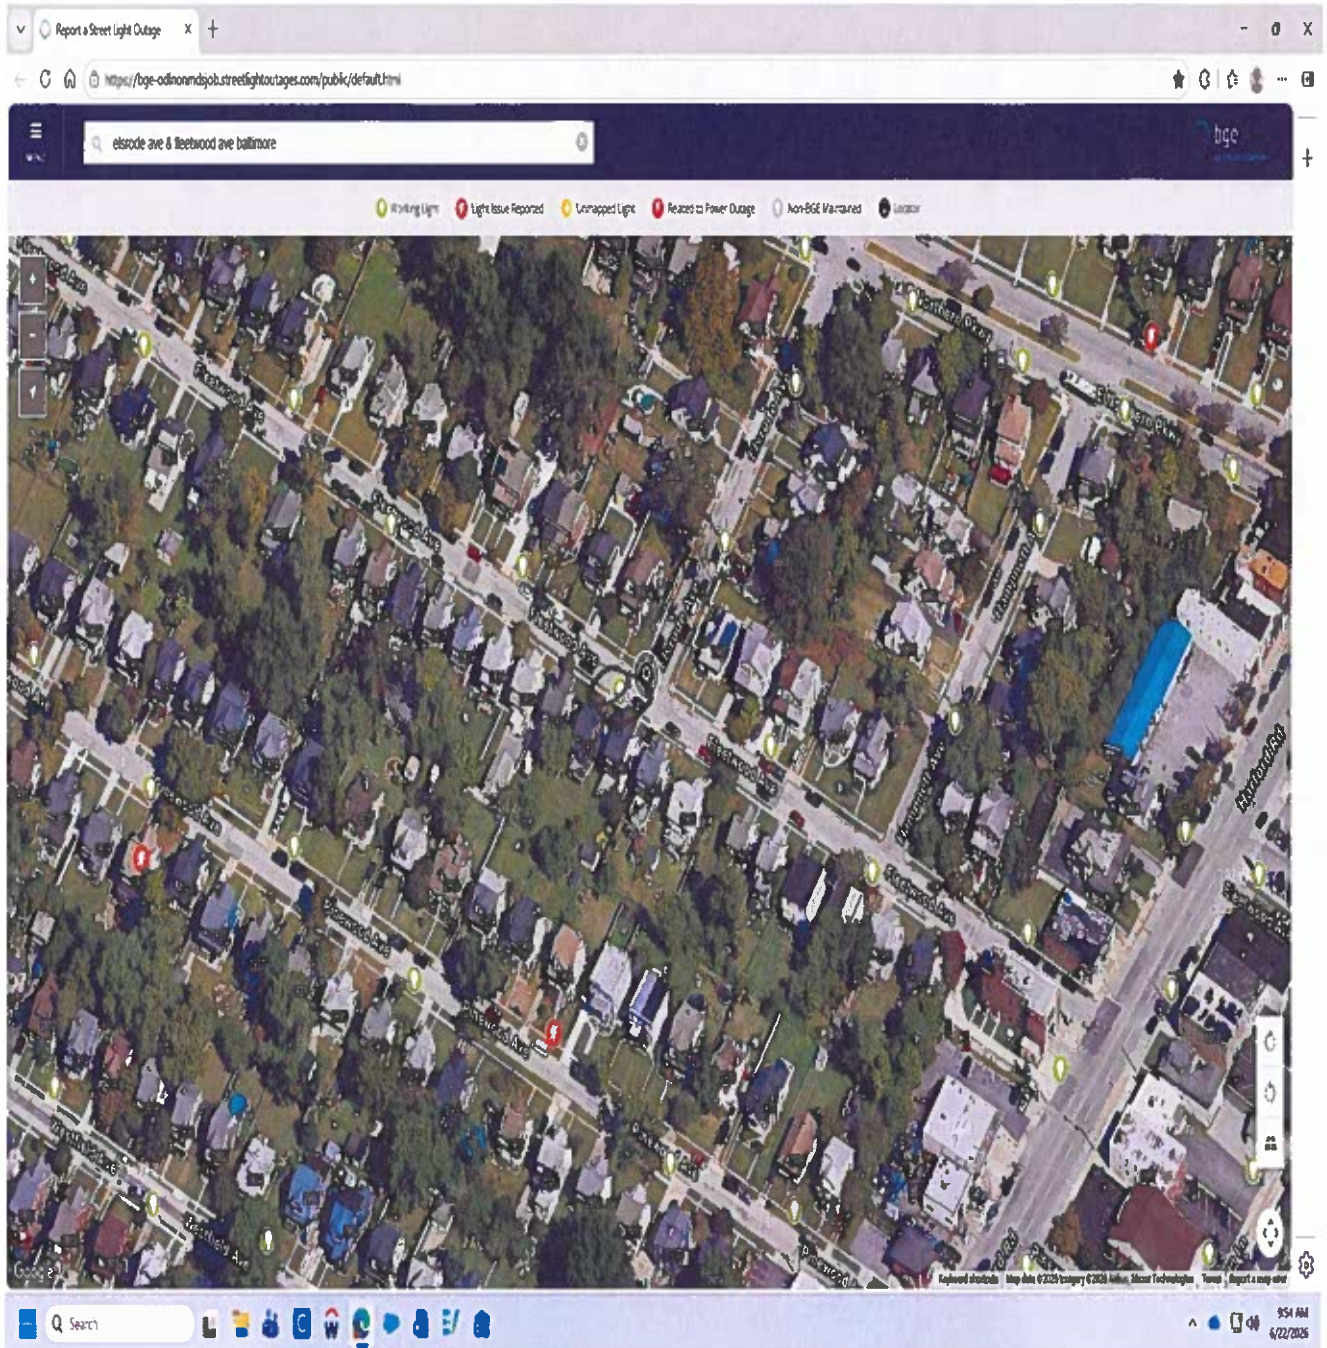
Deteriorated \_\_\_\_\_  
Missing ☒  
Damaged \_\_\_\_\_  
Arm/Fixture Missing \_\_\_\_\_  
Other \_\_\_\_\_

25 Foot  
Steel  
pole  
cobra Head  
LED

NEEDS  
New  
Base
