# Inspections: Damaged Pole Report

Service Request: 26-00577872 Sector: \_\_\_\_\_ Gateway: \_\_\_\_\_ Primary: \_\_\_\_\_

Location on Service Request: 3001 Hudson St

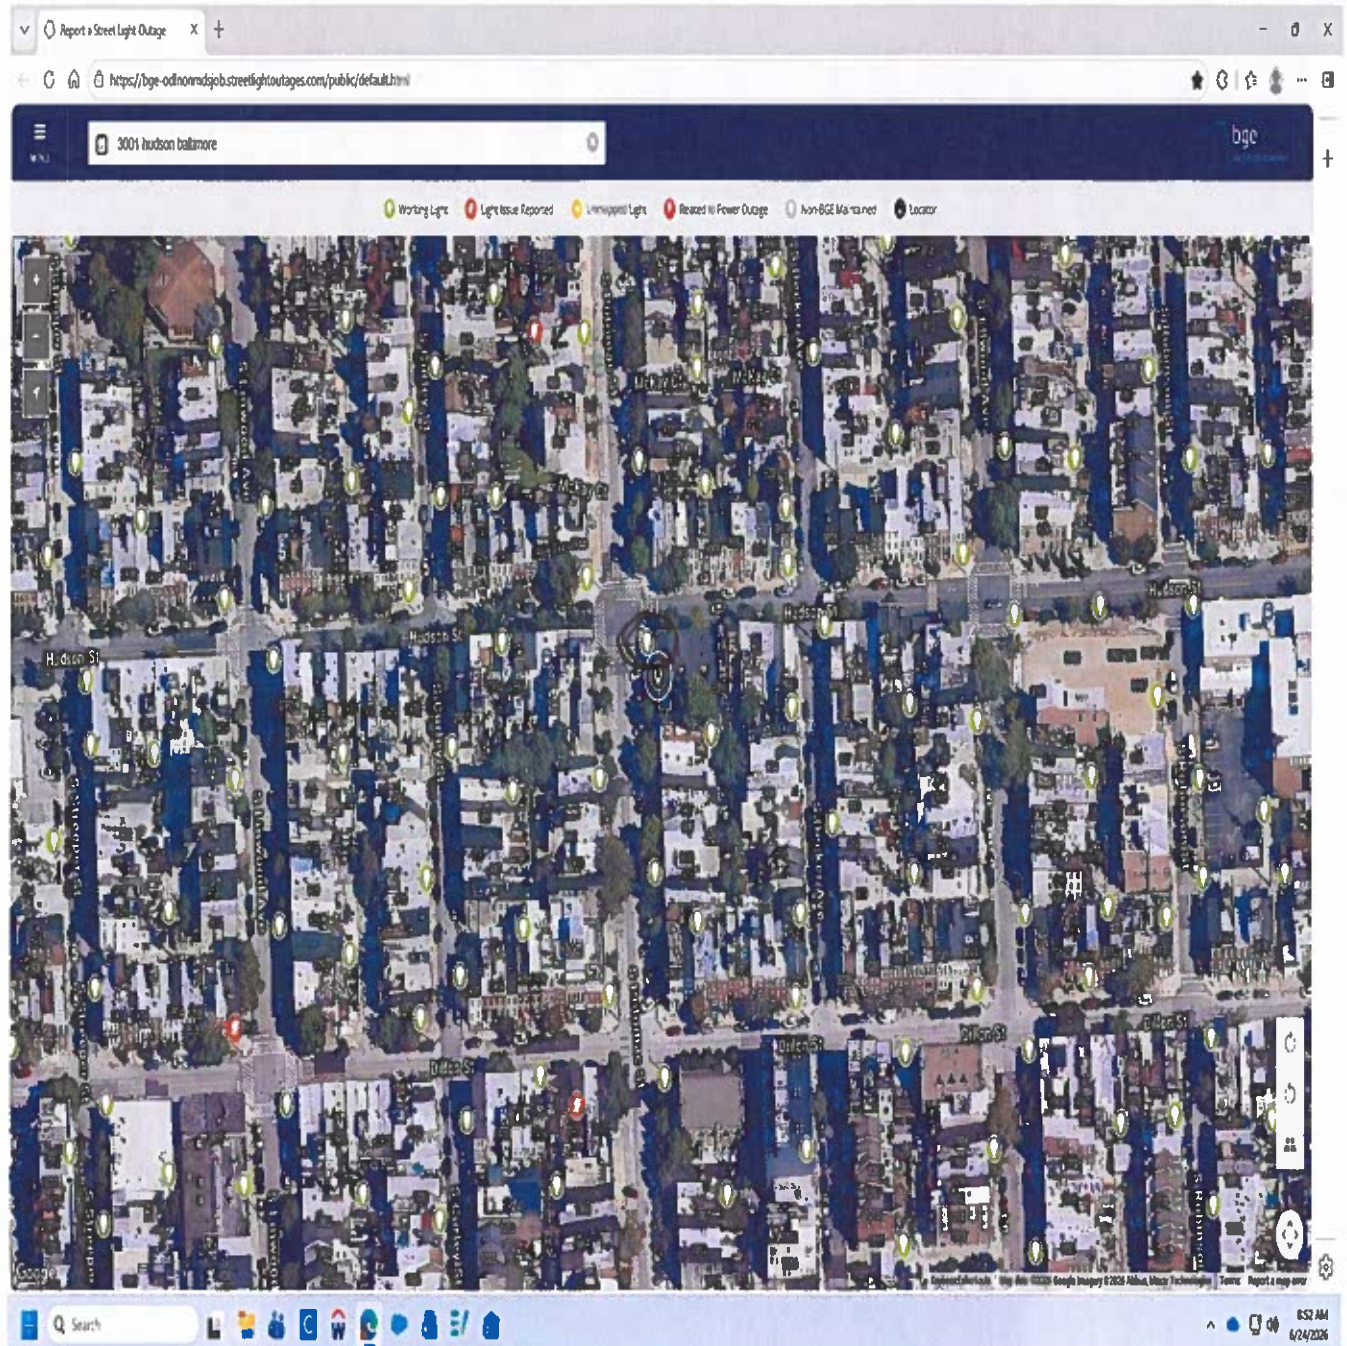
Deteriorated ☒

Missing ☒

25 Foot Aluminum  
pole  
Cobra Head  
LED
