# HOME LAND

## ENVIRONMENTAL

| 3503 Greenspring Avenue | Tyler Young |

Monday, June 15, 2026

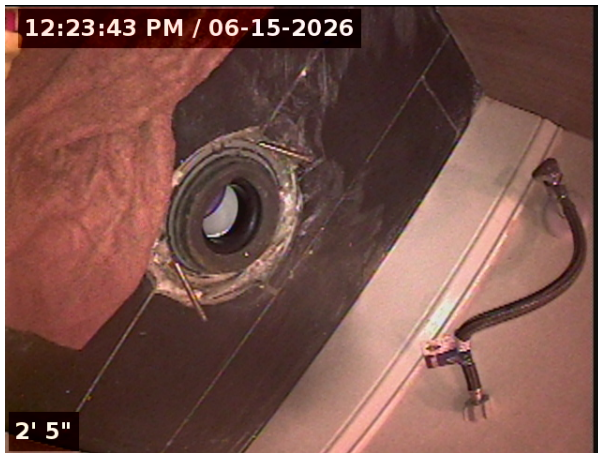
2' 5"

Showing the access to the sewer line. The basement toilet was pulled by another contractor, prior to arrival.

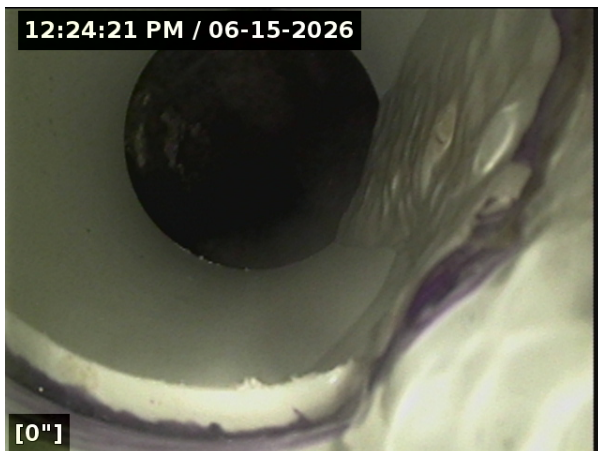
0"

The camera enters the sewer line. Water is entering the line from the basement bathroom sink.

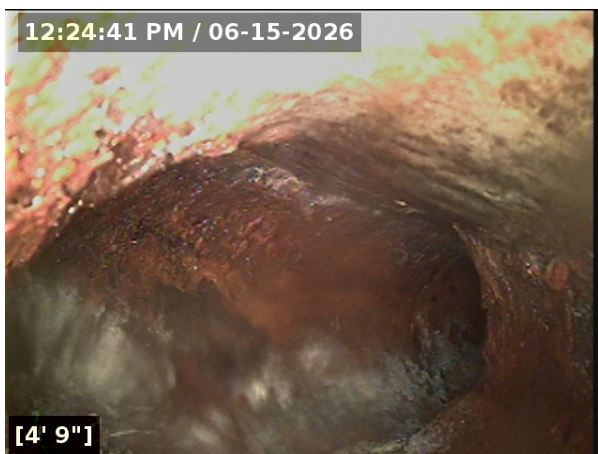
4' 9"

At approximately 5 feet, the line meets another sewer line under the foundation of the house.
