Inspections: Damaged Pole Report

Service Request: 26-00623367 Sector: \_\_\_\_\_ Gateway: \_\_\_\_\_ Primary: \_\_\_\_\_  
Location on Service Request: 700 N. Howard St  
Grid: 3010120 LLC: 7383

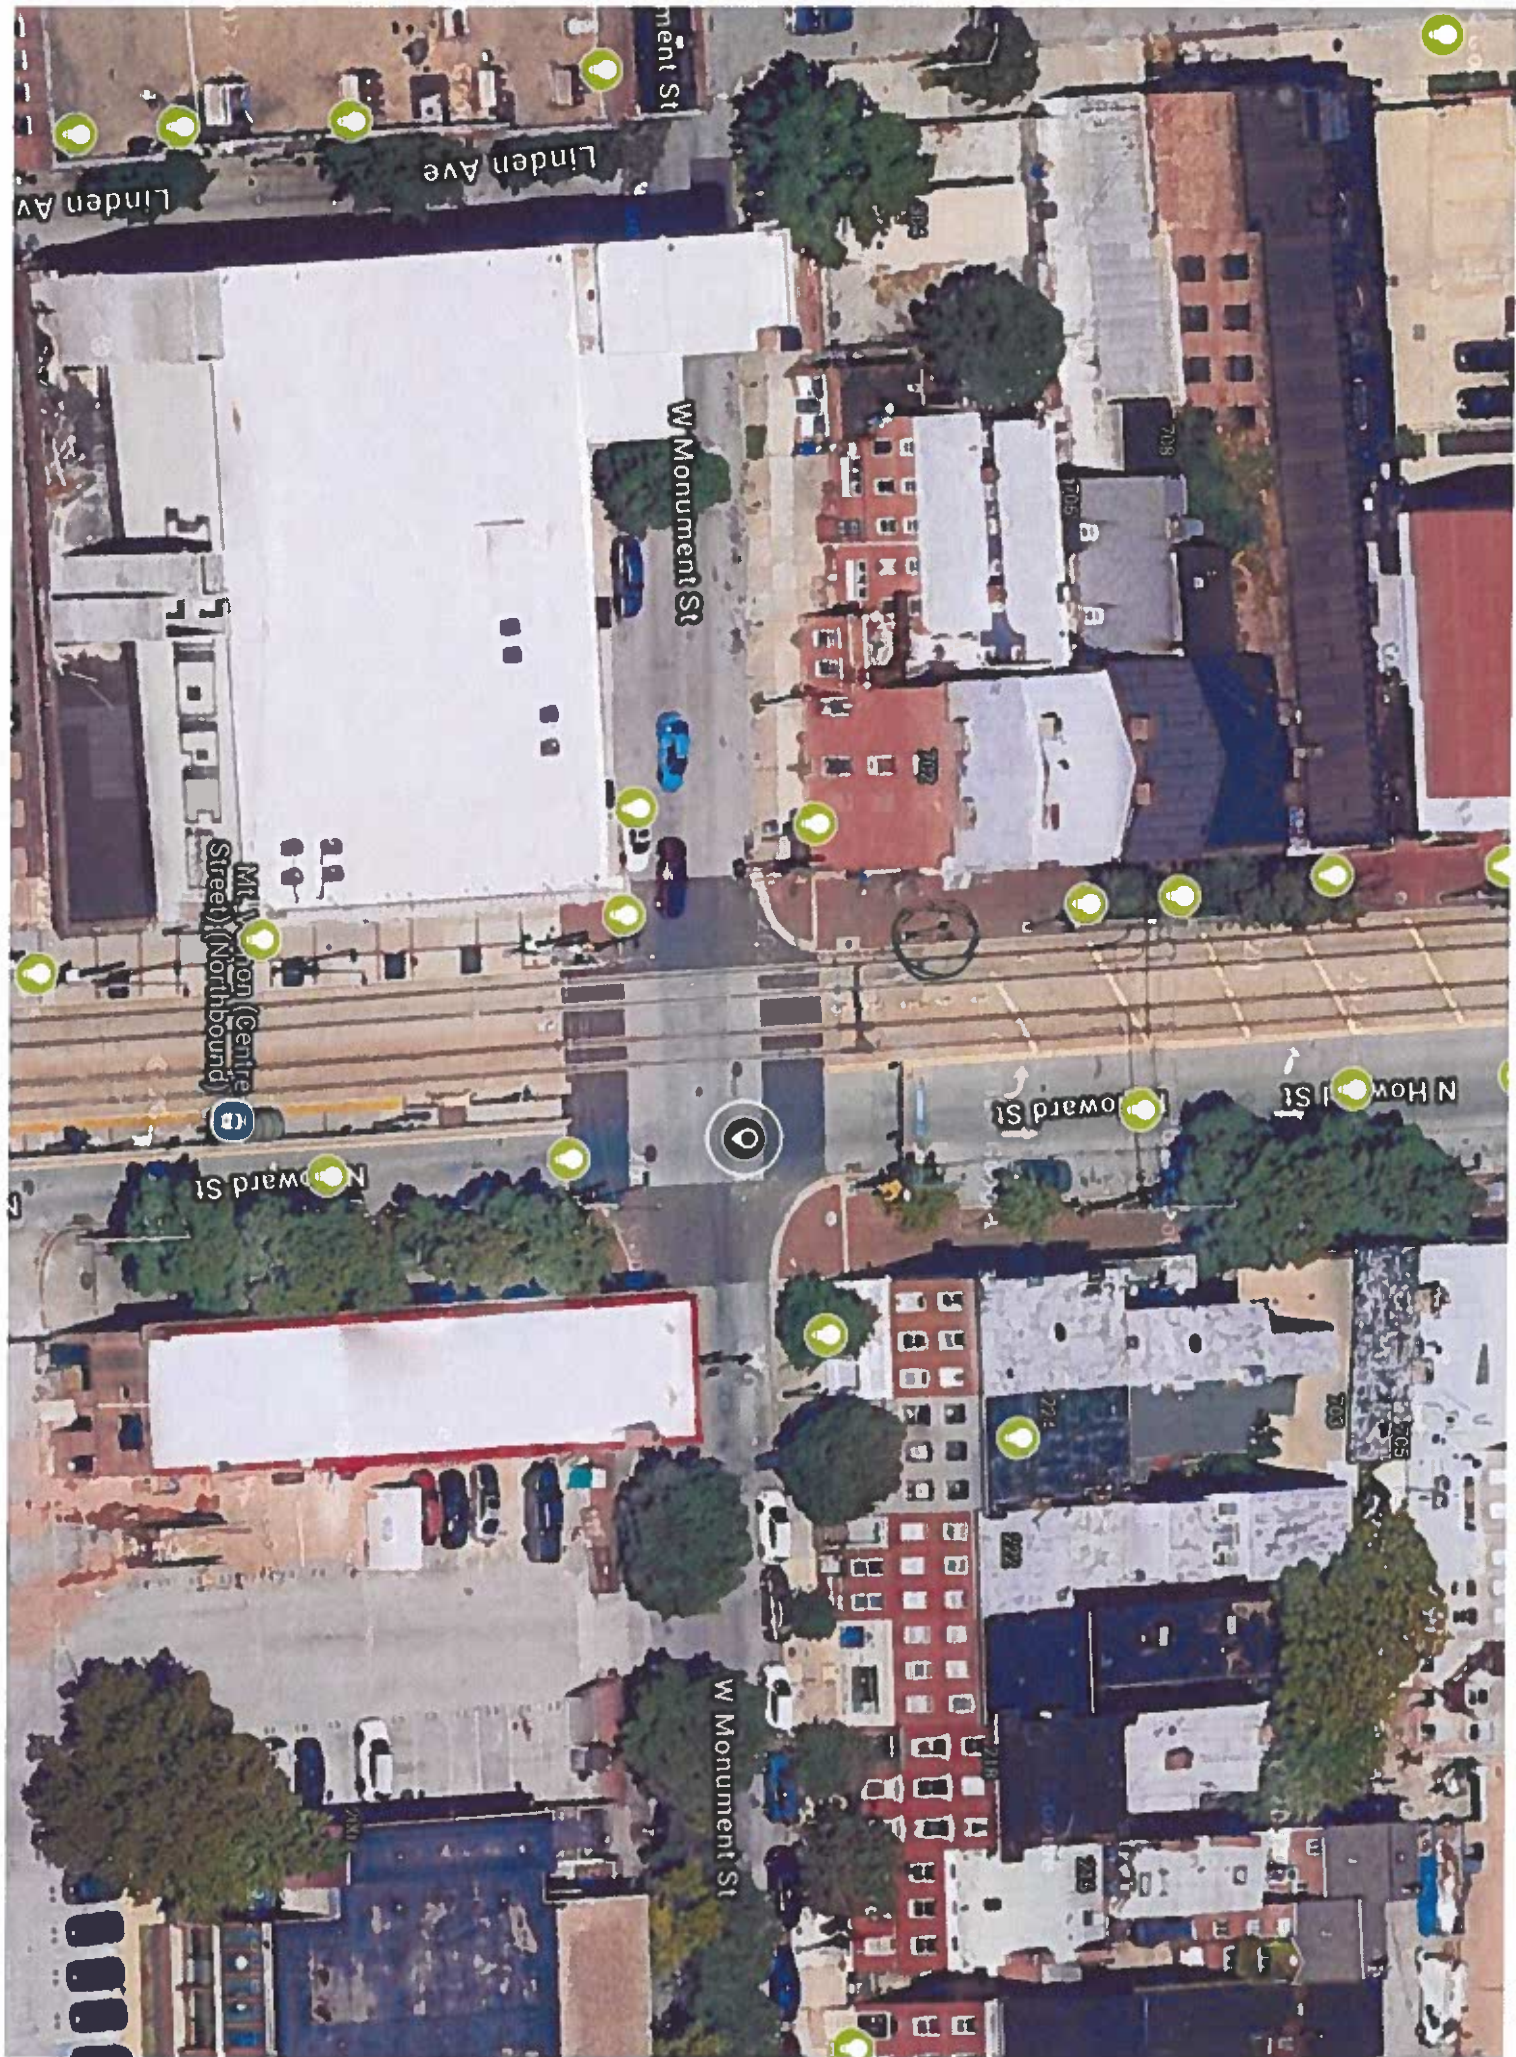
Deteriorated \_\_\_\_\_  
Missing ☒  
Damaged \_\_\_\_\_  
Arm/Fixture Missing \_\_\_\_\_  
Other \_\_\_\_\_
