# Inspections: Damaged Pole Report

Service Request 26-00618223 Sector: \_\_\_\_\_ Gateway: \_\_\_\_\_ Primary: \_\_\_\_\_

Location on Service Request: 936 E. Eager St

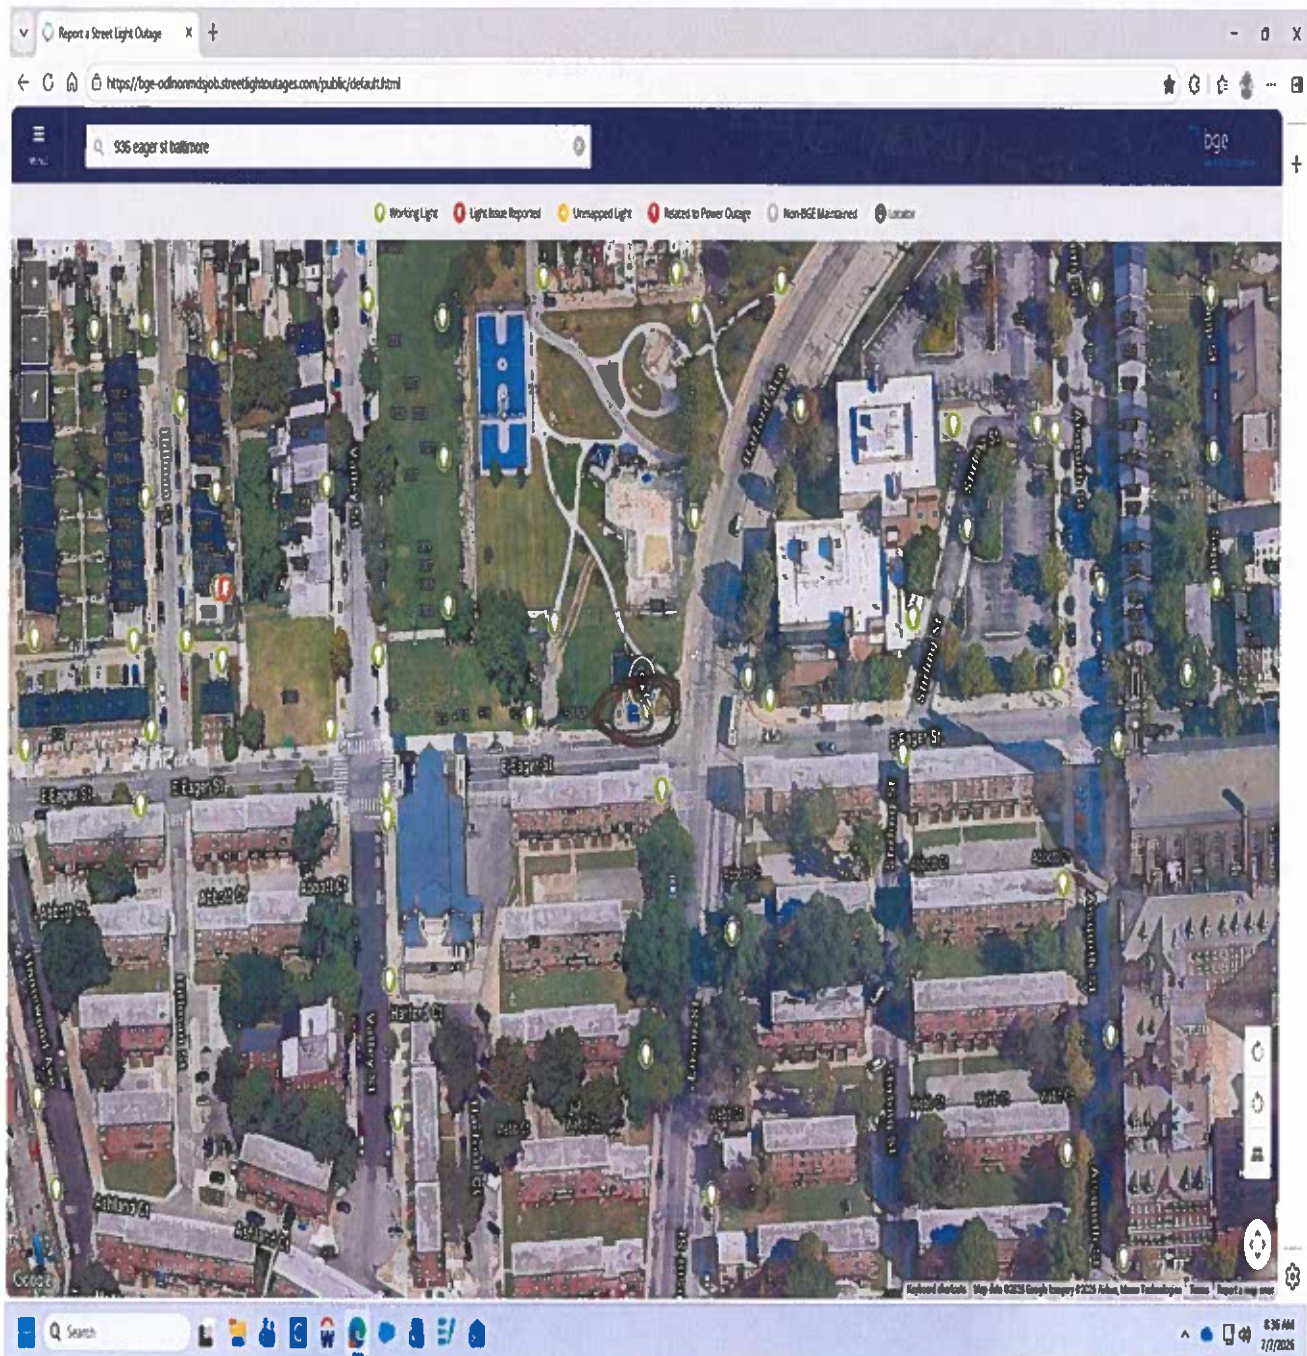
Deteriorated \_\_\_\_\_  
Missing ☒  
Damaged \_\_\_\_\_  
Arm/Fixture Missing \_\_\_\_\_  
Other \_\_\_\_\_

**NEEDS  
New  
Base**

30 Foot  
Steel  
pole  
Cobra Head  
LED

**WORK ORDER #  
21075614**
