# Inspections: Damaged Pole Report

Service Request 26-00622492 Sector: \_\_\_\_\_ Gateway: \_\_\_\_\_ Primary: \_\_\_\_\_

Location on Service Request: 1700 Fort Ave

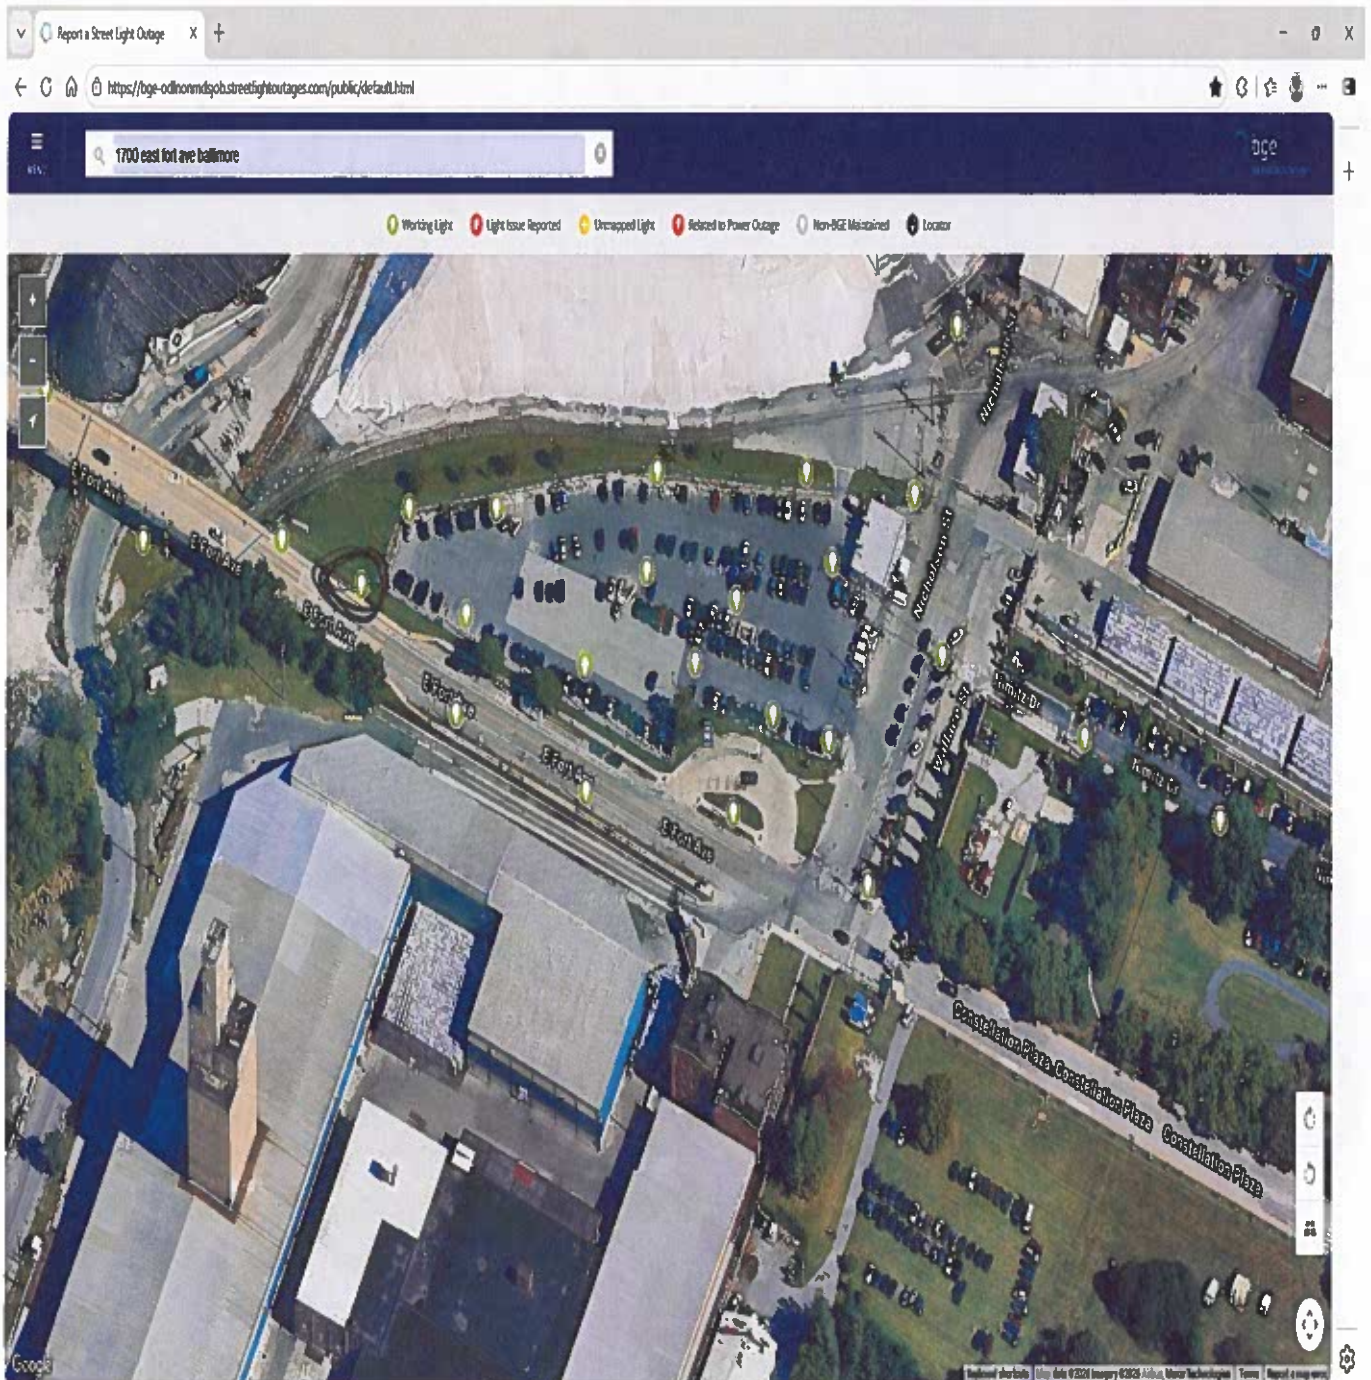
Missing ☒

30 Foot Aluminum  
pole  
Cobra Head  
LED
