# Inspections: Damaged Pole Report

Service Request 26-00621110 Sector: \_\_\_\_\_ Gateway: \_\_\_\_\_ Primary: \_\_\_\_\_

Location on Service Request: 1100 Borough Ave

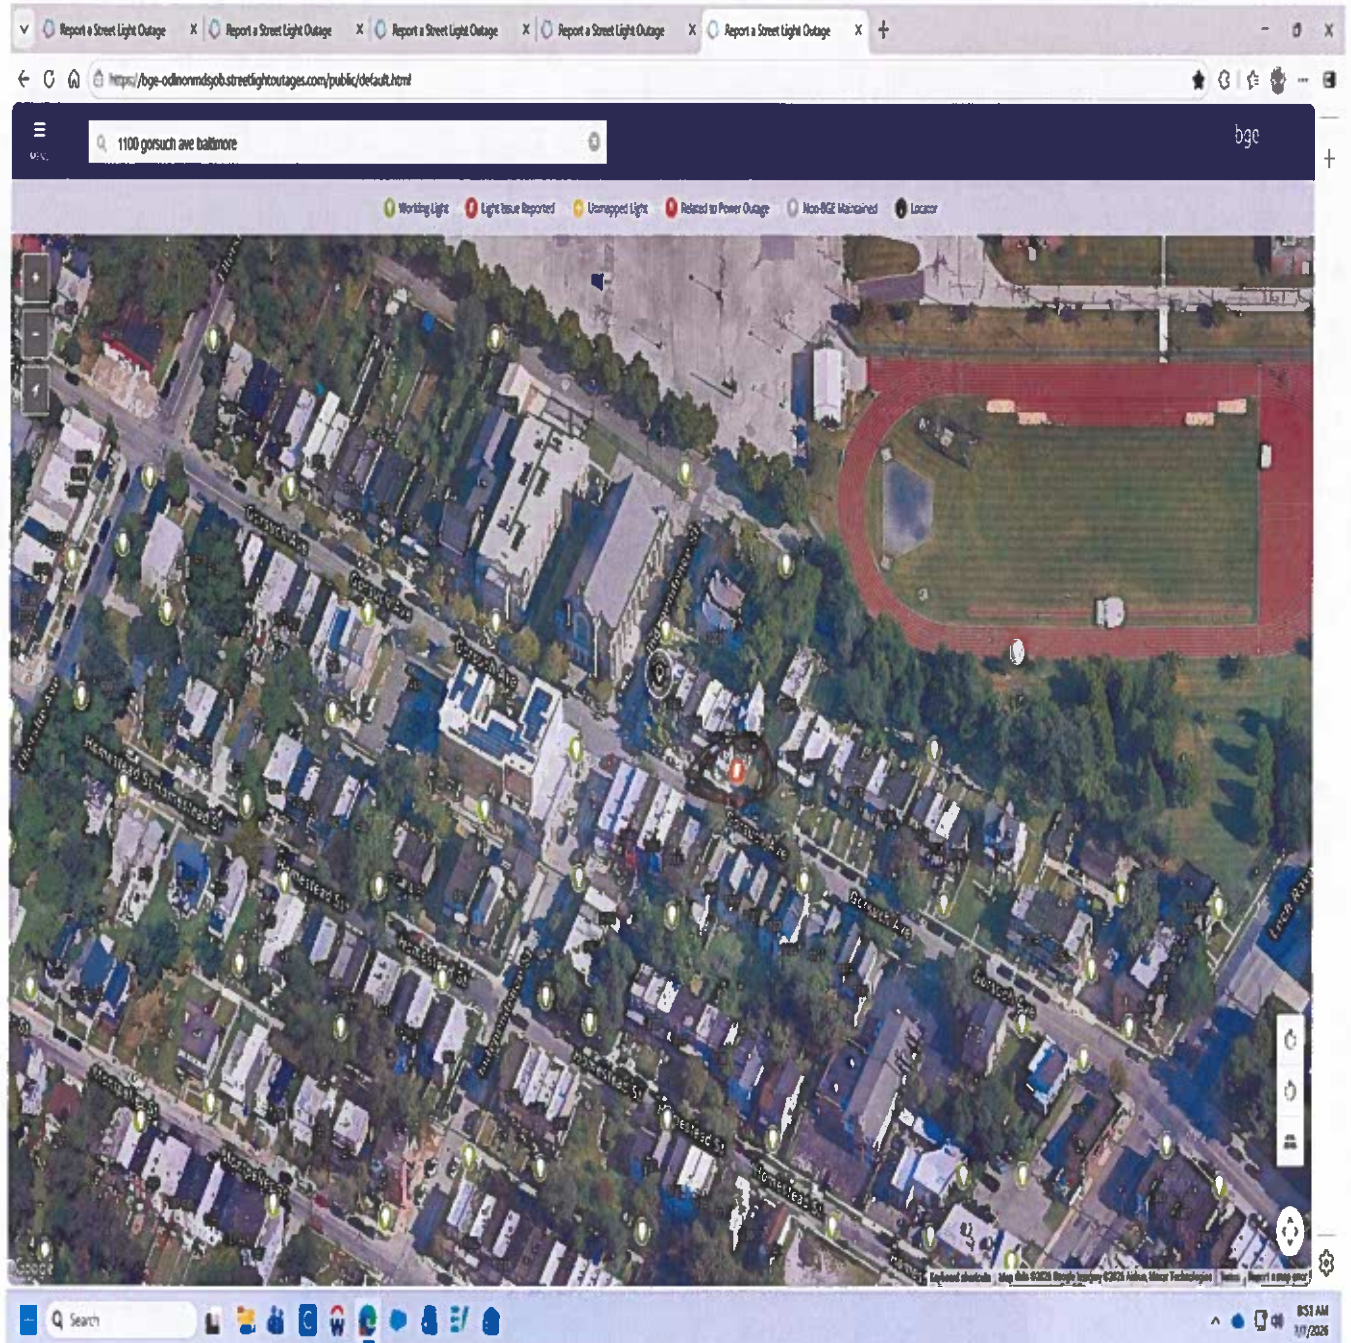
Deteriorated \_\_\_\_\_  
Missing ☒  
Damaged \_\_\_\_\_  
Arm/Fixture Missing \_\_\_\_\_  
Other \_\_\_\_\_

Damaged \_\_\_\_\_  
Missing ☒

25 Foot  
Aluminum pole  
Cobra Head  
LED

**NEEDS  
New  
Base**

**Work Order #  
21072740**
