# Inspections: Damaged Pole Report

Service Request: 26-00640669 Sector: \_\_\_\_\_ Gateway: \_\_\_\_\_ Primary: \_\_\_\_\_

Location on Service Request: 3400 Elmora Ave

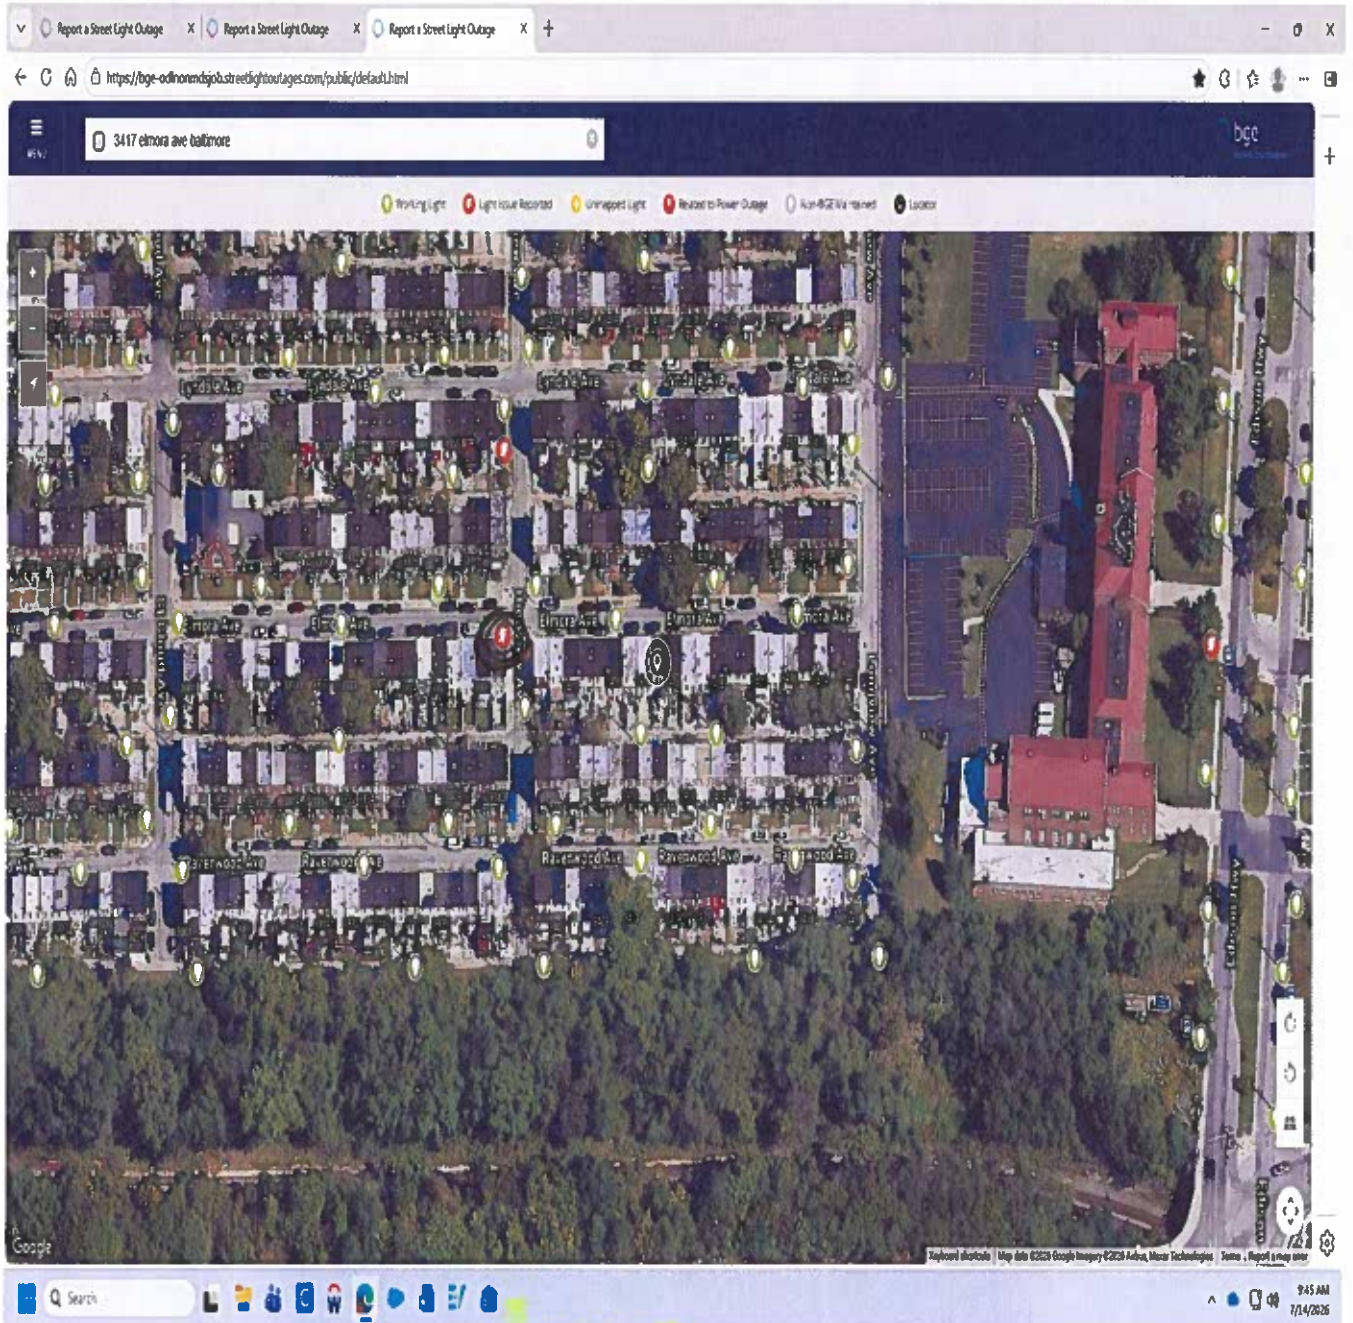
Missing ☒

NEEDS  
New  
Base

PMA  
LED

work order #  
21048651
