# Inspections: Damaged Pole Report

Service Request: 26-00643201 Sector: \_\_\_\_\_ Gateway: \_\_\_\_\_ Primary: \_\_\_\_\_  
 Location on Service Request: 1005 Brantley Ave  
 Grid : 3010220 LLC: 7133

Street: Brantley Ave  
 Side of Street: N/S \_\_\_\_\_ E/S ☒ S/S \_\_\_\_\_ W/S \_\_\_\_\_  
 Pole location: 1<sup>st</sup> ☒ 2<sup>nd</sup> \_\_\_\_\_ 3<sup>rd</sup> \_\_\_\_\_ 4<sup>th</sup> \_\_\_\_\_ 5<sup>th</sup> \_\_\_\_\_ 6<sup>th</sup> \_\_\_\_\_ Other \_\_\_\_\_  
 Direction : N/O \_\_\_\_\_ E/O \_\_\_\_\_ S/O ☒ W/O \_\_\_\_\_  
 Street or Landmark: N. Schneider St

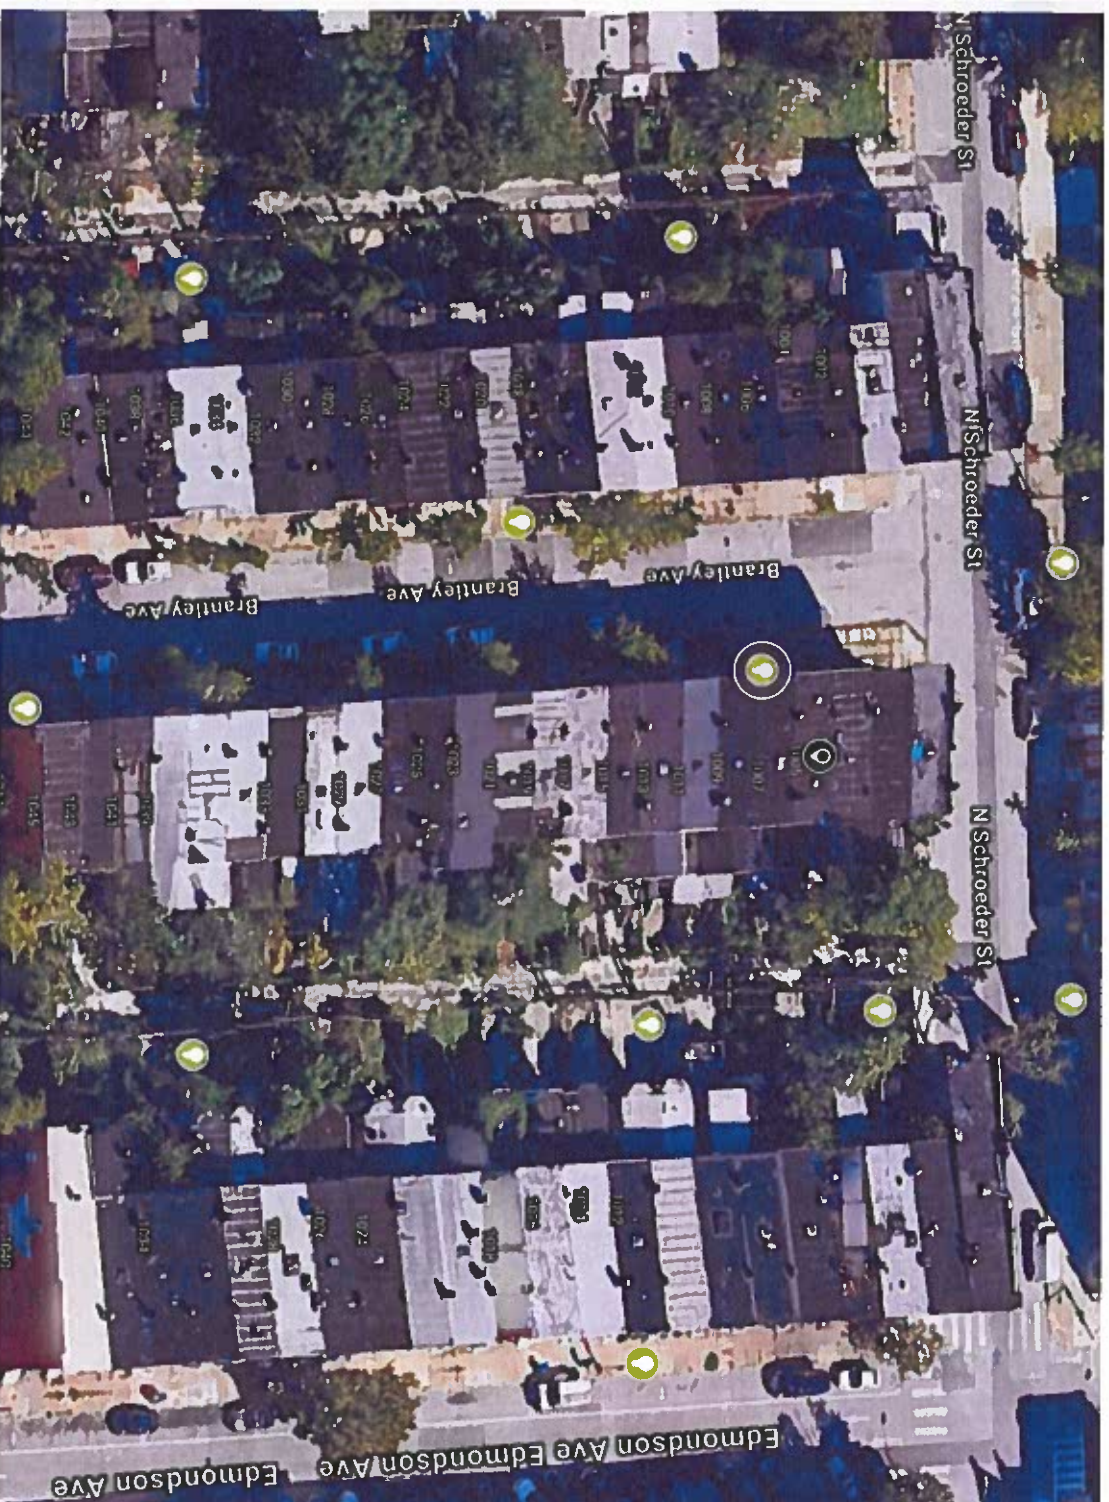
30102207133

HERE ARE THE KNOWN LOCATIONS FOR THIS LIGHT.
