# Inspections: Damaged Pole Report

Service Request: 26-00659813 Gateway: \_\_\_\_\_ Primary: \_\_\_\_\_

Location on Service Request: 3604 WHITE Ave

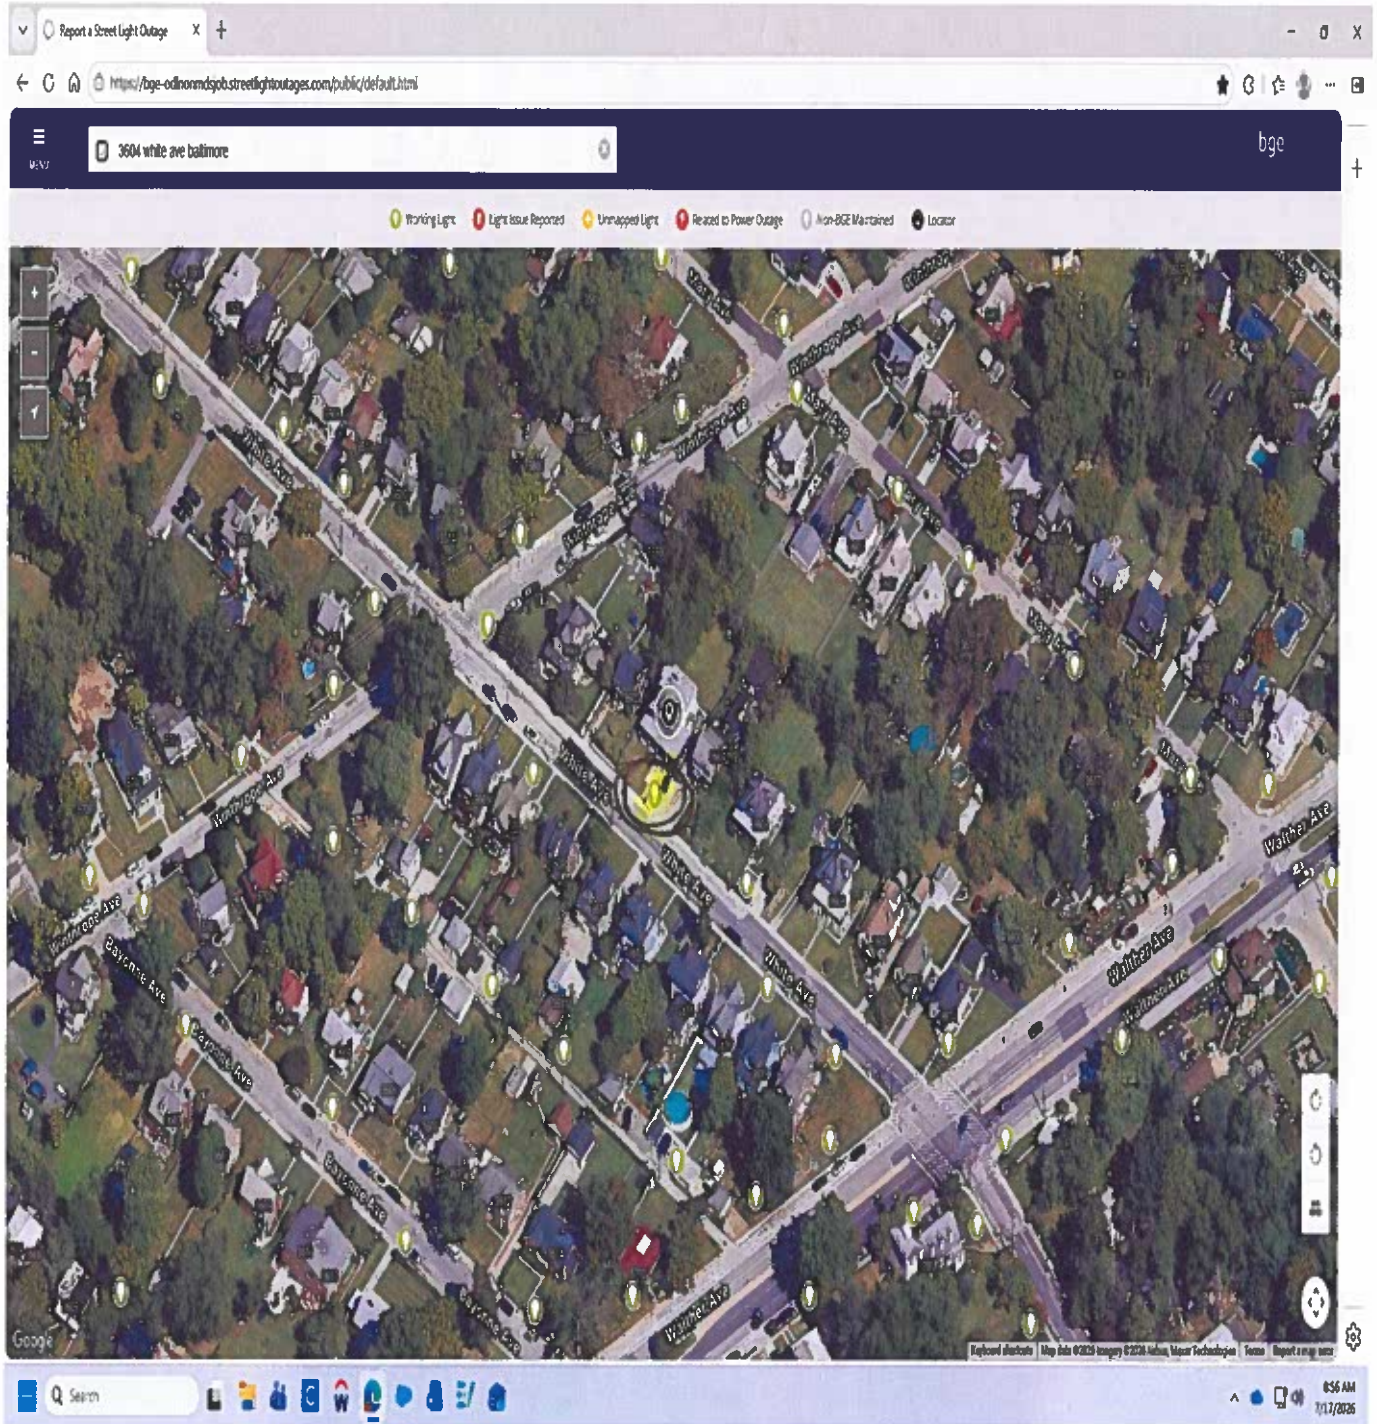
Deteriorated ☒  
Missing ☒  
Damaged \_\_\_\_\_  
Arm/Fixture Missing \_\_\_\_\_  
Other \_\_\_\_\_

**NEEDS  
New  
Base**

PMIA  
LED
