Inspections: Damaged Pole Report

Service Request: 26-00660809 Sector: \_\_\_\_\_ Gateway: \_\_\_\_\_ Primary: \_\_\_\_\_

Location on Service Request: 701 Winans Way

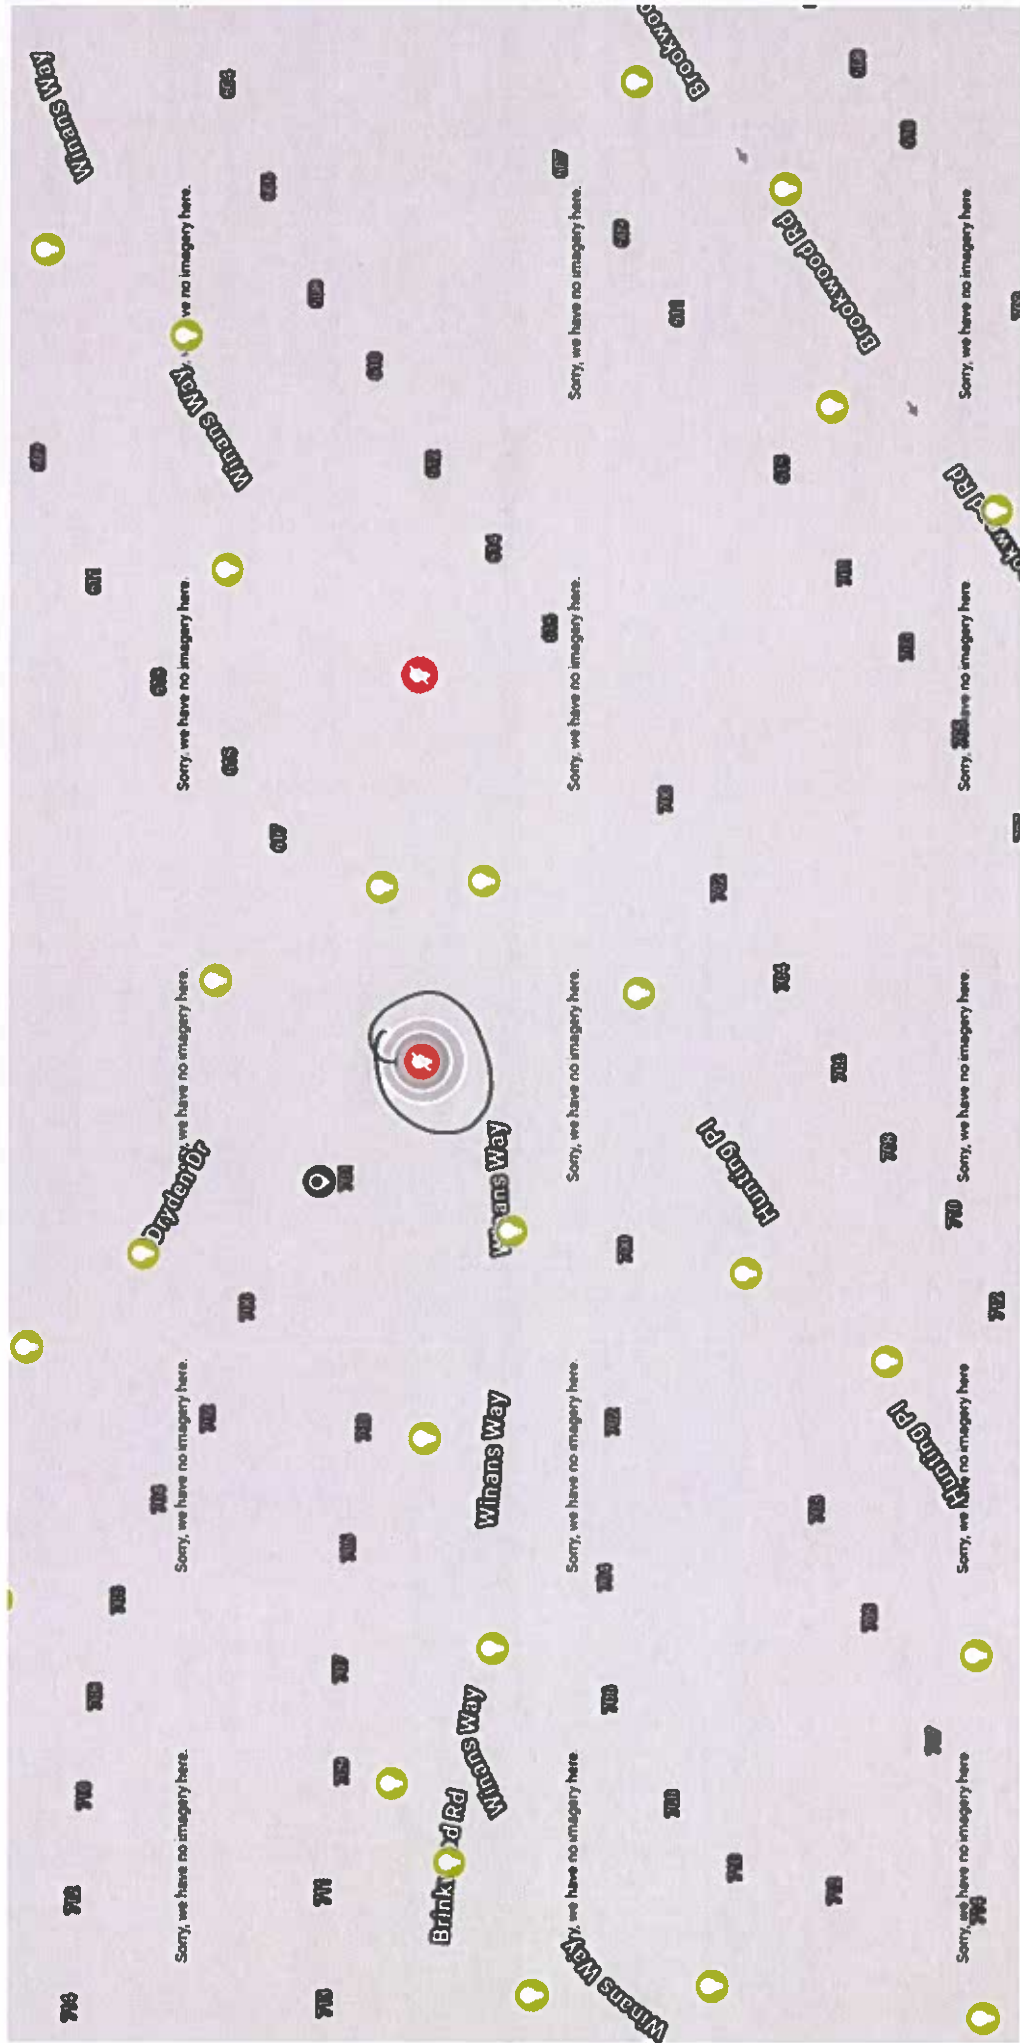
701  
Winans Way 3010 520  
12 ft Admin: Acorn Fixtures  
150 watts

Missing ☒

Bolts ☒  
Wires ☒  
Conduit ☒
