# HOME LAND

## ENVIRONMENTAL

| Location | Inspector |
|---|---|
| 624 W. 33rd Street<br>Baltimore MD. 21211 | Jason Jamison<br>Environmental Inspector |

## Camera Sewer Inspection

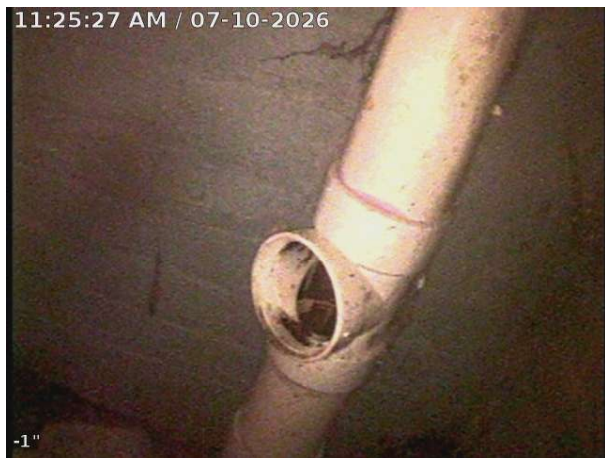
-1"

PVC cleanout in basement of 624 W. 33rd Street.

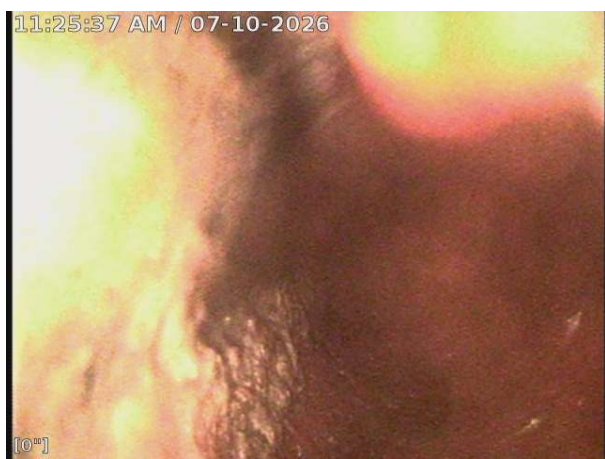
0"

\*\*\*Cast Iron pipe- typically last 40-50 years. Is prone to pitting. Pitting is corrosion of metal that can cause holes and or deterioration to develop over time. Heavy pitting can cause clogging points.

Start of cast iron sewer service pipe from cleanout in basement to sewer main in alleyway.

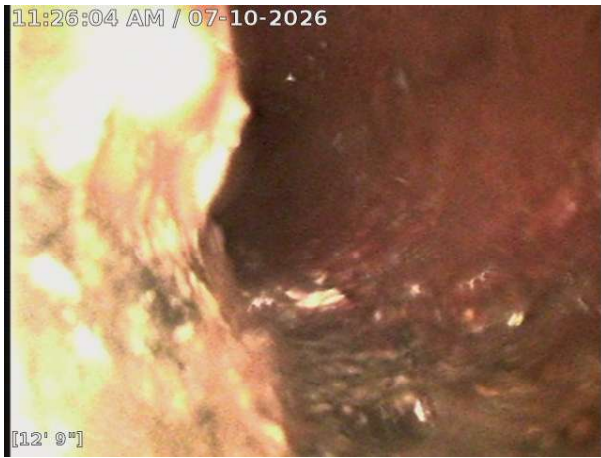
12' 9"

End of standing water in sewer service pipe.

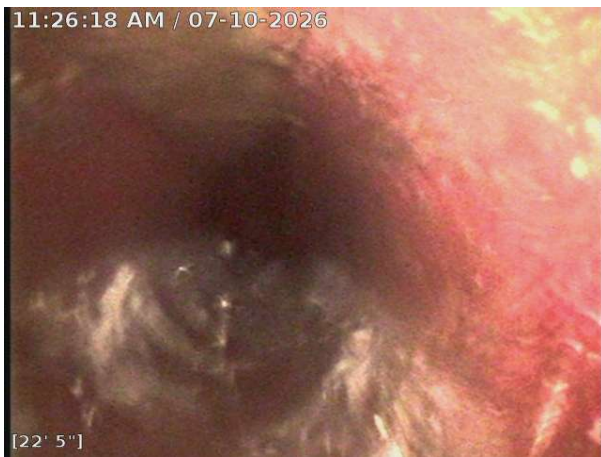
22' 5"

\*\*\*Terracotta pipe: Installed prior to the 1980's is prone to cracks and breaks as it is composed of clay. Terracotta pipe come in sections of 4-6 feet section having bell and spigot joints. As these joints are rarely sealed the have the potential to have roots and or sediment infiltrate the piping.

Change in pipe material from cast iron to terracotta.

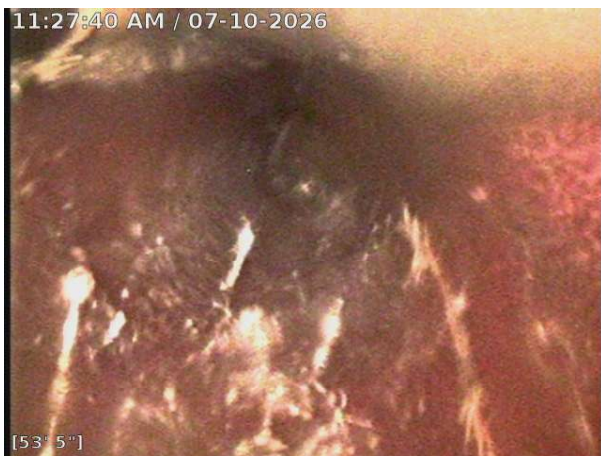
53' 5"

\*\*\*Root Intrusion- Roots infiltrate a sewer line in different ways depending on the composition of the pipe. Roots should not be present in a sewer line as they can cause clogs and or blockages. Herbaceous roots, from some shrubs and grasses, appear to be "nest like" and can fluctuate in size depending on season. Woody Roots are thick roots from trees and shrubs. These roots do not fluctuate depending on season. Roots are attracted to waste water as it is full of nitrogen and other nutrients. When roots are removed from a sewer line it is possible to find additional defects with the pipe that may causing additional remediation requirements.

Root intrusion in sewer service pipe. This a potential future clogging point.  
This is located in the public right of way.

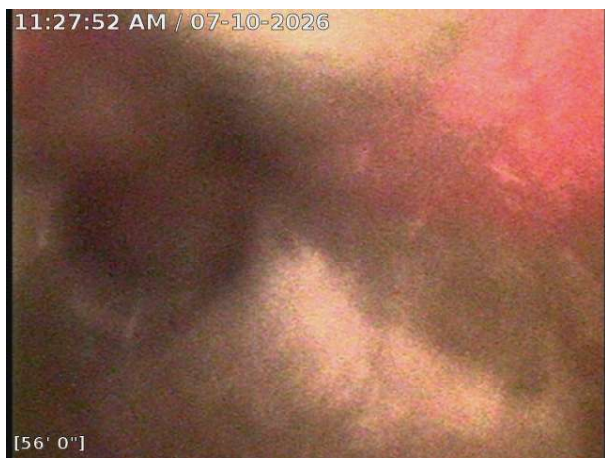
56' 0"

Left bend in sewer service pipe.
