# Inspections: Damaged Pole Report

Service Request: 26-00686479 Sector: \_\_\_\_\_ Gateway: \_\_\_\_\_ Primary: \_\_\_\_\_  
 Location on Service Request: 2301 W. Baltimore St  
 Grid : 3010 340 LLC: 7256

**Service Request Summary Report**  
**26-00686479**

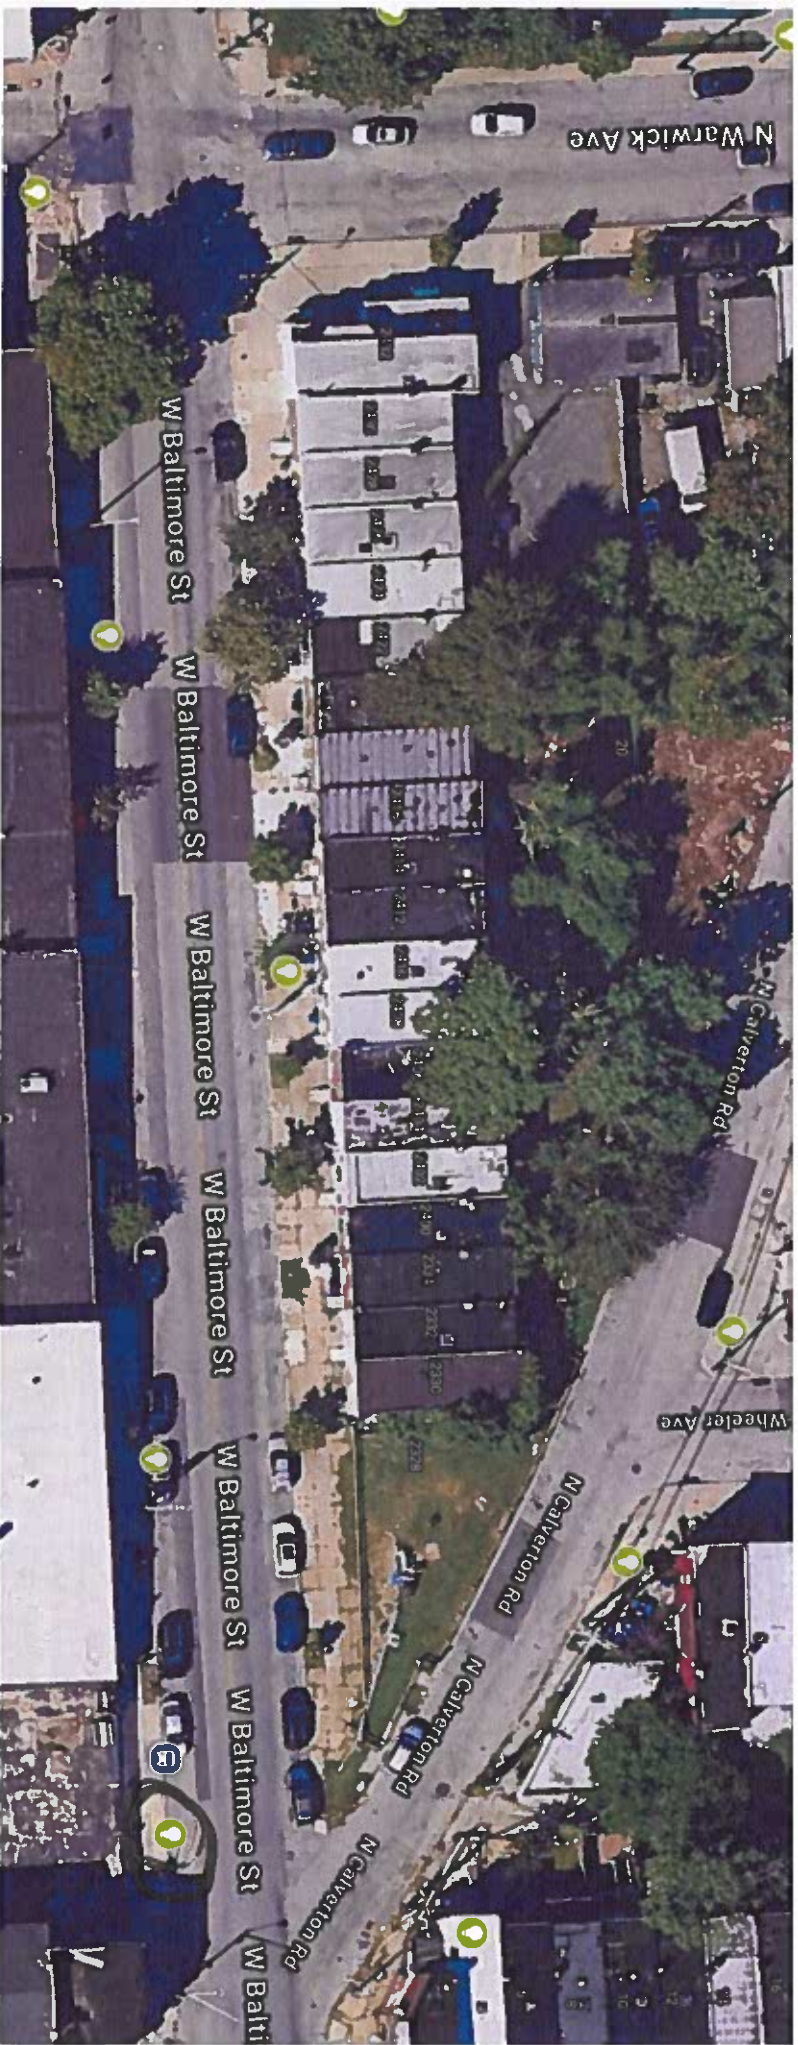
Street: W. Baltimore  
 Side of Street: N/S \_\_\_\_\_ E/S \_\_\_\_\_ S/S ☒ W/S \_\_\_\_\_  
 Pole location: 1<sup>st</sup> ☒ 2<sup>nd</sup> \_\_\_\_\_ 3<sup>rd</sup> \_\_\_\_\_ 4<sup>th</sup> \_\_\_\_\_ 5<sup>th</sup> \_\_\_\_\_ 6<sup>th</sup> \_\_\_\_\_ Other \_\_\_\_\_  
 Direction : N/O \_\_\_\_\_ E/O \_\_\_\_\_ S/O \_\_\_\_\_ W/O ☒  
 Street or Landmark: S. Calverton Rd

Deteriorated \_\_\_\_\_  
 Missing ☒  
 Damaged \_\_\_\_\_  
 Arm/Fixture Missing \_\_\_\_\_  
 Other \_\_\_\_\_
