# Inspections Damaged Pole Report

Service Request 26-00705208 Sector 712 Gateway So Hawaver St Primary 7501

Location on Service Request: 712 So Hawaver St

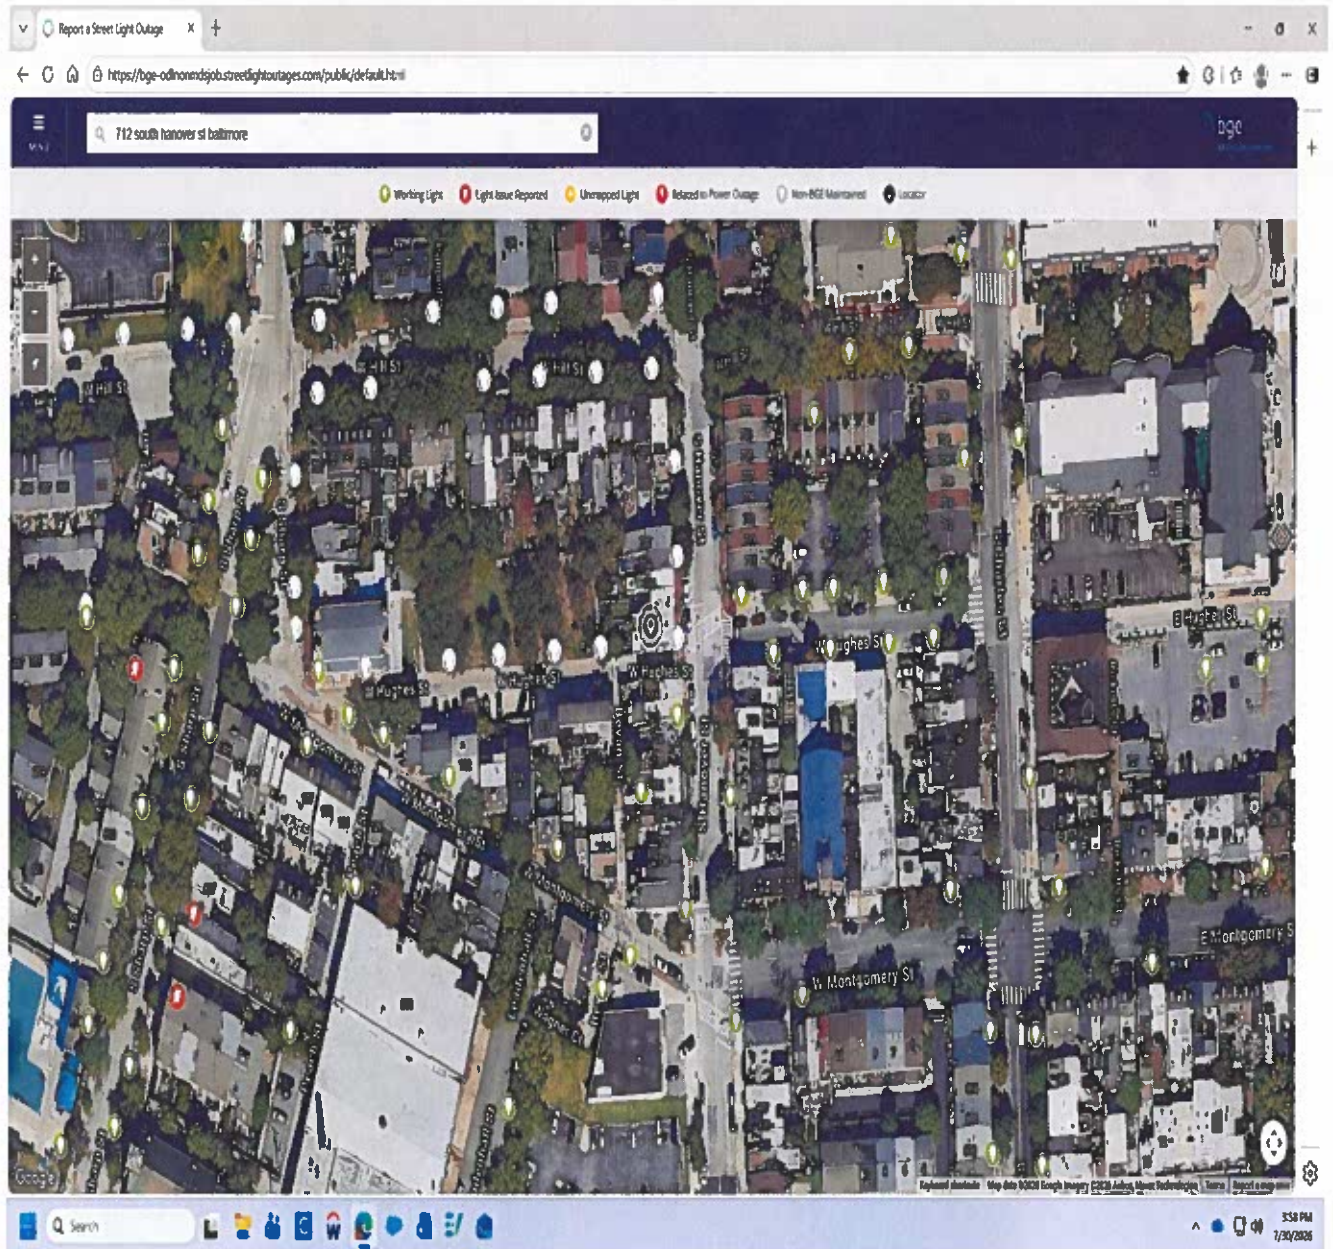
Other been pole  
Other been fixture
