Inspections: Damaged Pole Report

Service Request: 26-00706227 Sector:            Gateway:            Primary:

Location on Service Request: 901 Woodson Rd

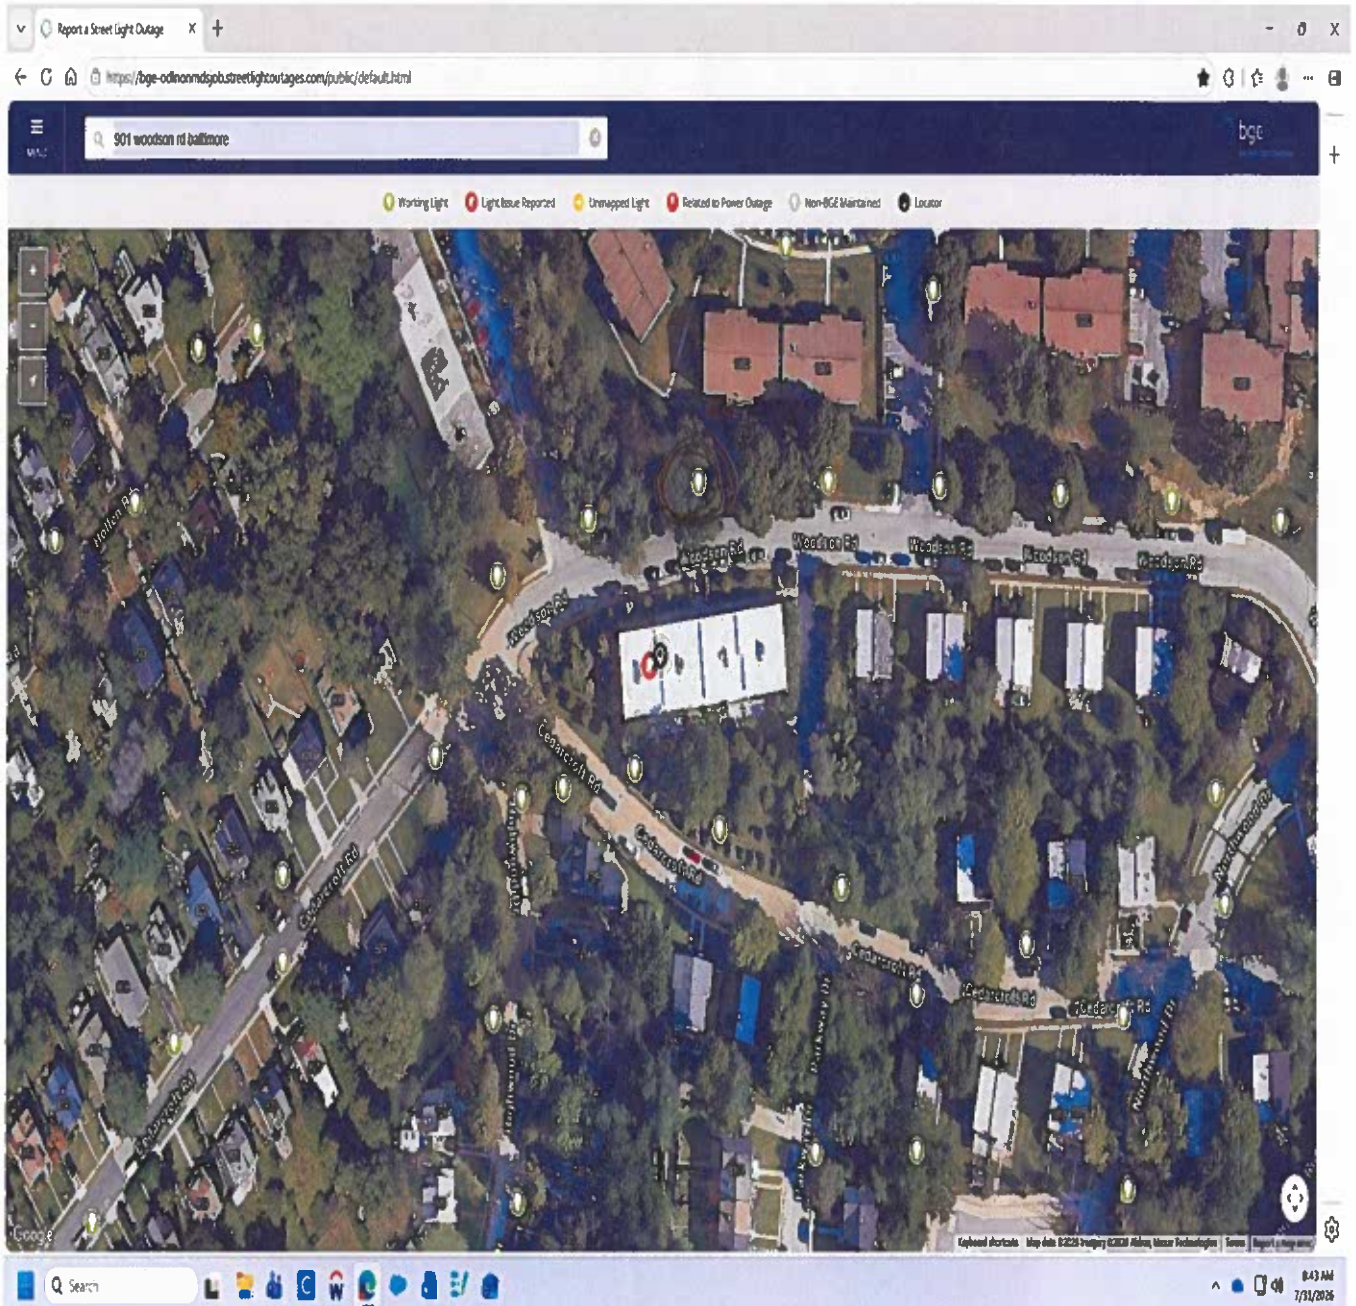
Deteriorated ✓  
Missing ✓  
Damaged             
Arm/Fixture Missing             
Other

**NEEDS  
New  
Base**

25 Foot Aluminum  
pole  
cobra head  
LED
