Inspections: Damaged Pole Report

Service Request 26-0077255 to Gateway, Prim Rd  
 Location on Service Request: 3400 Edgewood  
 Grid : 1020420 LLC: 7174

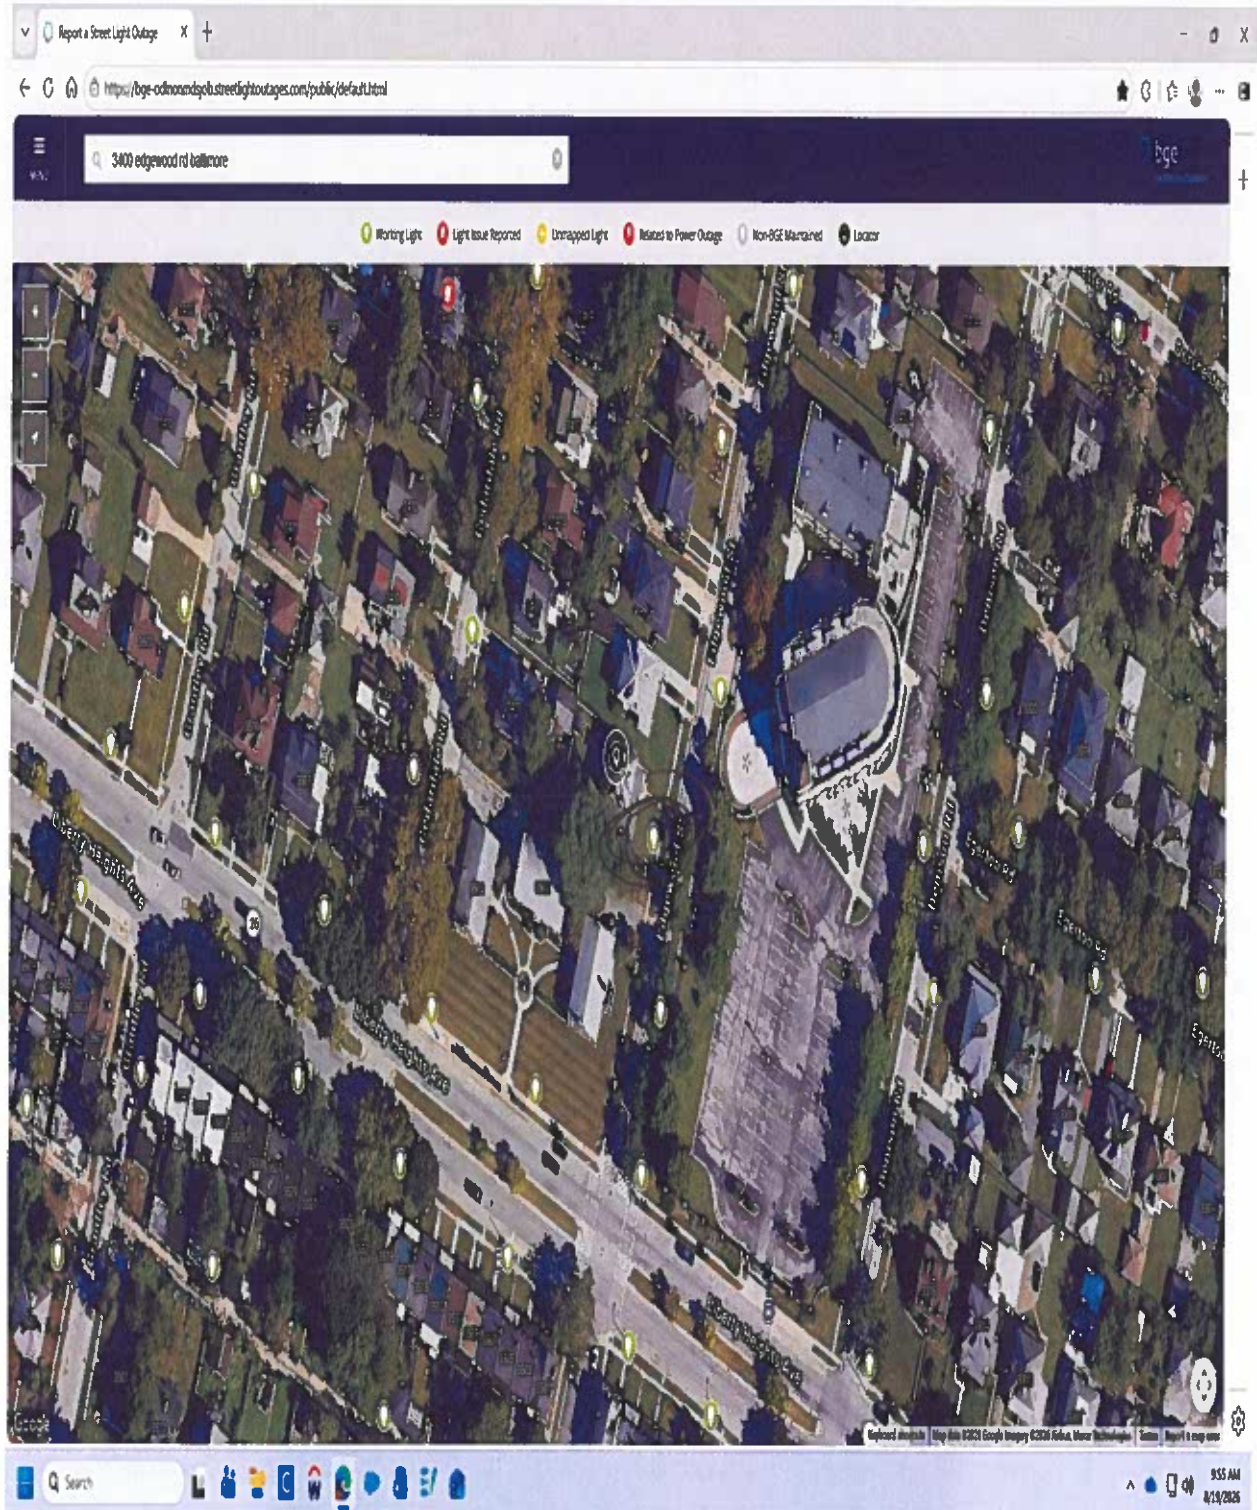
Deteriorated \_\_\_\_\_  
 Missing ✓  
 Damaged \_\_\_\_\_  
 Arm/Fixture Missing \_\_\_\_\_  
 Other \_\_\_\_\_

NEEDS  
NEW  
BASE

PMA  
LED
