### Domestic Water System Testing:

**Performed complete electronic leak detection of the domestic hot/cold water system. The following type of leak was located.**

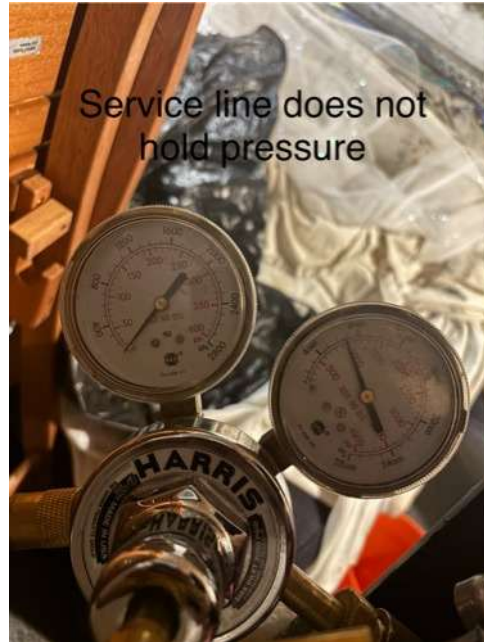
Pressure Test - Image(s):

0

Test Failed. Tested for 20 minutes or less with total pressure loss.

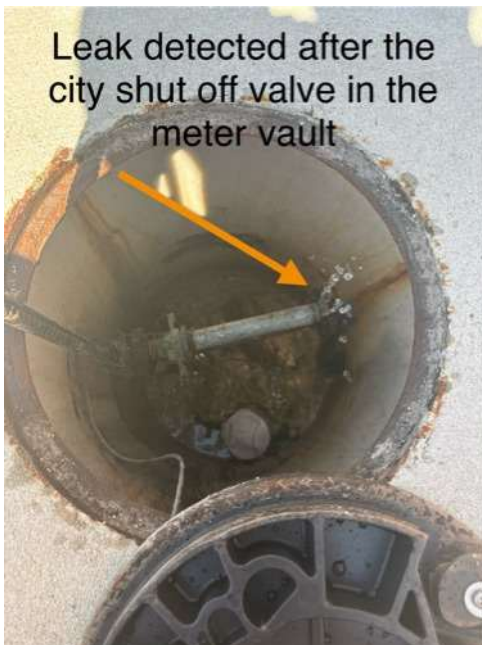
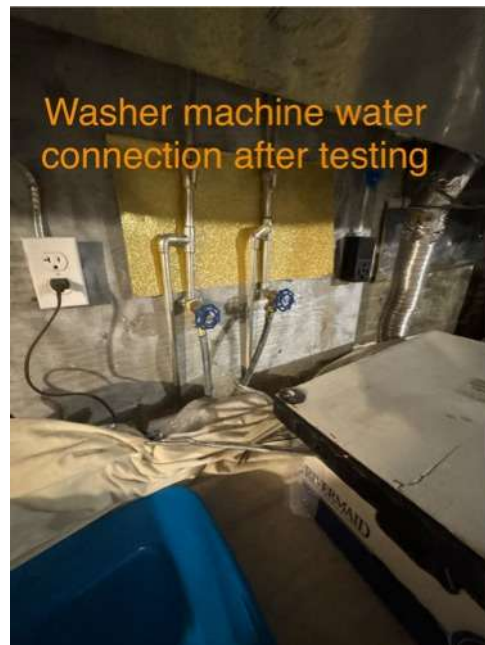
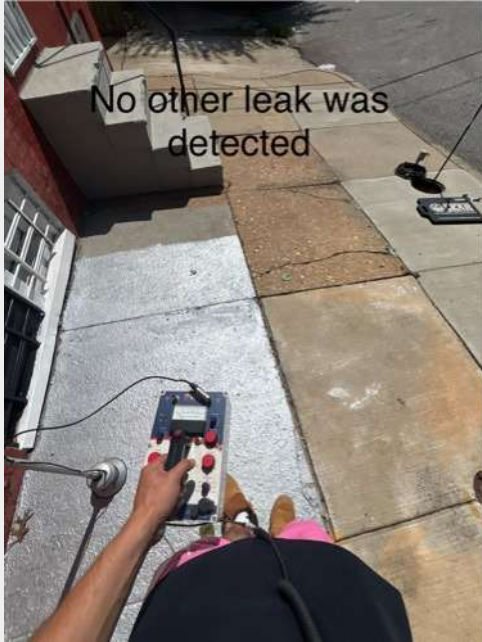
**Marked leak location - Image(s):**

Service Line

In Front Yard

Galvanized

Leak located inside the better vault after the city main shut off valve

The technician started by conducting a pressure test on the home pressure plumbing system. The domestic cold-water line does not hold pressure, confirming a leak does exist. A visual inspection was performed in the meter vault. A leak was detected after the city shut off main valve. No other leaks were detected within the 15-minutes of testing. Ending today's

In conclusion, the technician recommends consulting with a plumber for any future repairs. Insured was advised on today's findings.
