# Inspections - Damaged Pole Report

Service Request 26-00786099 Sector            Gateway            Primary             
 Location on Service Request: S. HIGHLAND Ave & SCHUCK St  
 Grid : 4010346 LLC: 7218

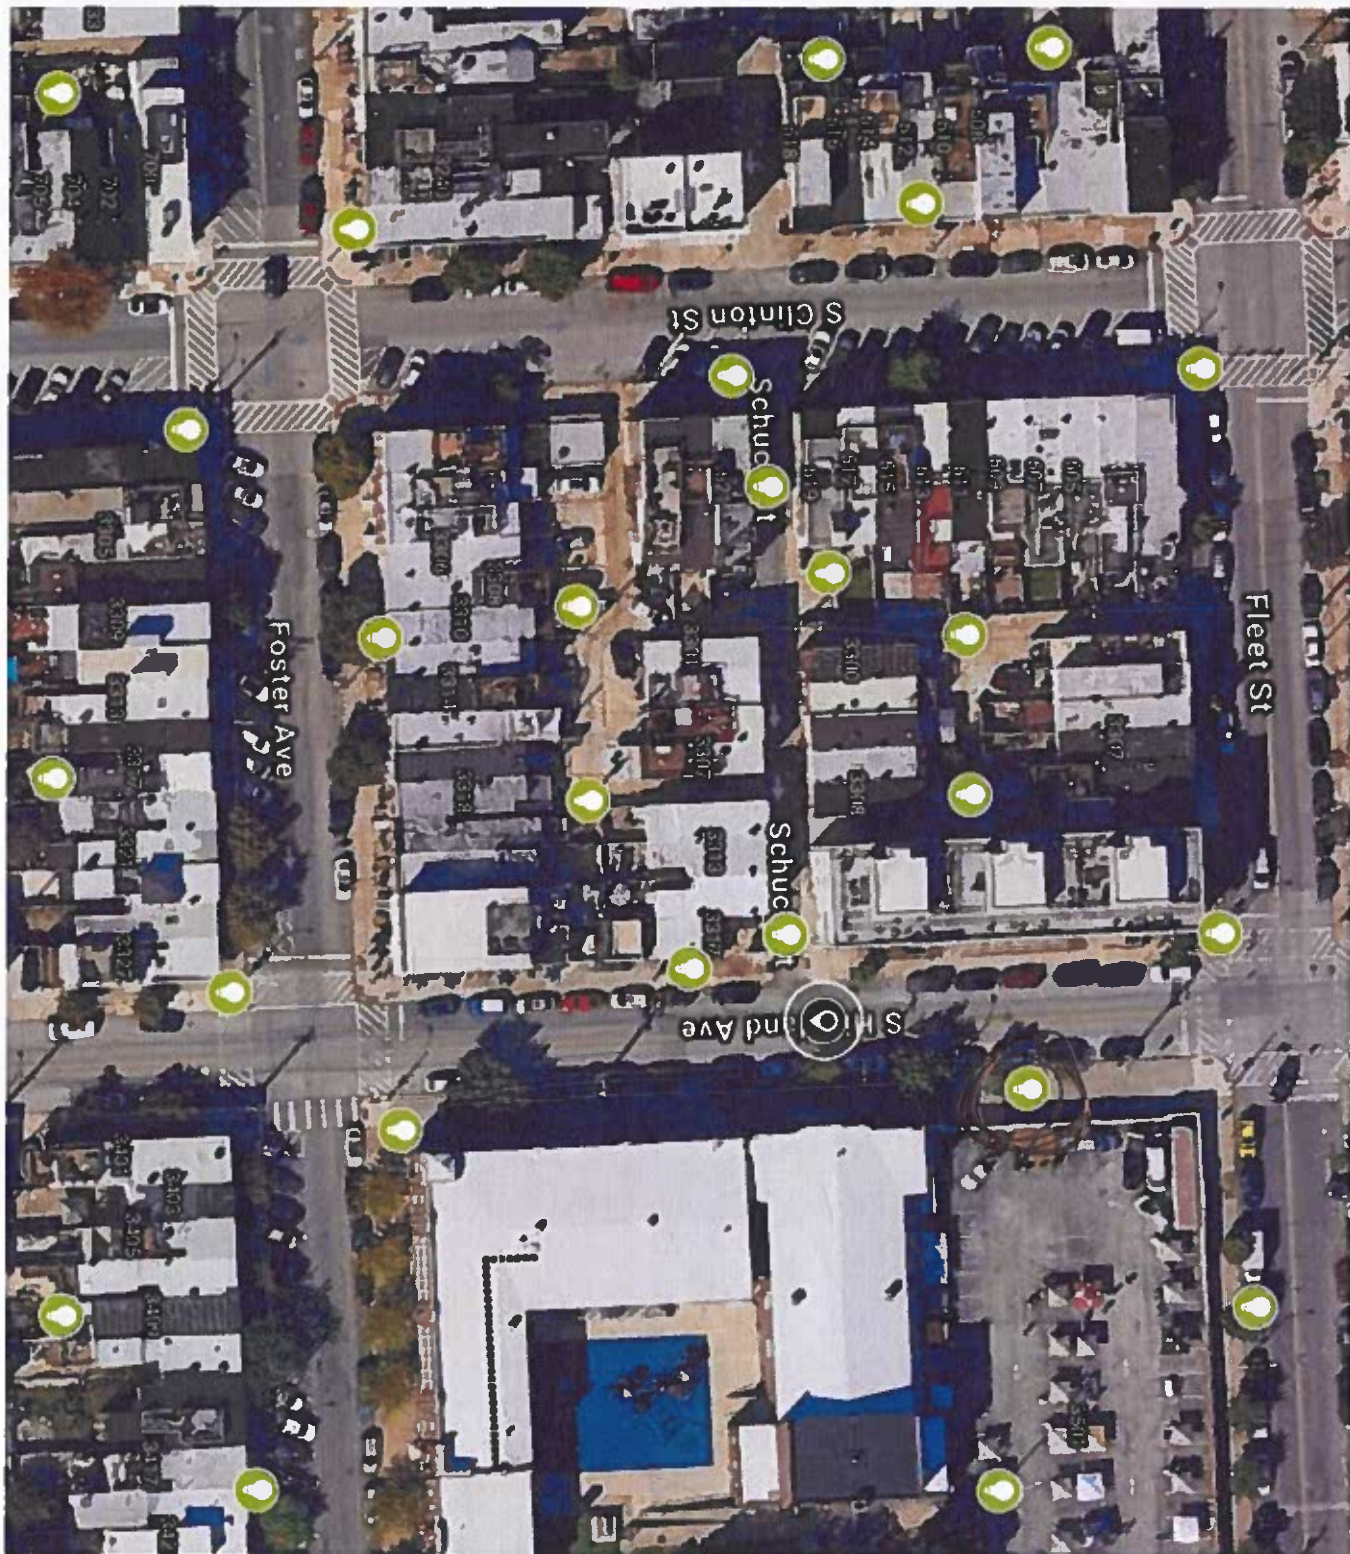
Deteriorated             
 Missing ✓  
 Damaged             
 Arm/Fixture Missing             
 Other

**NEEDS  
New  
Base**

25 Foot  
steel pole  
cobra head  
LED
