# Inspections Damaged Pole Report

Service Request 26-00792632 for Gateway Primary 4805 Eastern Ave  
 Location on Service Request: 4805 Eastern Ave  
 Grid : 4010430 LLC: 6366

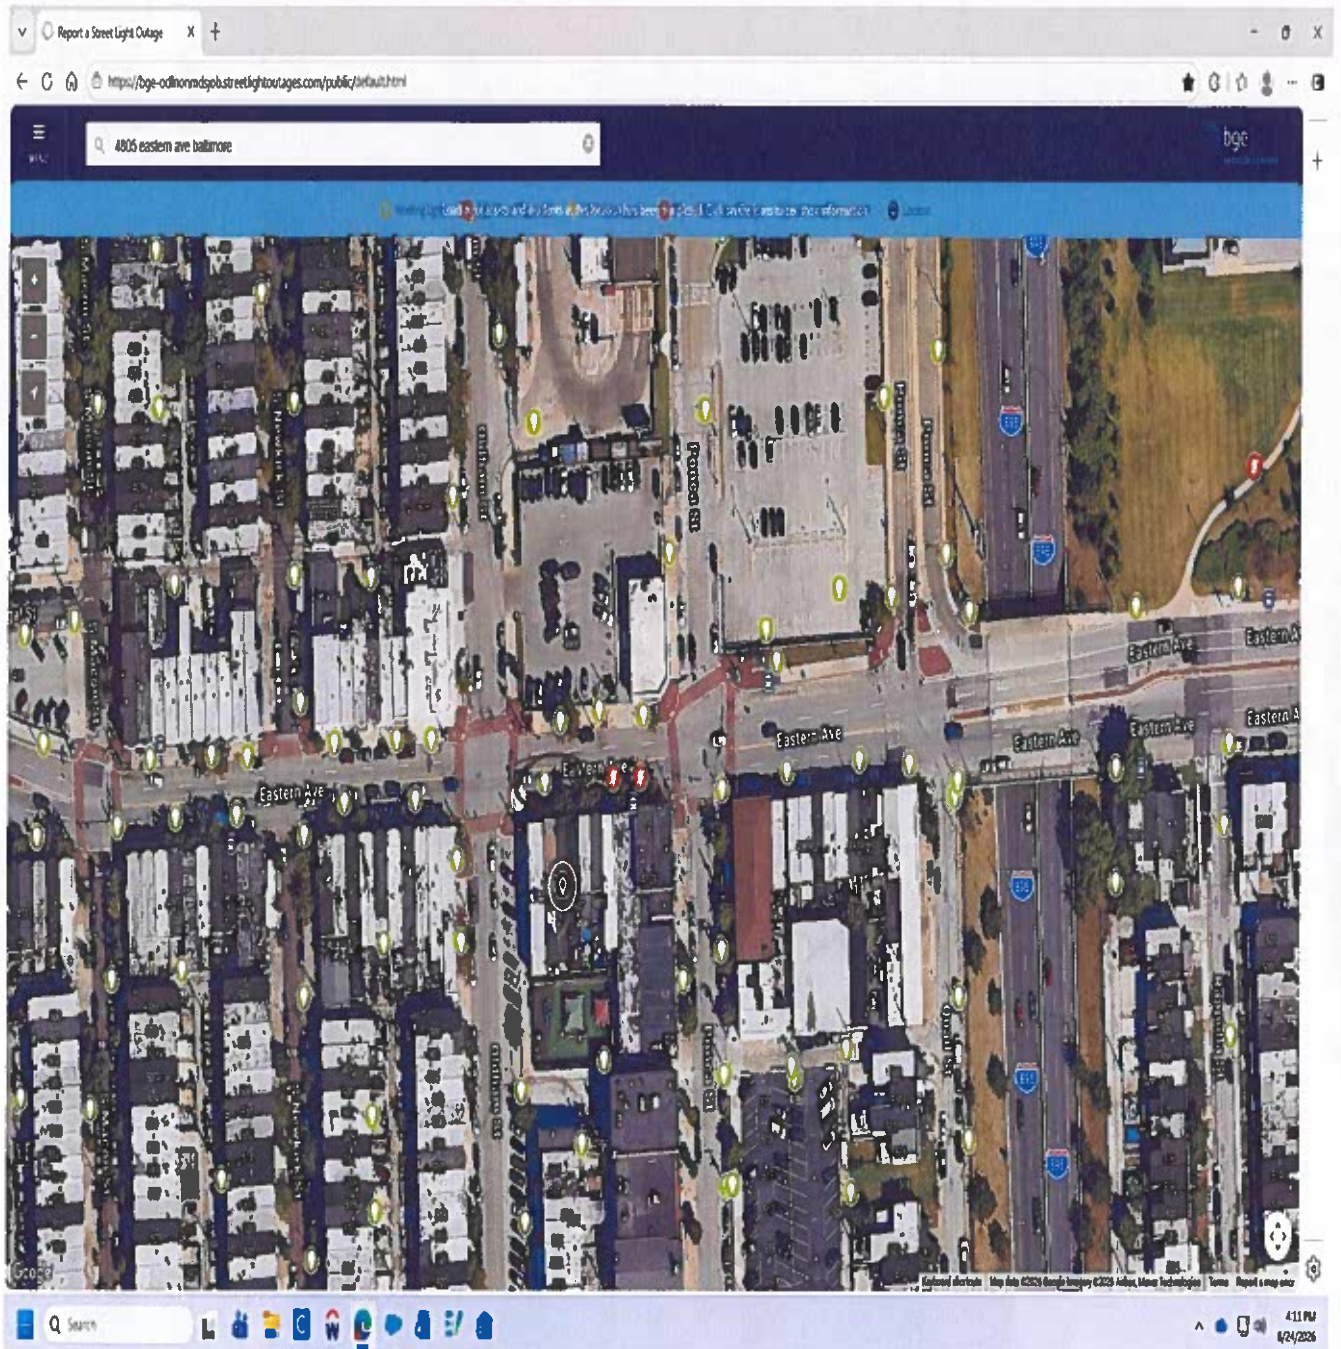
Deteriorated         
 Missing ✓  
 Damaged         
 Arm/Fixture Missing         
 Other

HomeIwud  
Acorn Fextone
