Inspections: Damaged Pole Report

Service Request 26-00798183 Nor Gateway Primary             
 Location on Service Request 442 E. North Ave  
 Grid : 2010110 LLC: 5031

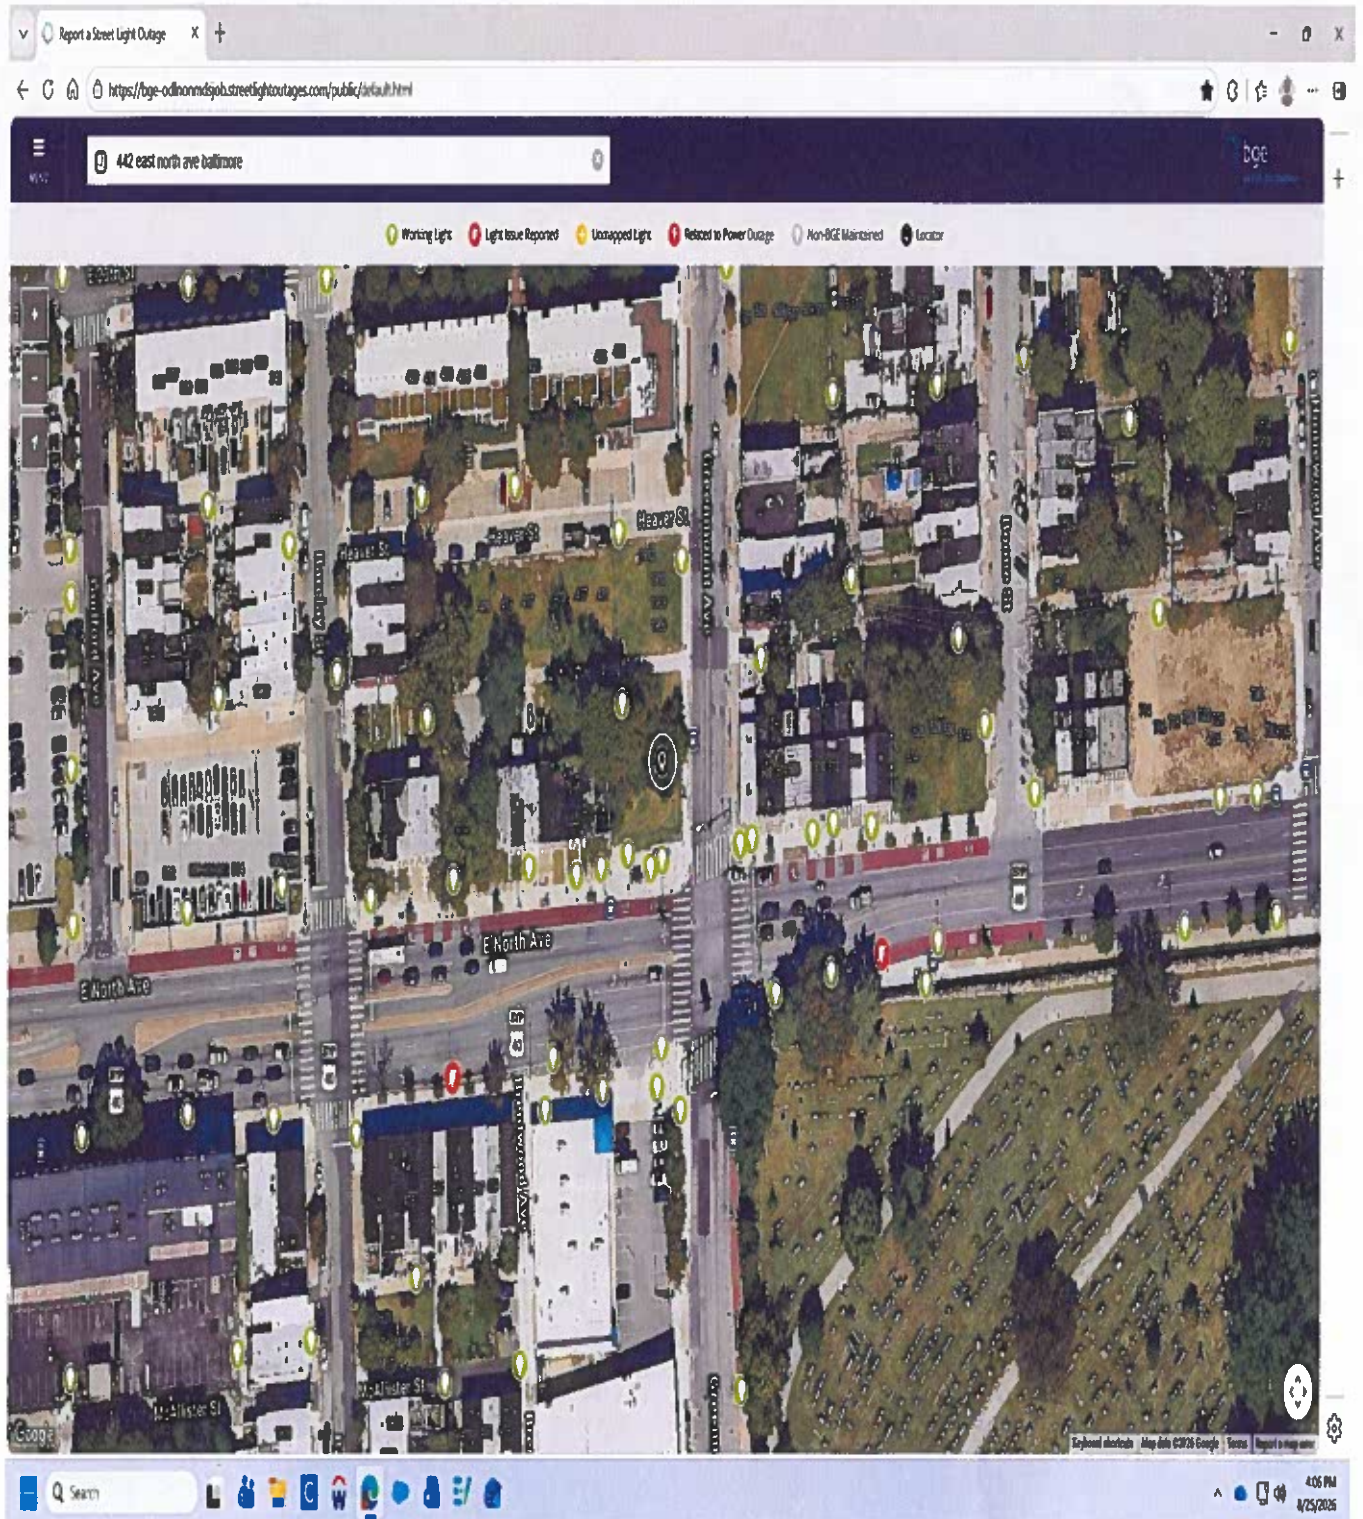
Deteriorated ☐  
 Missing ☒  
 Damaged ☐  
 Arm/Fixture Missing ☐  
 Other ☐

HomeLand  
Acorn Fixture
