# Inspections - Damaged Pole Report

Service Request 26-00800 473 Gateway Primary  
 Location on Service Request: 1930 Heathfield Rd  
 Grid : 2040220 LLC: 7411

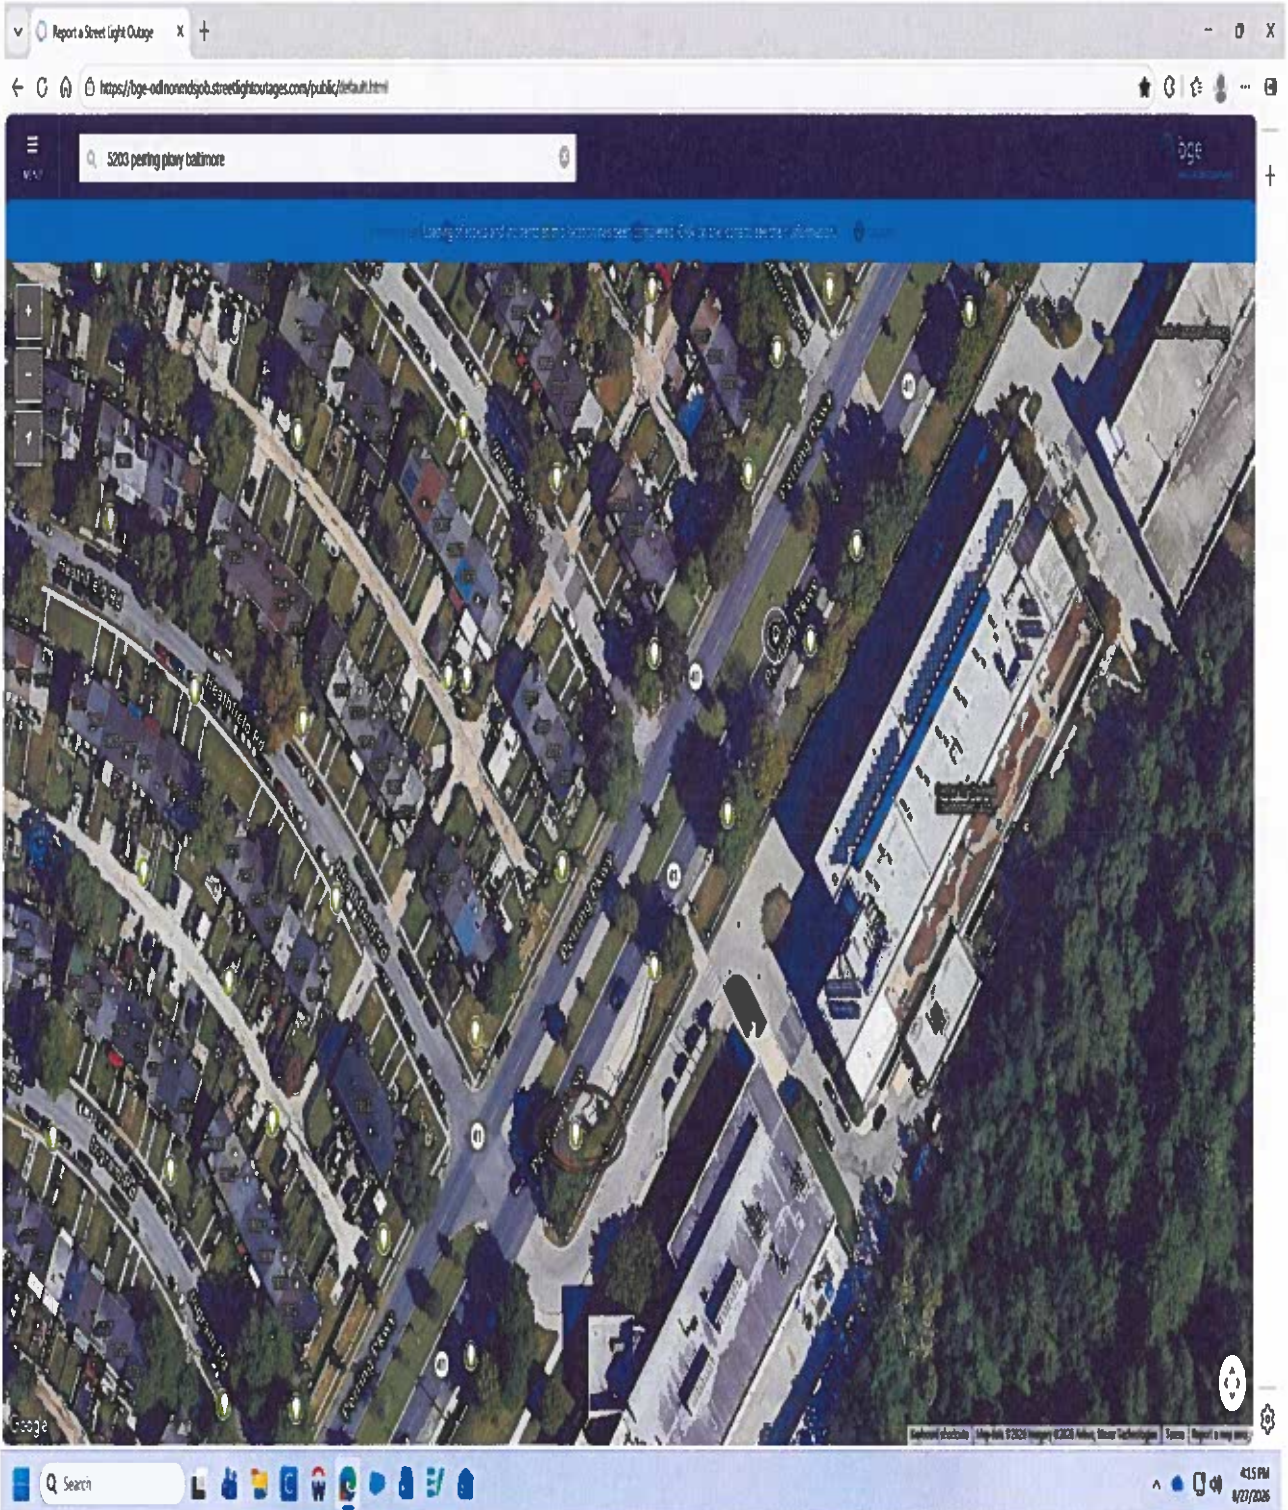
30 Foot  
Aluminum w  
pole  
cobra Head  
LED
