# Inspections: Damaged Pole Report

Service Request: 26-00753 262 Gateway: Primary  
 Location on Service Request: 900 Fell St  
 Grid: 4020210 LLC: 7208

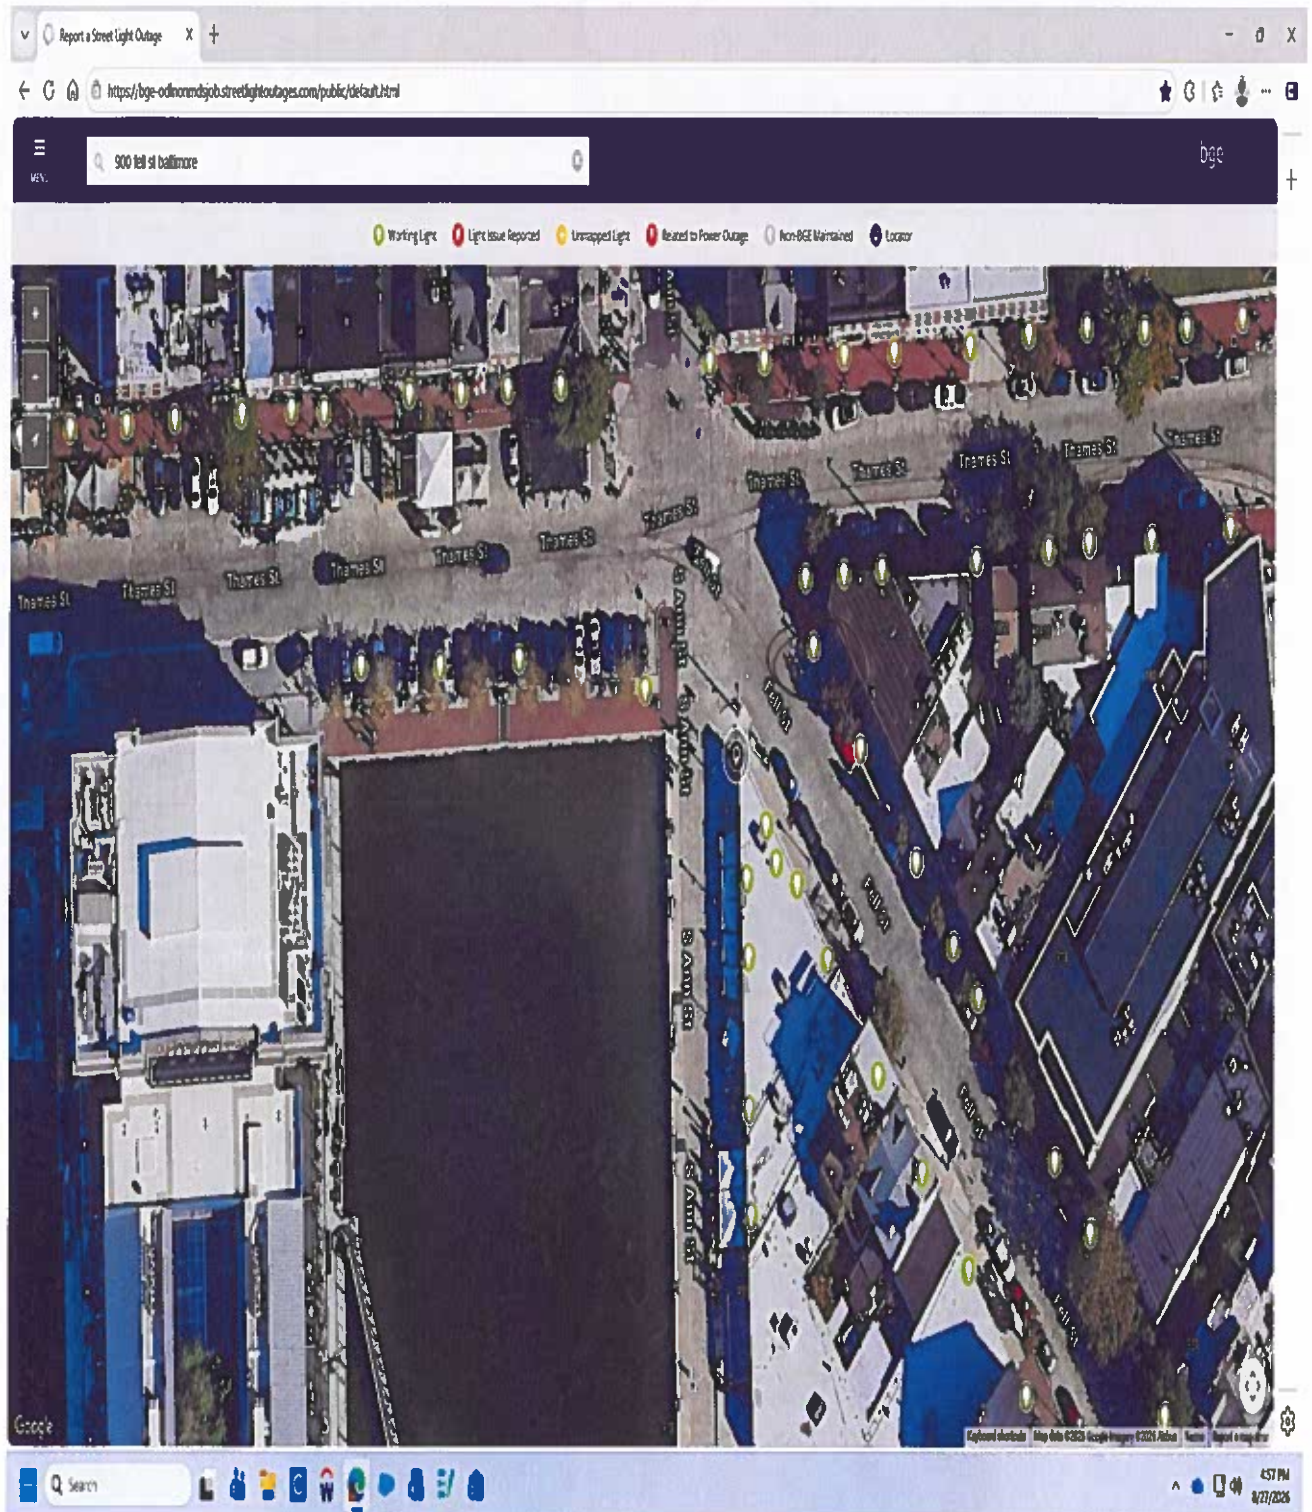
Deteriorated         
 Missing ✓  
 Damaged         
 Arm/Fixture Missing         
 Other

Otterbein  
Otterbein fixture
