# Inspections Damaged Pole Report

Service Request 26-00823071 for Gateway Primary 211 FALLSWAY  
 Location on Service Request: 4010110 LLC: 7005

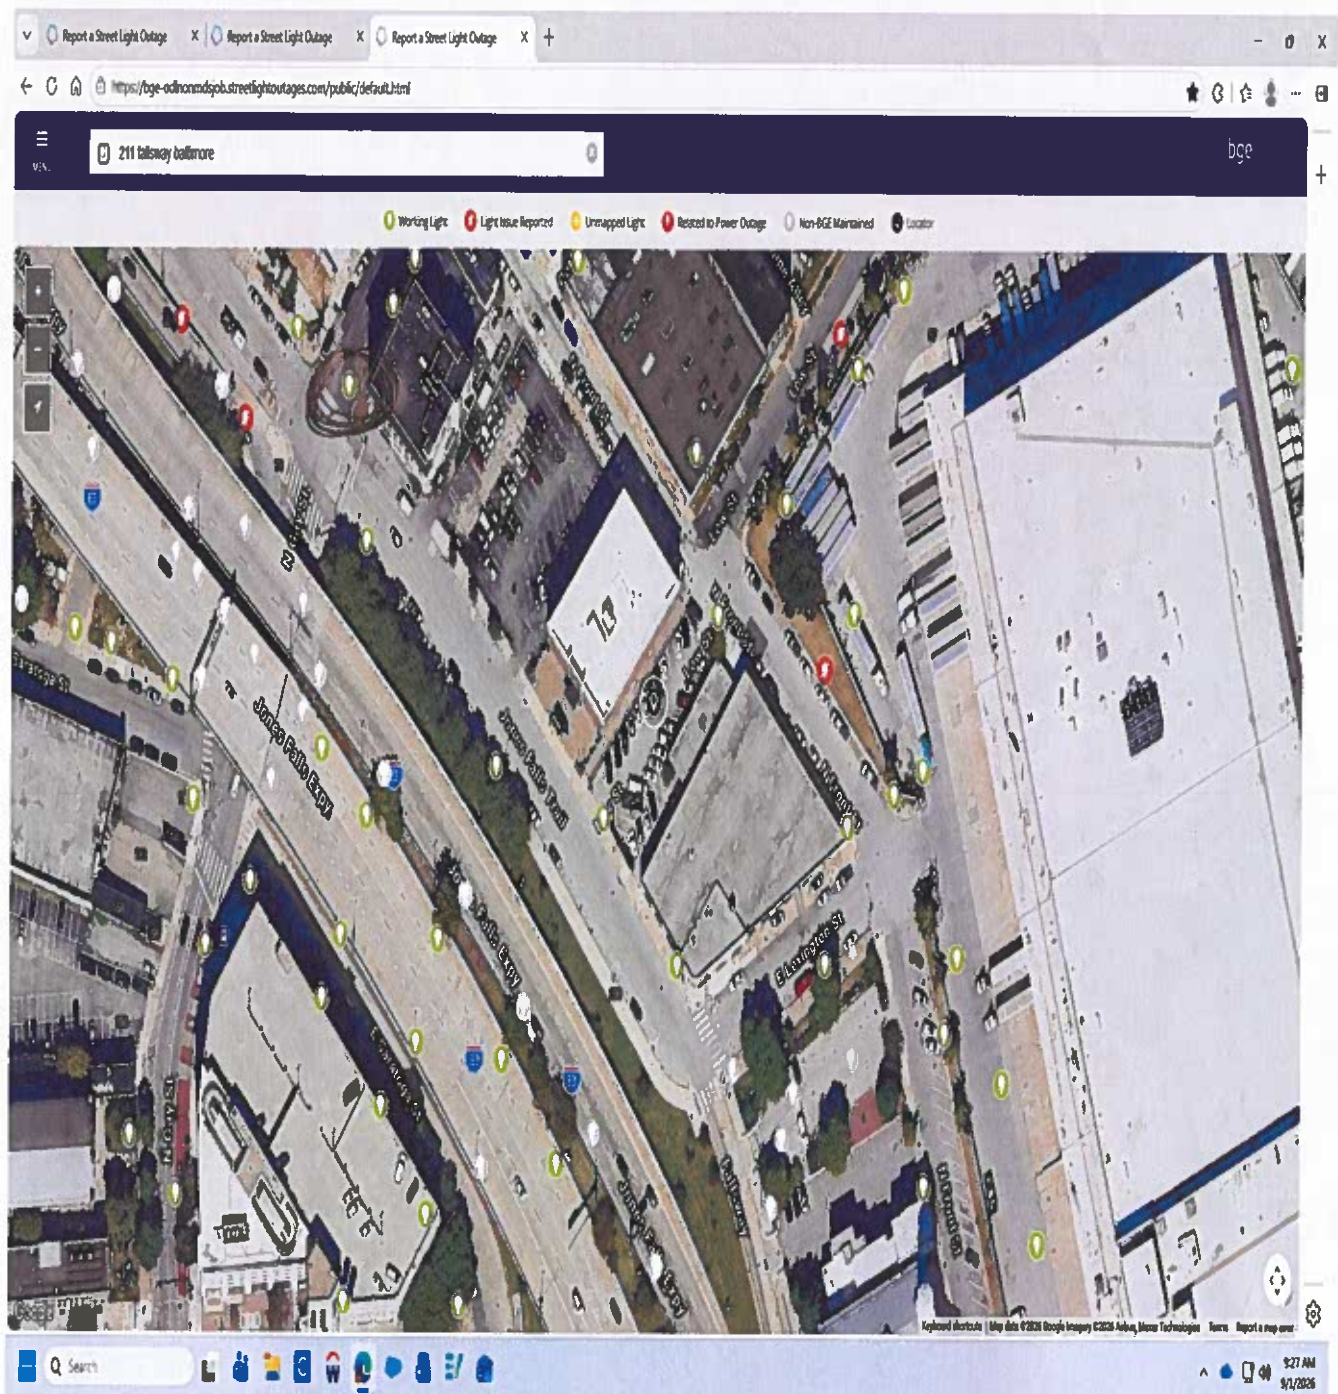
NEEDS  
New  
Pedestal  
BASE

30 Foot Aluminum  
pole  
Cobra Head  
LED
