# Inspections: Damaged Pole Report

Service Request: 26-00850535 Sector: \_\_\_\_\_ Gateway: \_\_\_\_\_ Primary: \_\_\_\_\_

Location on Service Request: 2300 Cyburn Ave

**Service Request Summary Report**  
**26-00850535**

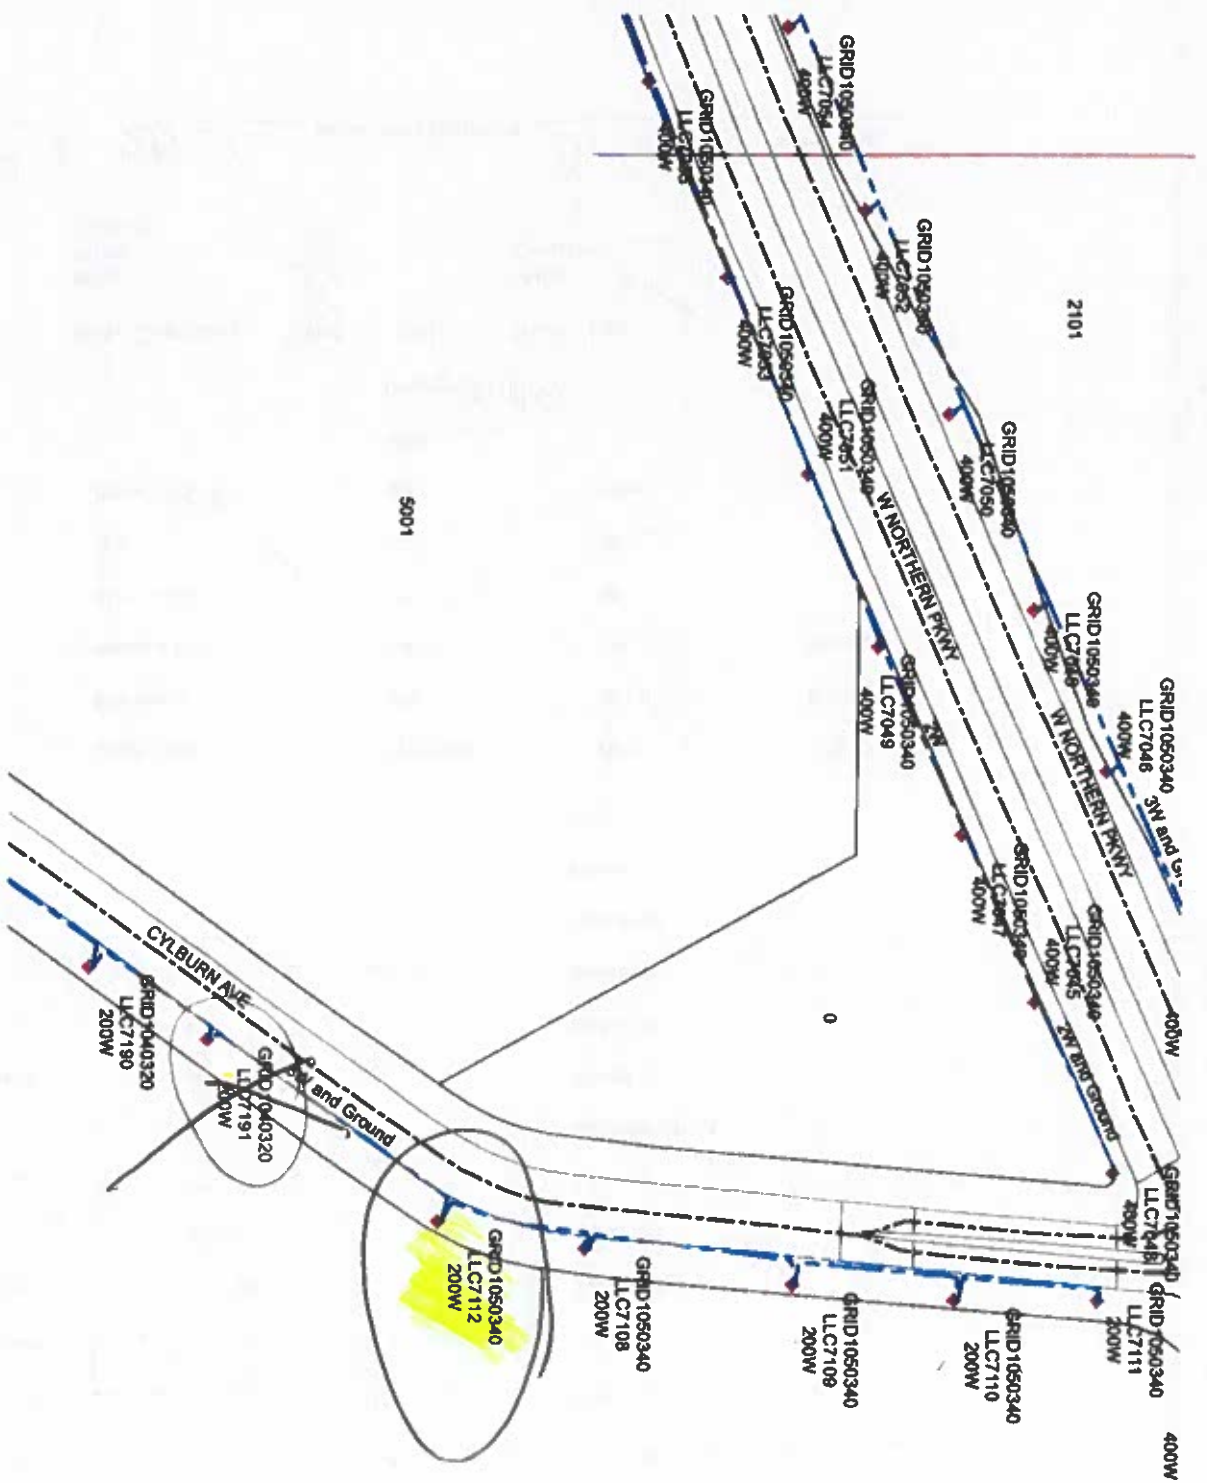
Arm/Fixture Missing ☒

Missing ☒

| Comment | Comment By | Created Date | Visibility |
|---|---|---|---|
| Assign inspector : missing pole report created for missing Gregory Crowder 6ft Arm with cobra head LED light fixture only | Gregory Crowder | 9/8/2026 3:50 PM | Private |
