# Sewer Scope Report

3105 Evergreen Ave  
Baltimore, MD 21214

Inspected by:  
Luke Bunting  
Blue Crab Inspections

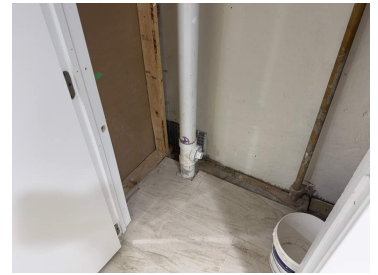
2. ☒ ☐ ☐ ☐ ☐ Drain Access Location Front of Basement  
- Location of sewer cleanout utilized for sewer scope camera inspection noted.

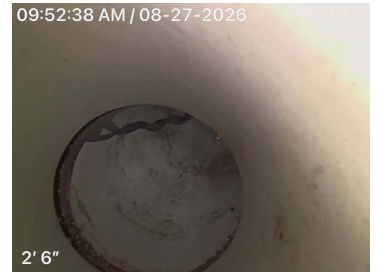
3. ☒ ☐ ☐ ☐ ☐ Sewer Lateral PVC - Camera was inserted into the drainage system and line counter was reset to zero to begin sewer lateral inspection.

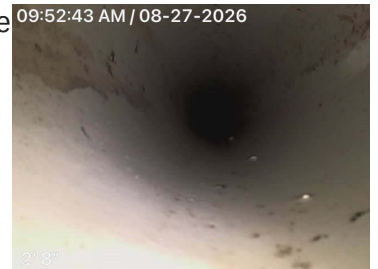
4. ☒ ☐ ☐ ☐ ☐ Sewer Lateral PVC - PVC piping noted in use. PVC has been in use since 1982 with an expected lifespan of over 100 years. PVC joints are sealed and more resistant to root intrusion. Installation of PVC in ground requires special care to ensure proper bedding of the material. Common failures of PVC are bellies in the pipe.

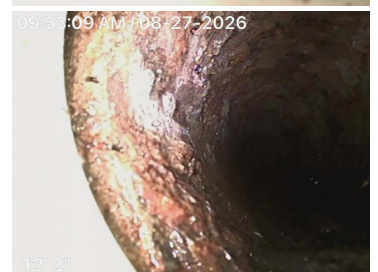
5. ☒ ☐ ☐ ☐ ☐ Sewer Lateral Cast Iron - The sewer lateral transitioned to cast iron at approximately 12 feet. Cast iron drain piping observed. Cast iron drain piping has a typical lifespan of about 50 years. Common issues with cast iron drain piping can include scaling and pitting.

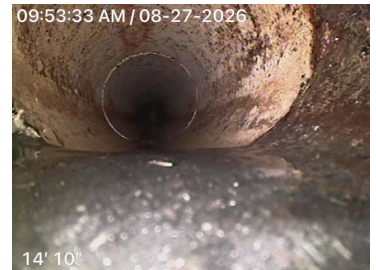
6. ☒☐☐☐☐ Sewer Lateral PVC - The sewer lateral transitioned back to PVC at approximately 14 feet.

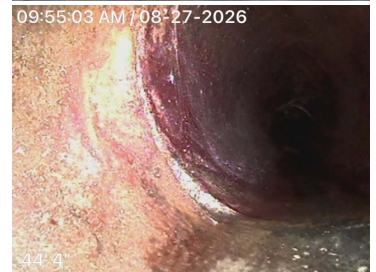
8. ☒☐☐☐☐ Sewer Lateral Terracotta - The sewer lateral transitioned to terracotta at approximately 44 feet.

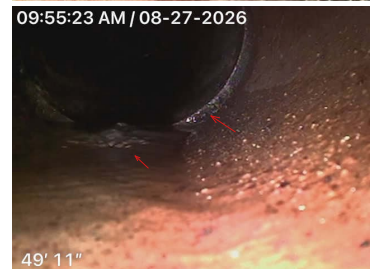
9. ☐☐☐☒☐ Sewer Lateral Terracotta - Offset noted in the line at approximately 49 feet. A licensed plumber is recommended to evaluate and estimate repairs.
