# Inspections: Damaged Pole Report

Service Request: 26-00846954 Sector: \_\_\_\_\_ Gateway: \_\_\_\_\_ Primary: \_\_\_\_\_

Location on Service Request: 1703 ALICEANNA St

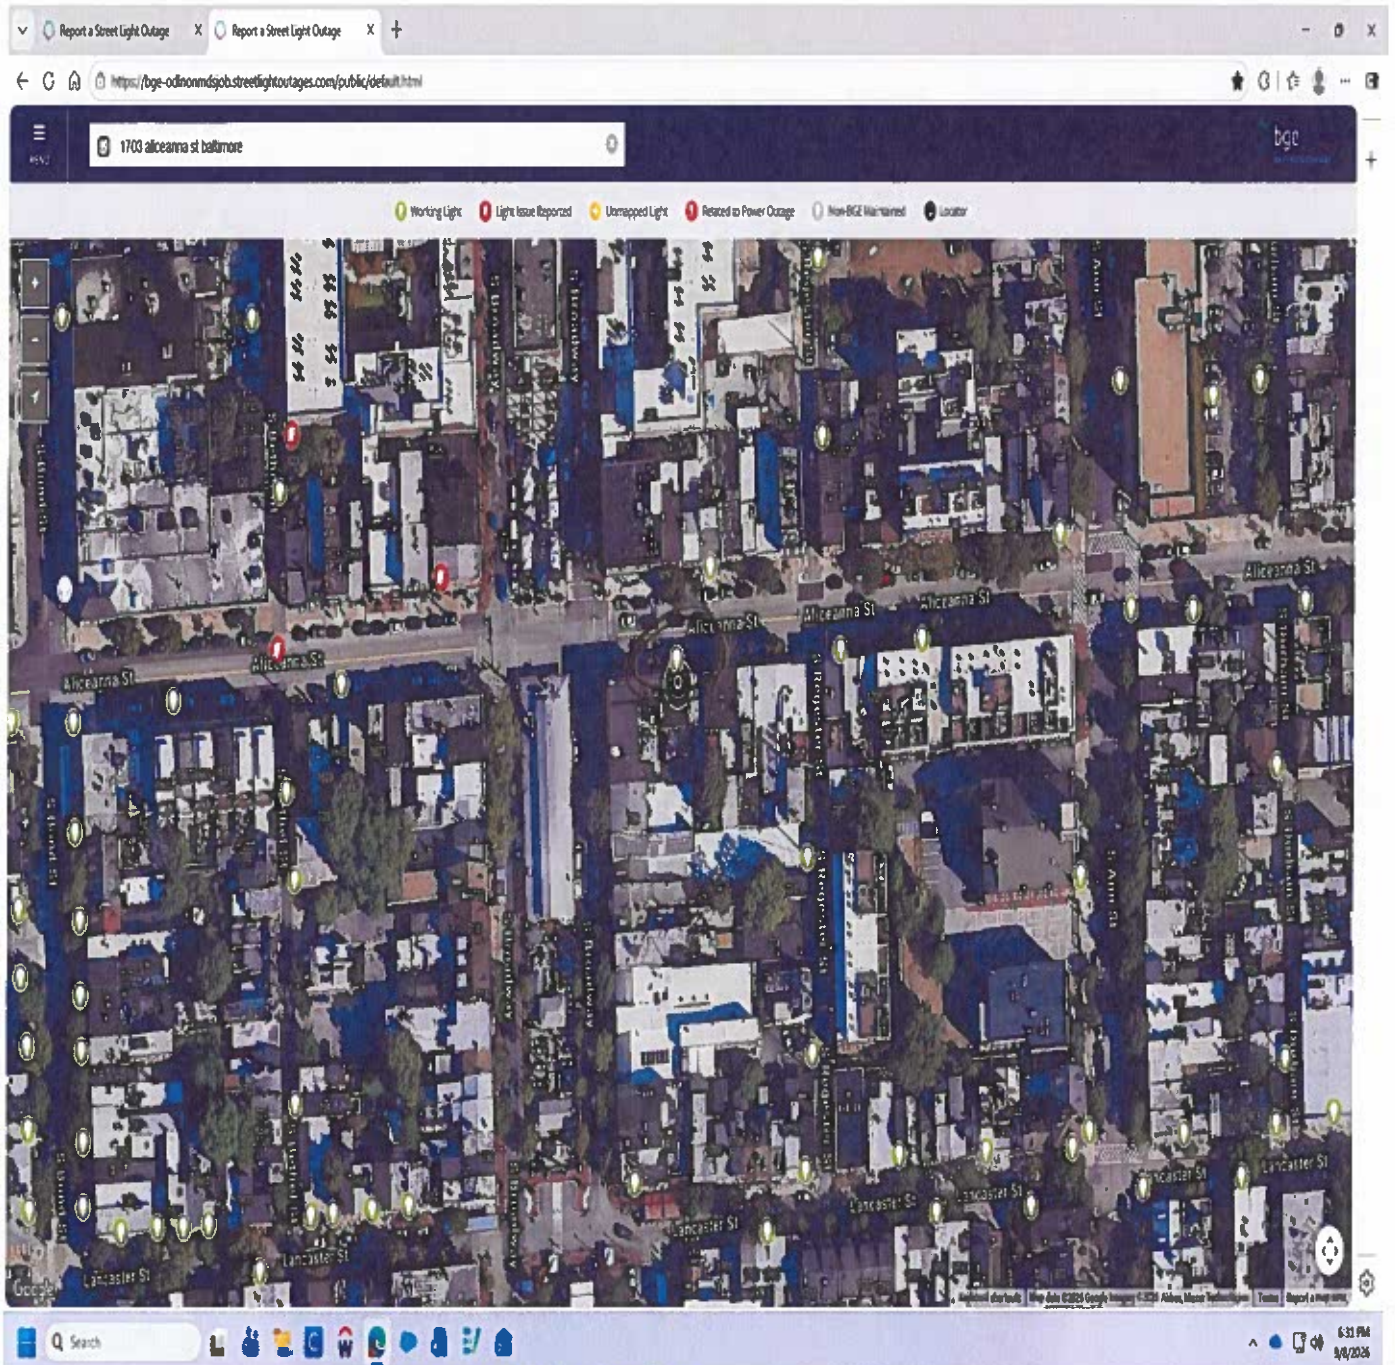
25 Foot  
Aluminum  
pole  
Cobra Head  
LED
