Inspections: Damaged Pole Report

Service Request: 26-'60 858940 Sector: \_\_\_\_\_ Gateway: \_\_\_\_\_ Primary: \_\_\_\_\_  
Location on Service Request: Wabash Ave w/ Patterson Ave  
Grid: 1040510 LLC: 2070

Street: Patterson Park Ave  
Side of Street: N/S \_\_\_\_\_ E/S ☒ S/S \_\_\_\_\_ W/S \_\_\_\_\_  
Pole location: 1<sup>st</sup> ☒ 2<sup>nd</sup> \_\_\_\_\_ 3<sup>rd</sup> \_\_\_\_\_ 4<sup>th</sup> \_\_\_\_\_ 5<sup>th</sup> \_\_\_\_\_ 6<sup>th</sup> \_\_\_\_\_ Other \_\_\_\_\_  
Direction: N/O ☒ E/O \_\_\_\_\_ S/O \_\_\_\_\_ W/O \_\_\_\_\_  
Street or Landmark: Wabash Ave

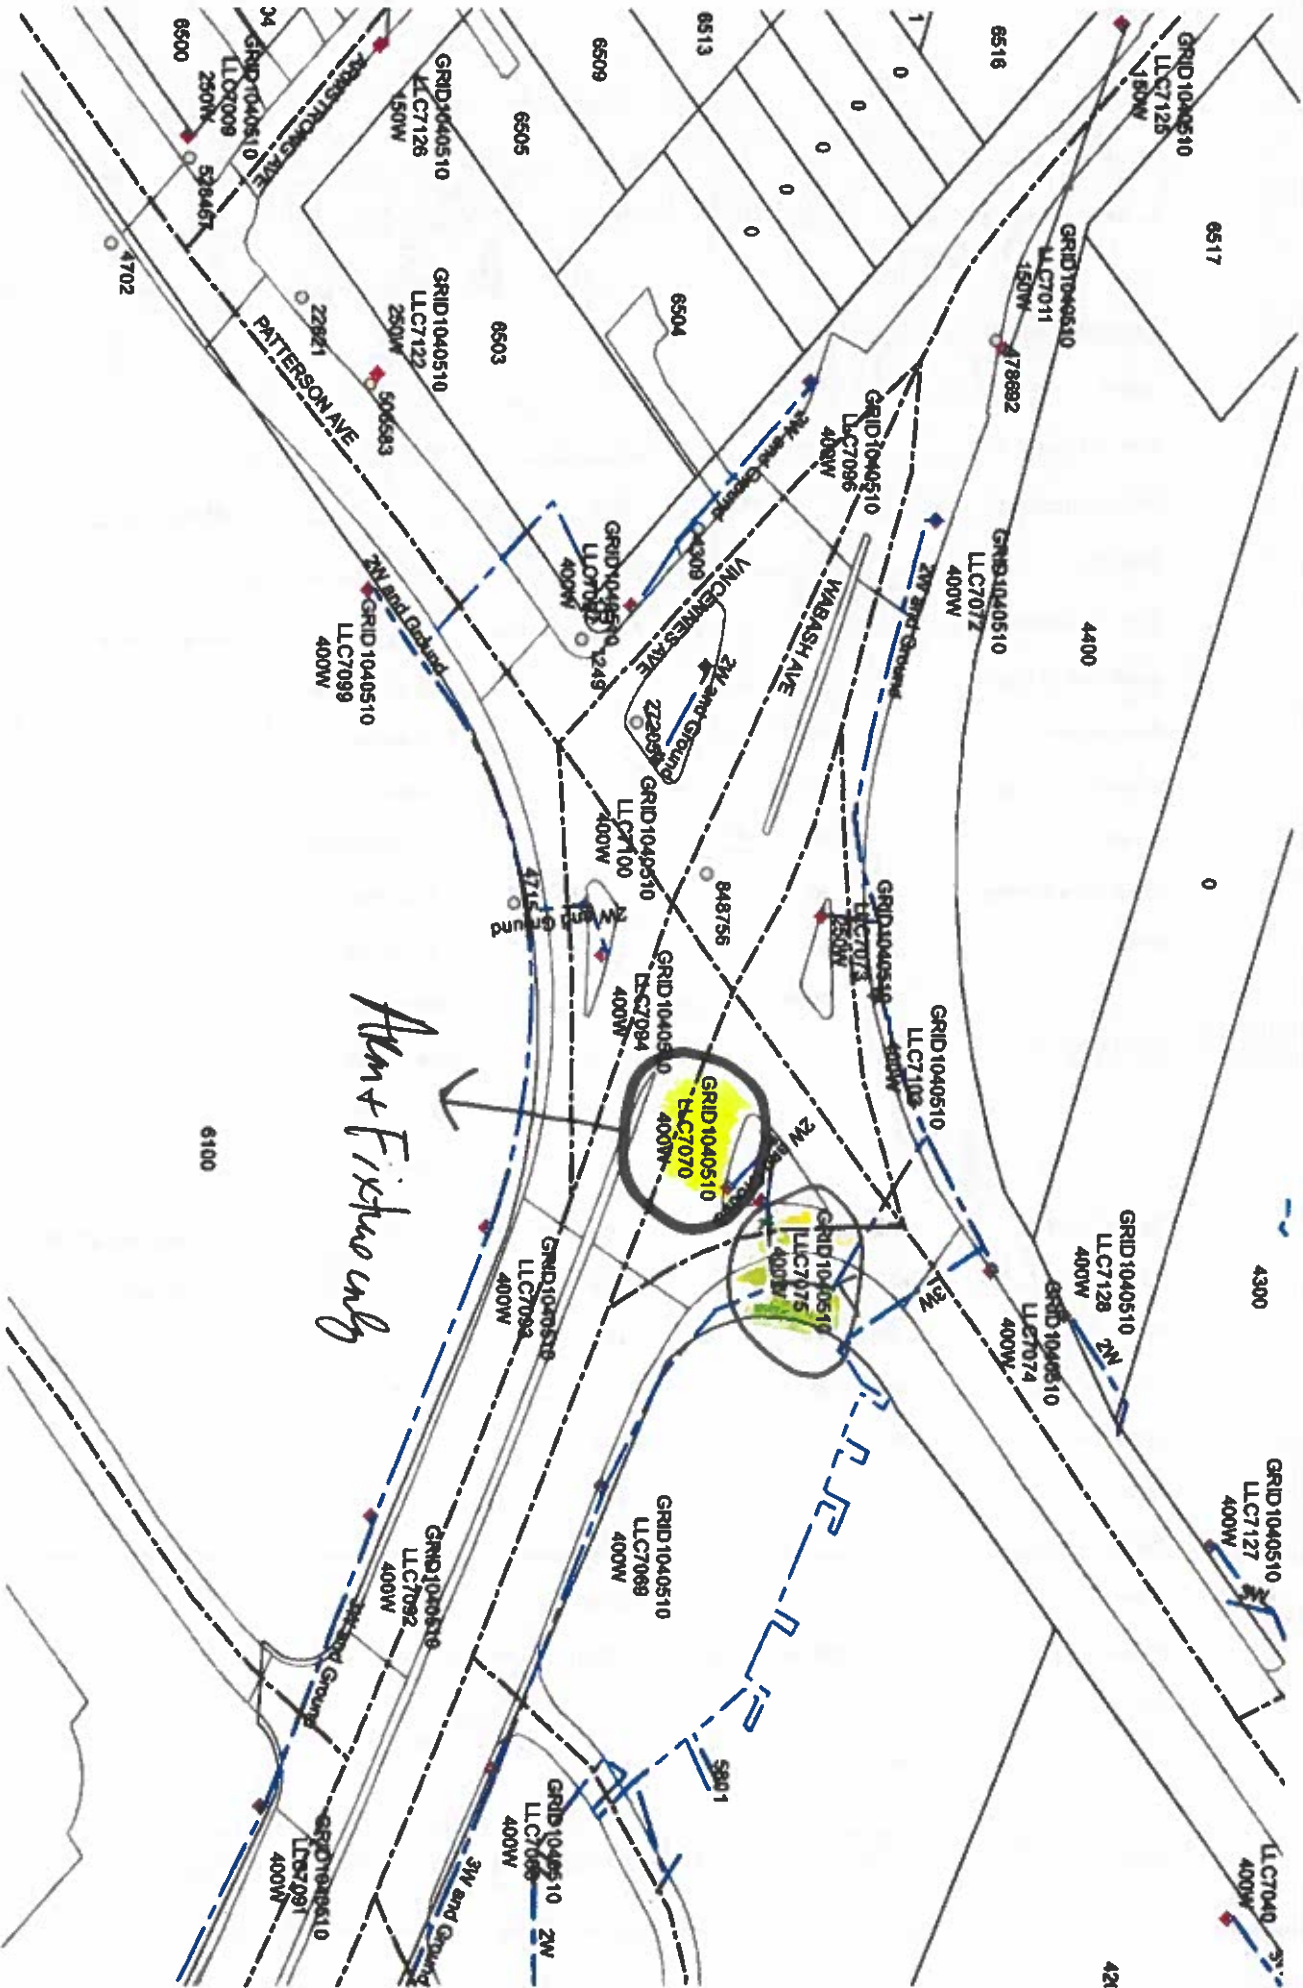
*Arm + Fixture missing only*

Airt Fictio only

25 ft CA UED
