Inspections: Damaged Pole Report

Service Request: 26-0086299 Sector: \_\_\_\_\_ Gateway: \_\_\_\_\_ Primary: \_\_\_\_\_  
 Location on Service Request: 2826 Rosalind Ave  
 Grid : 1040 330 LLC: 7254

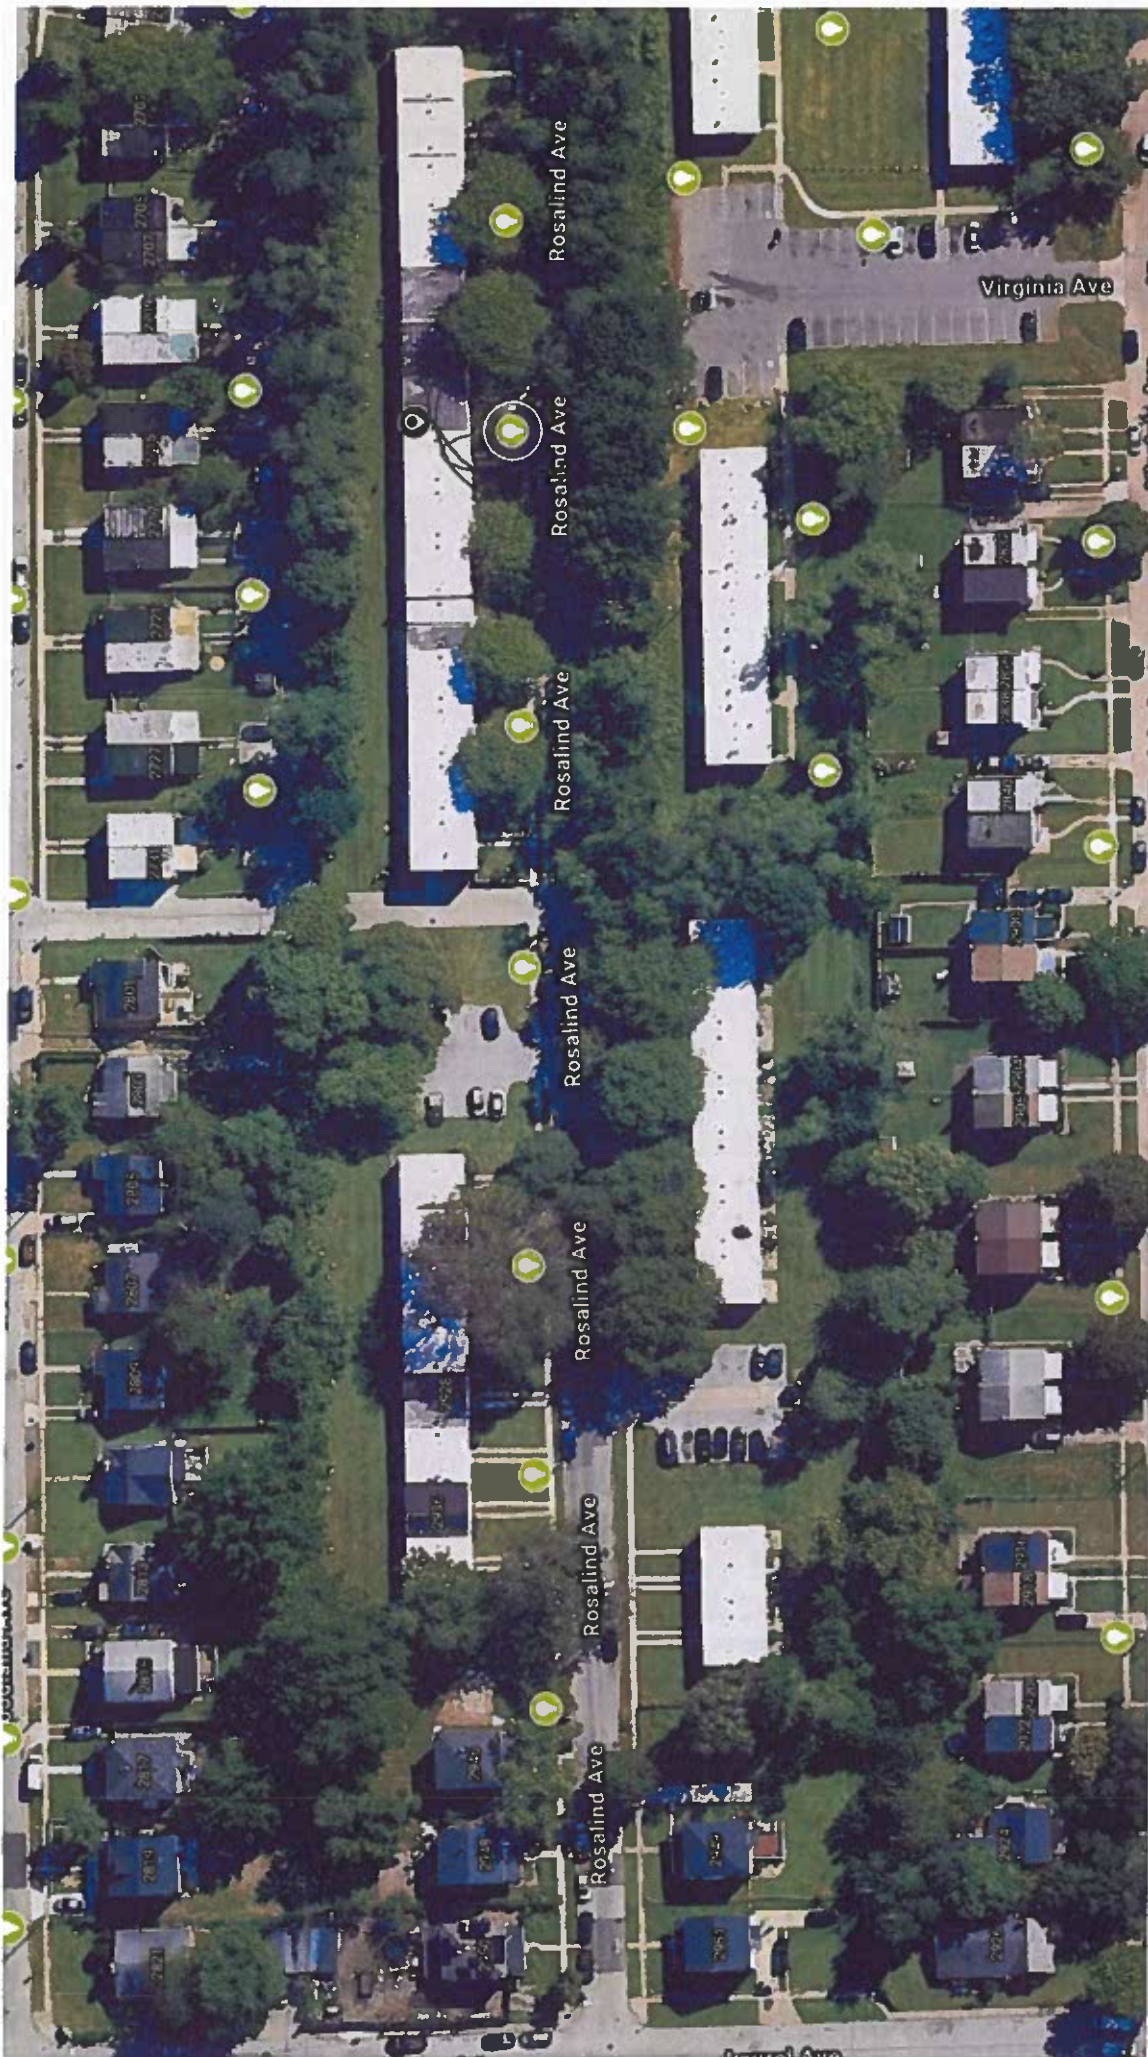
Street: Rosalind Ave  
 Side of Street: N/S ☒ E/S \_\_\_\_\_ S/S \_\_\_\_\_ W/S \_\_\_\_\_  
 Pole location: 1<sup>st</sup> \_\_\_\_\_ 2<sup>nd</sup> \_\_\_\_\_ 3<sup>rd</sup> \_\_\_\_\_ 4<sup>th</sup> \_\_\_\_\_ 5<sup>th</sup> \_\_\_\_\_ 6<sup>th</sup> ☒ Other \_\_\_\_\_  
 Direction : N/O \_\_\_\_\_ E/O \_\_\_\_\_ S/O \_\_\_\_\_ W/O \_\_\_\_\_  
 Street or Landmark: Canal Ave

| Condition of Pole: | Pole Size : | Type of Pole: |
|---|---|---|
| Missing <input checked="" type="checkbox"/> | 12' _____ | Steel _____ |
