# Inspections: Damaged Pole Report

Service Request: 26-00861750 Sector: \_\_\_\_\_ Gateway: \_\_\_\_\_ Primary: \_\_\_\_\_  
 Location on Service Request: 3601 Frankford Ave  
 Grid : 2040430 LLC: 7296

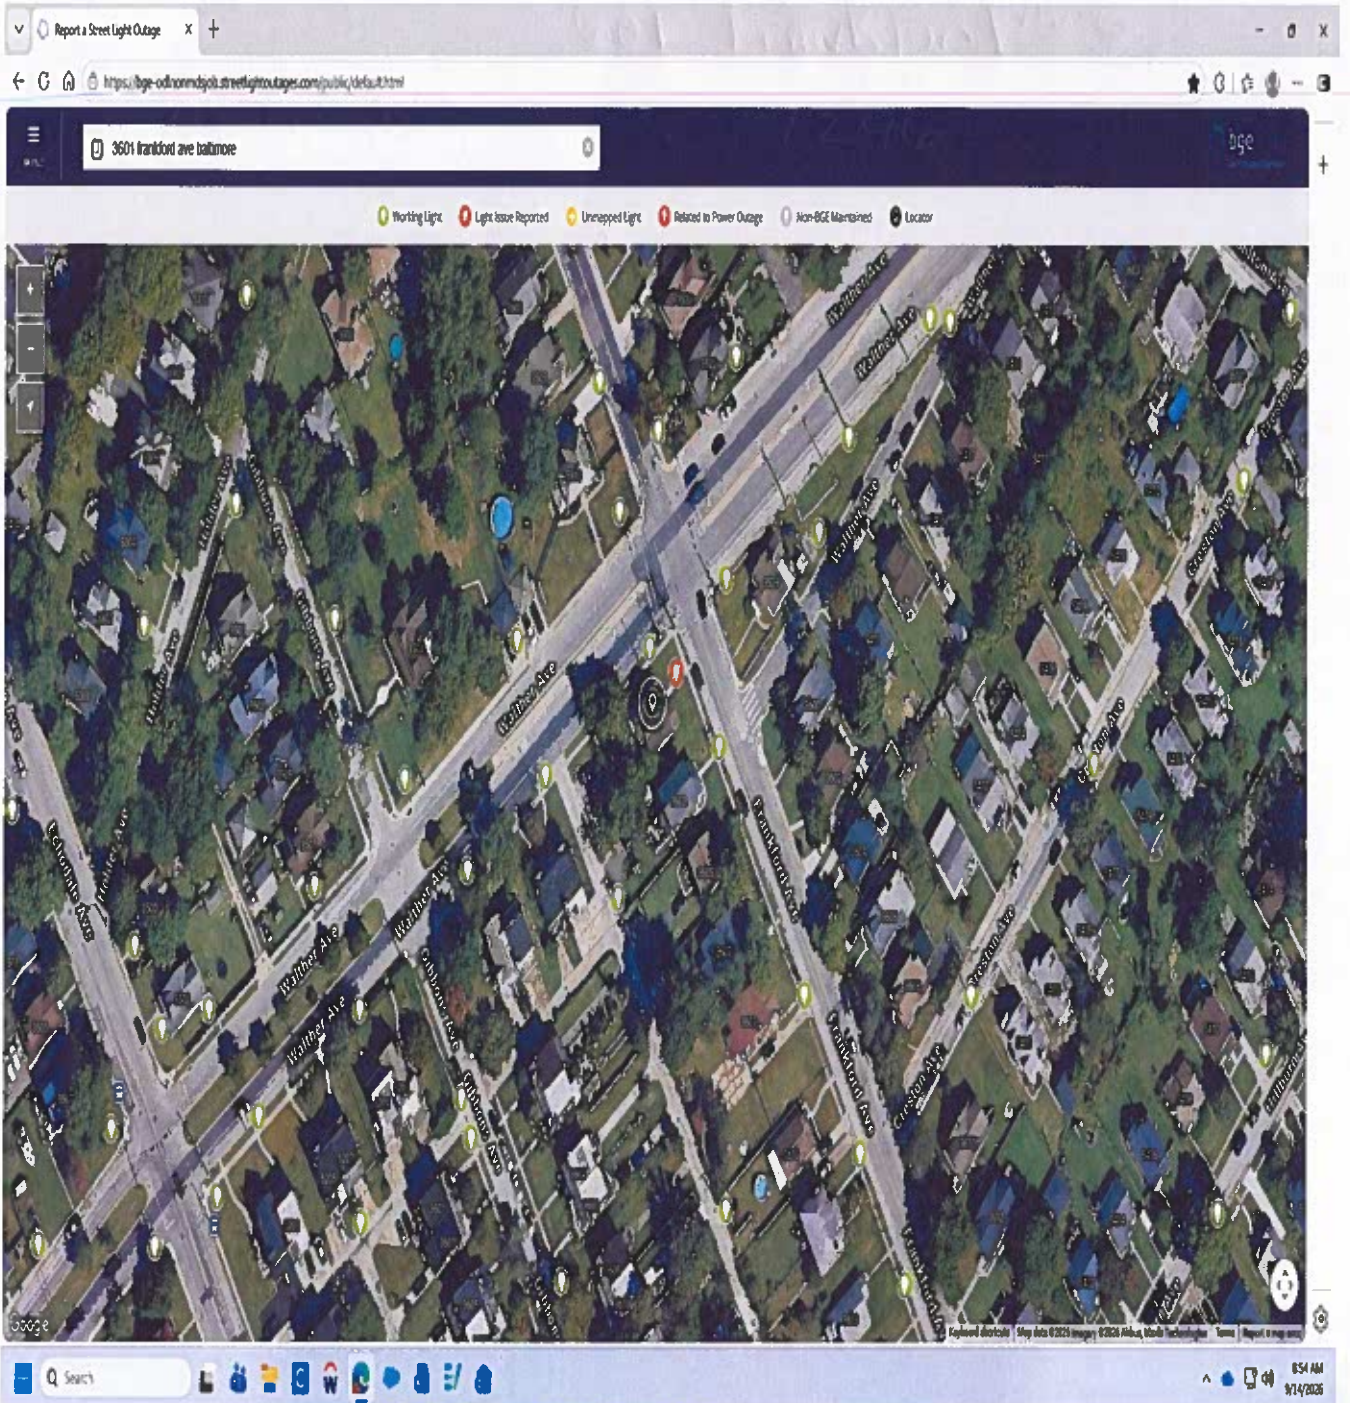
Deteriorated \_\_\_\_\_  
 Missing ☒  
 Damaged \_\_\_\_\_  
 Arm/Fixture Missing \_\_\_\_\_  
 Other \_\_\_\_\_

Damaged \_\_\_\_\_  
 Missing ☒

25 Foot +  
Aluminum  
pole  
cobra head  
LED
