# Inspections: Damaged Pole Report

Service Request: 26-00879267 Sector: \_\_\_\_\_ Gateway: \_\_\_\_\_ Primary: \_\_\_\_\_

Location on Service Request: 1312 E. 33rd St

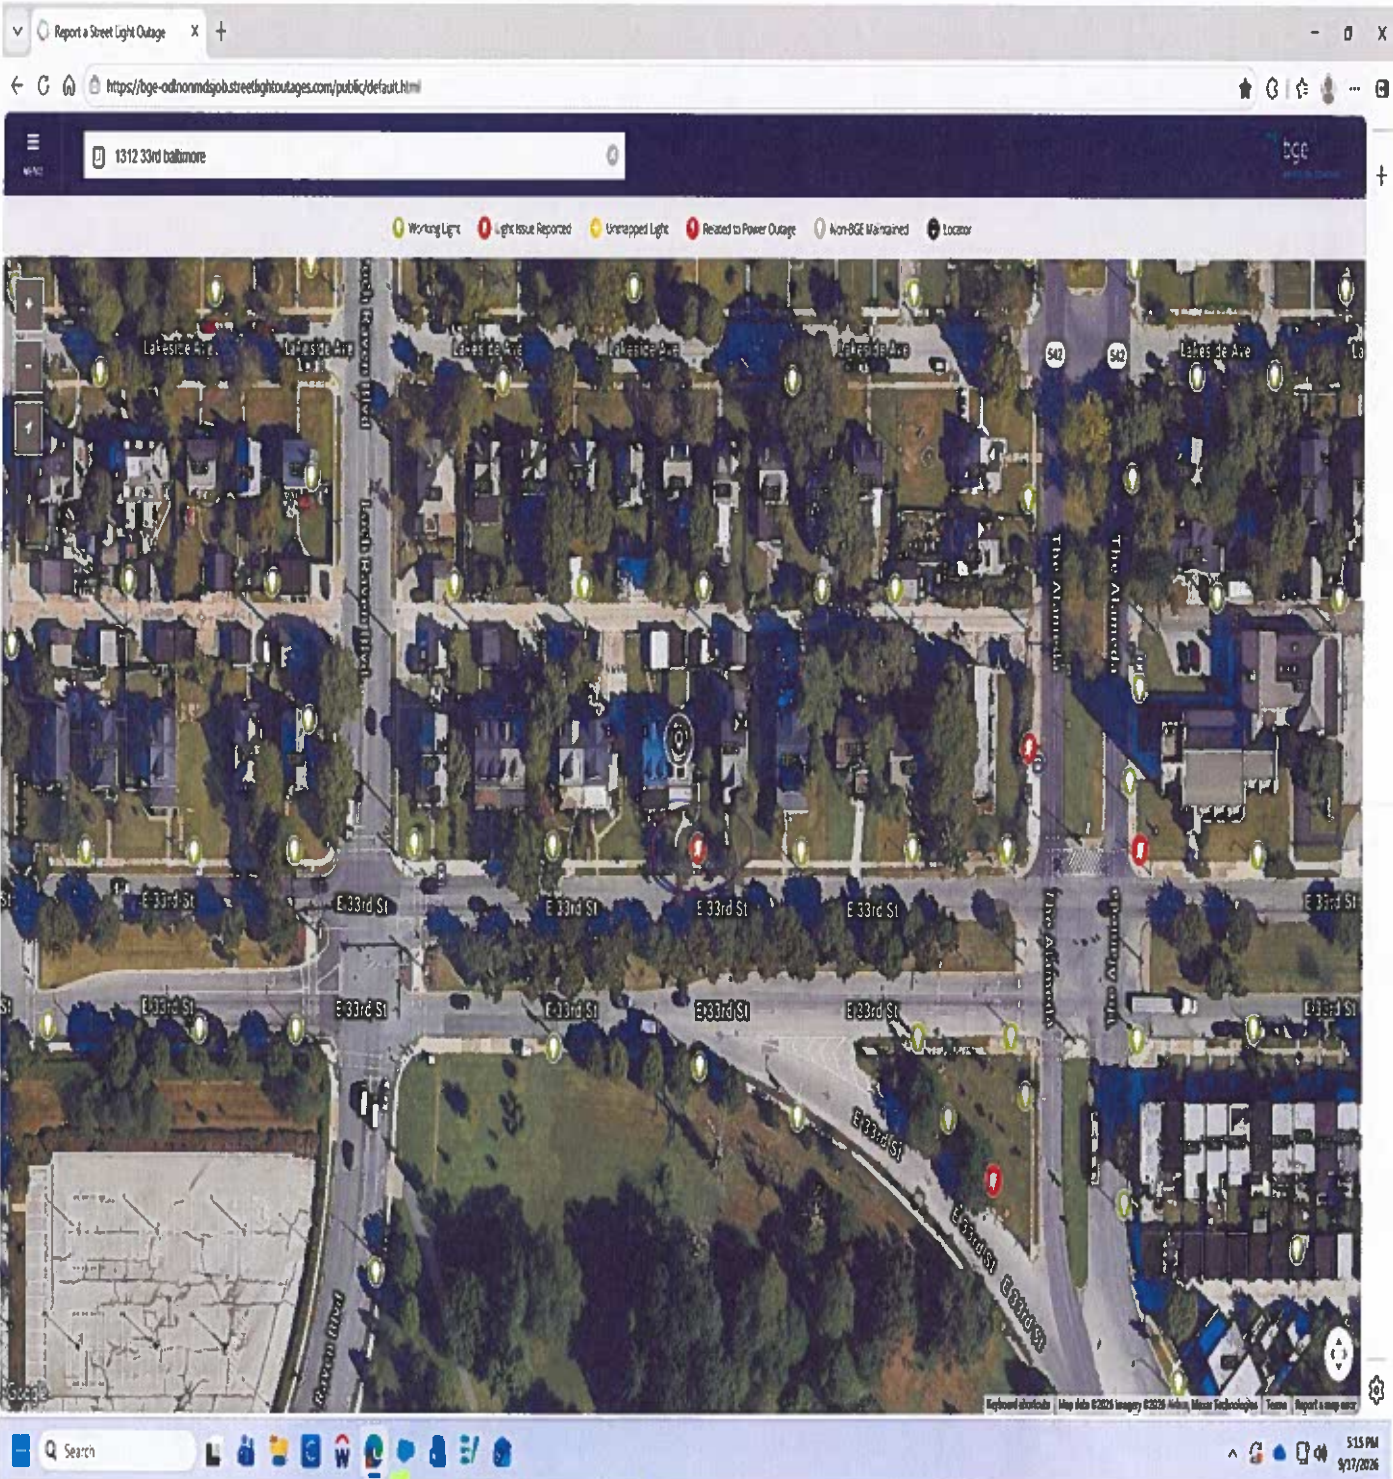
Deteriorated ☒  
Missing ☒  
Damaged \_\_\_\_\_  
Arm/Fixture Missing \_\_\_\_\_  
Other \_\_\_\_\_

**NEEDS  
New  
Pole  
Base**

30 Foot  
Aluminum  
pole  
Cobra Head  
LED

**Work Order #  
21198964**
