# Inspections: Damaged Pole Report

Service Request: 26-00881814 Sector: \_\_\_\_\_ Gateway: \_\_\_\_\_ Primary: \_\_\_\_\_

Location on Service Request: Belair Rd & Erdman Ave

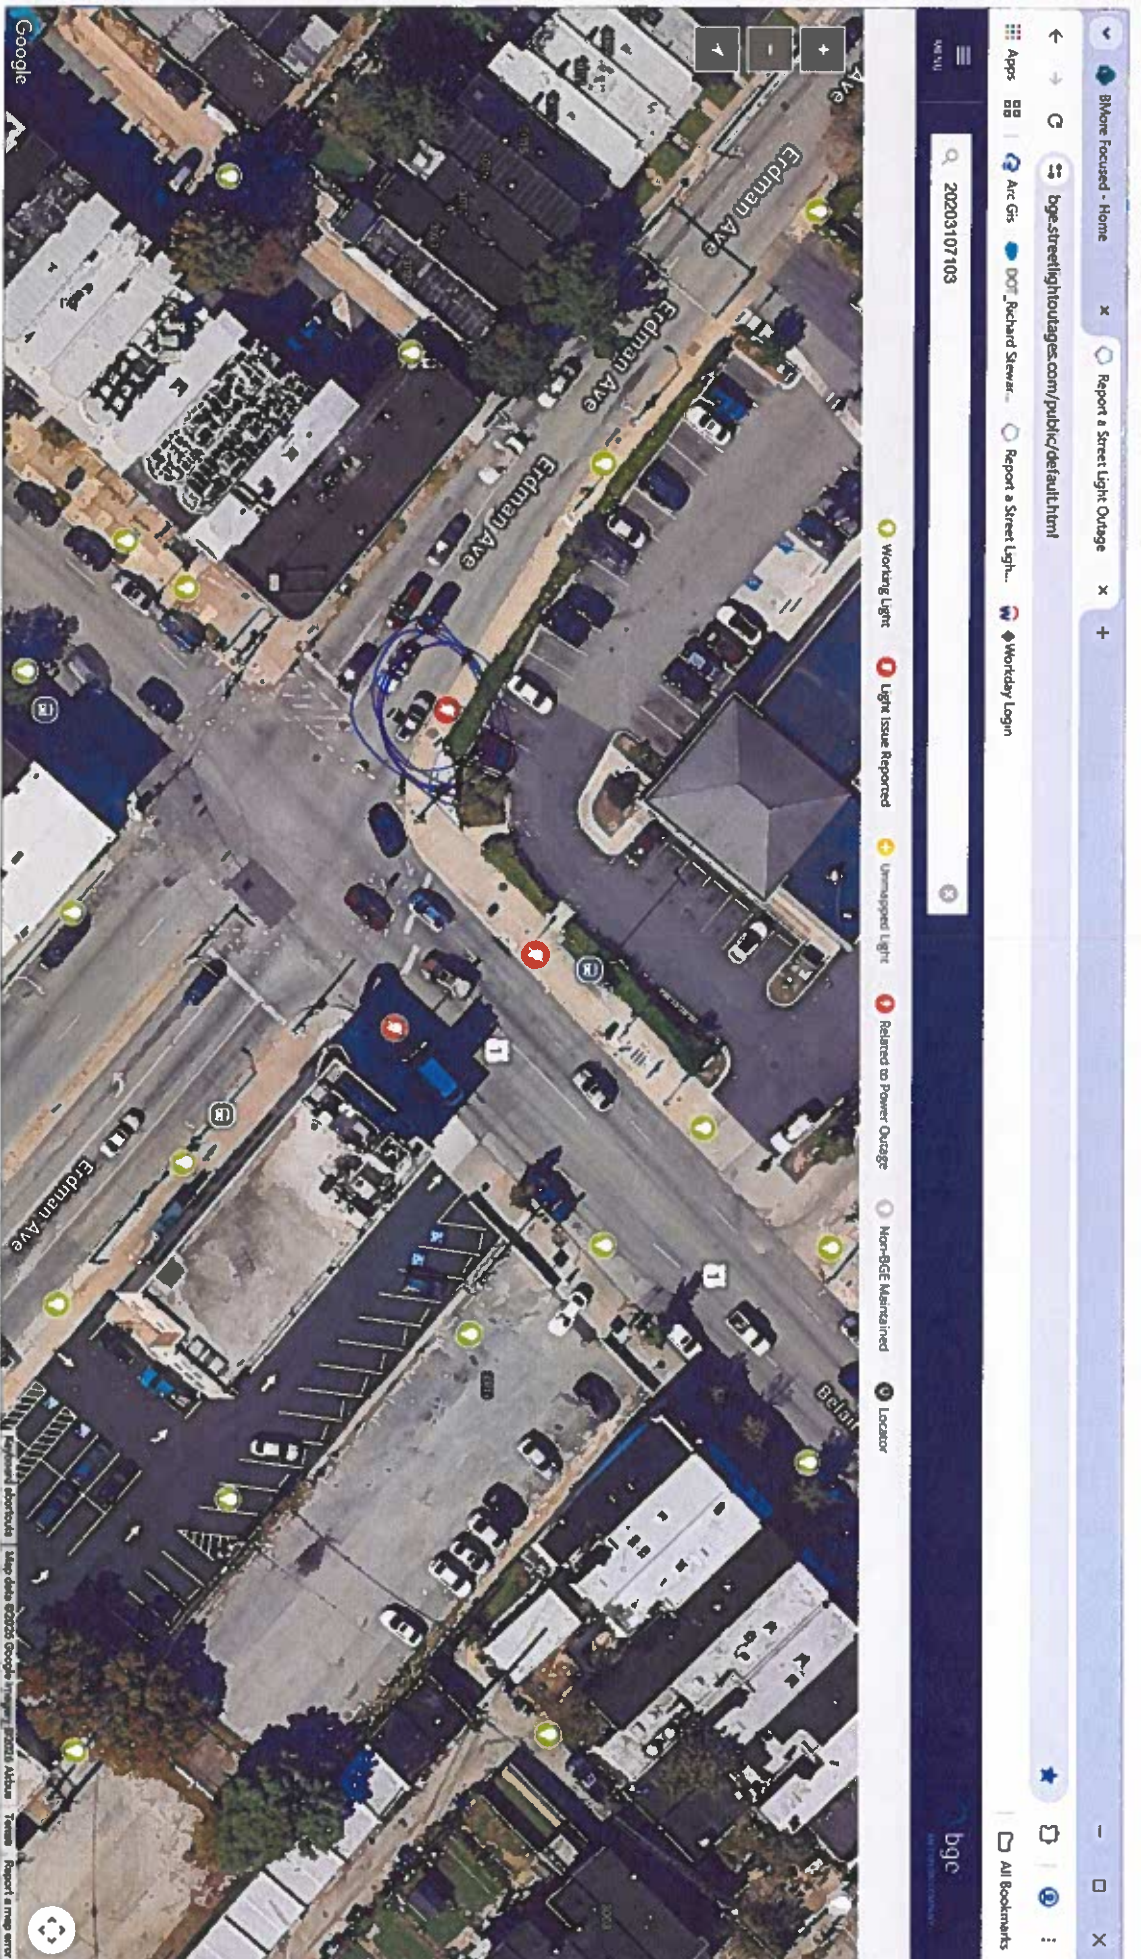
Deteriorated ☒

NEEDS  
New  
pedestal  
Base

38 Foxst Aluminum  
Camera pole  
Cobra Head  
LED
