# Inspections: Damaged Pole Report

Service Request: 26-00877081 Sector: \_\_\_\_\_ Gateway: \_\_\_\_\_ Primary: \_\_\_\_\_  
 Location on Service Request: 2114 Northcliff DR  
 Grid: 1060330 LLC: 7002

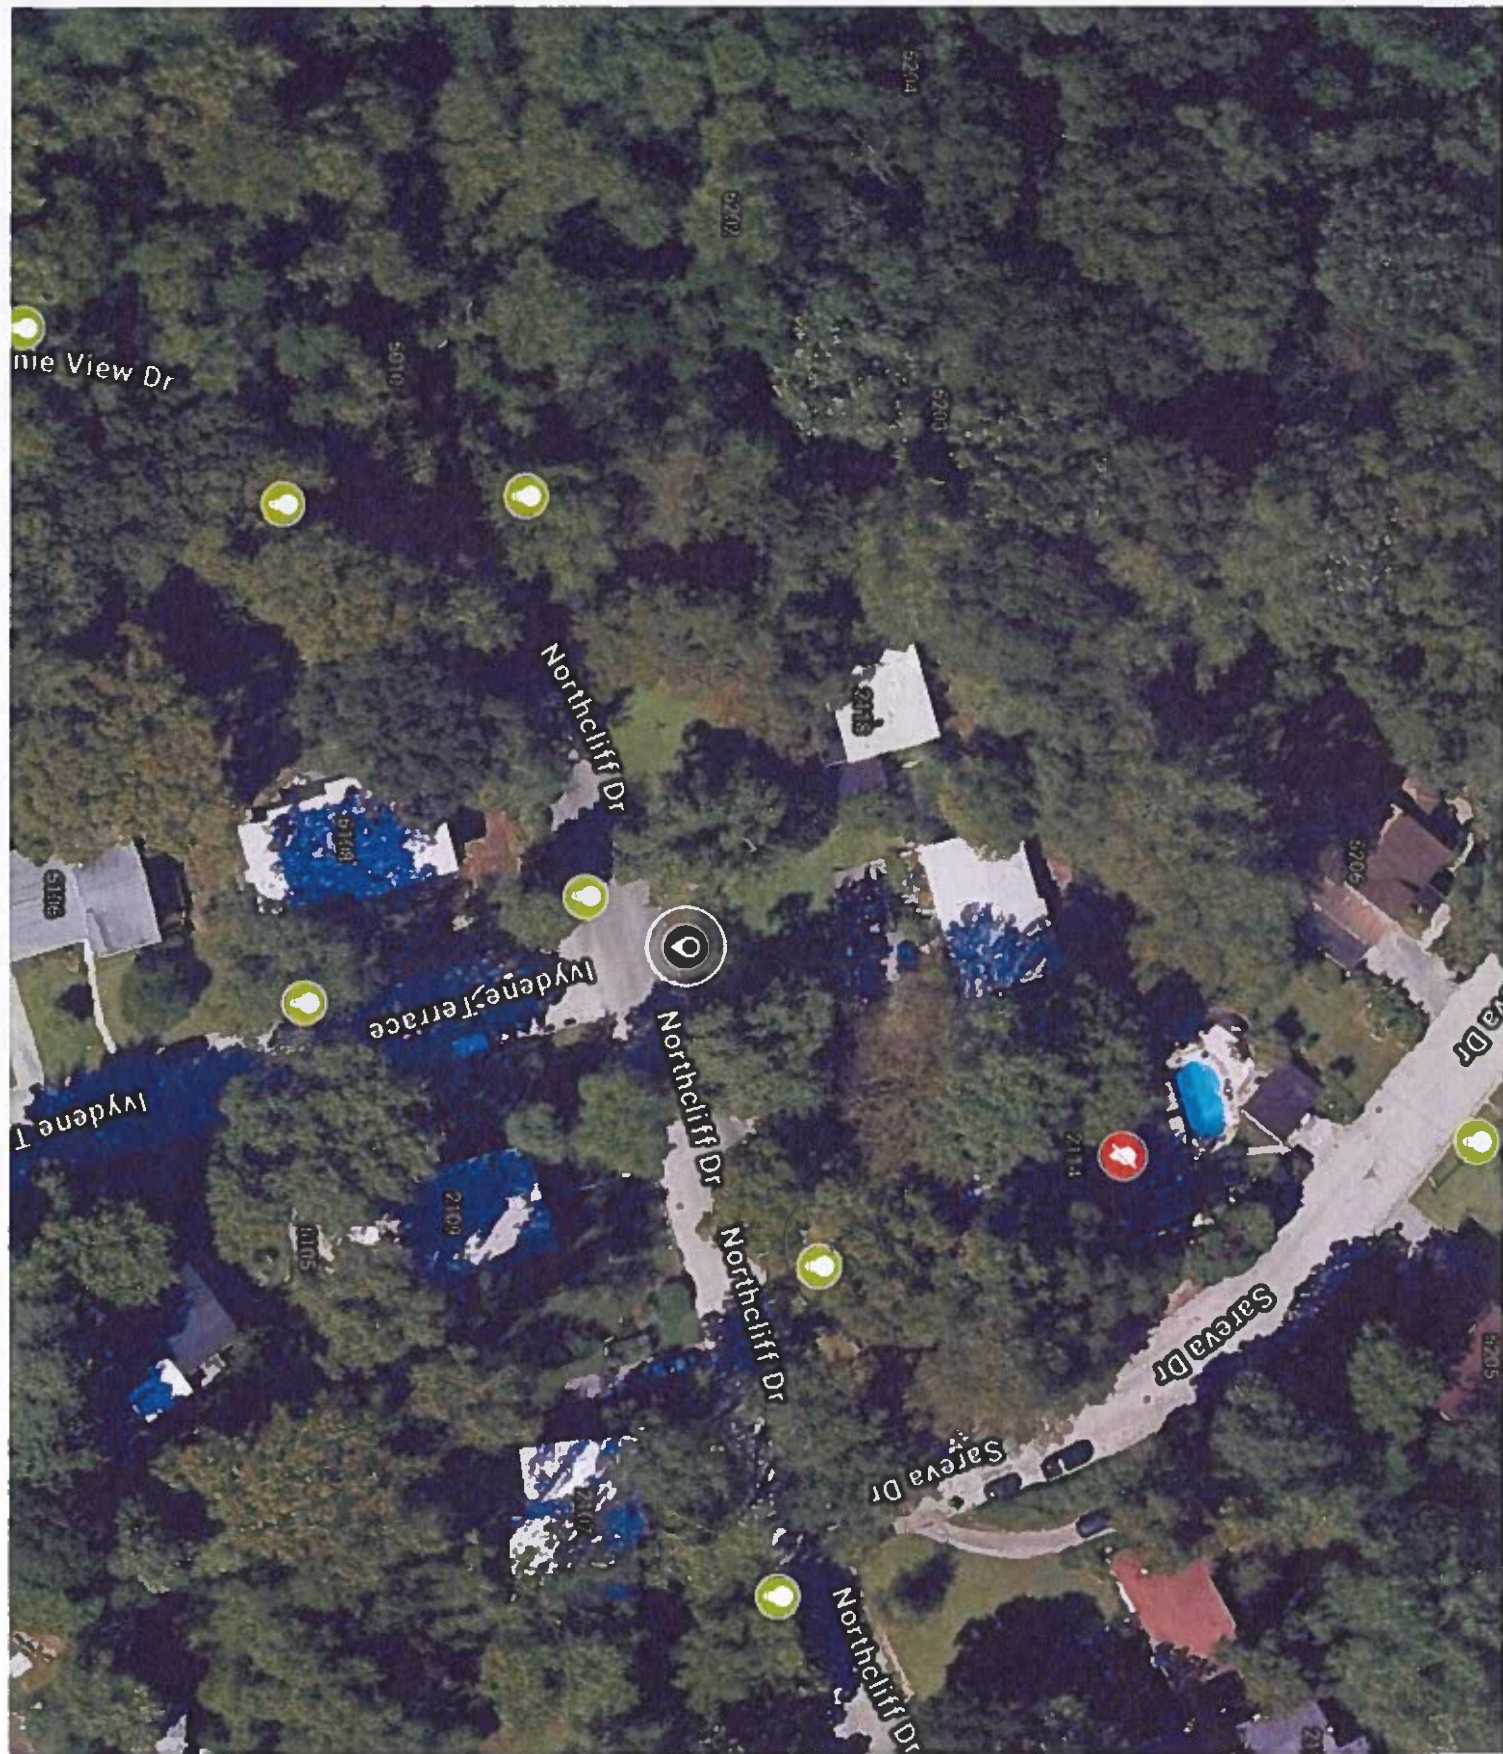
Deteriorated \_\_\_\_\_  
 Missing ☒  
 Damaged \_\_\_\_\_  
 Arm/Fixture Missing \_\_\_\_\_  
 Other \_\_\_\_\_

Good ☒  
 Bad: \_\_\_\_\_  
 Bolts ☒  
 Wires ☒  
 Conduit ☒

*Need new base*
