# Inspections: Damaged Pole Report

Service Request: 20-00905934 Sector: \_\_\_\_\_ Gateway: \_\_\_\_\_ Primary: \_\_\_\_\_  
 Location on Service Request: 6700 Popping PKWY  
 Grid : 2060310 LLC: 7180

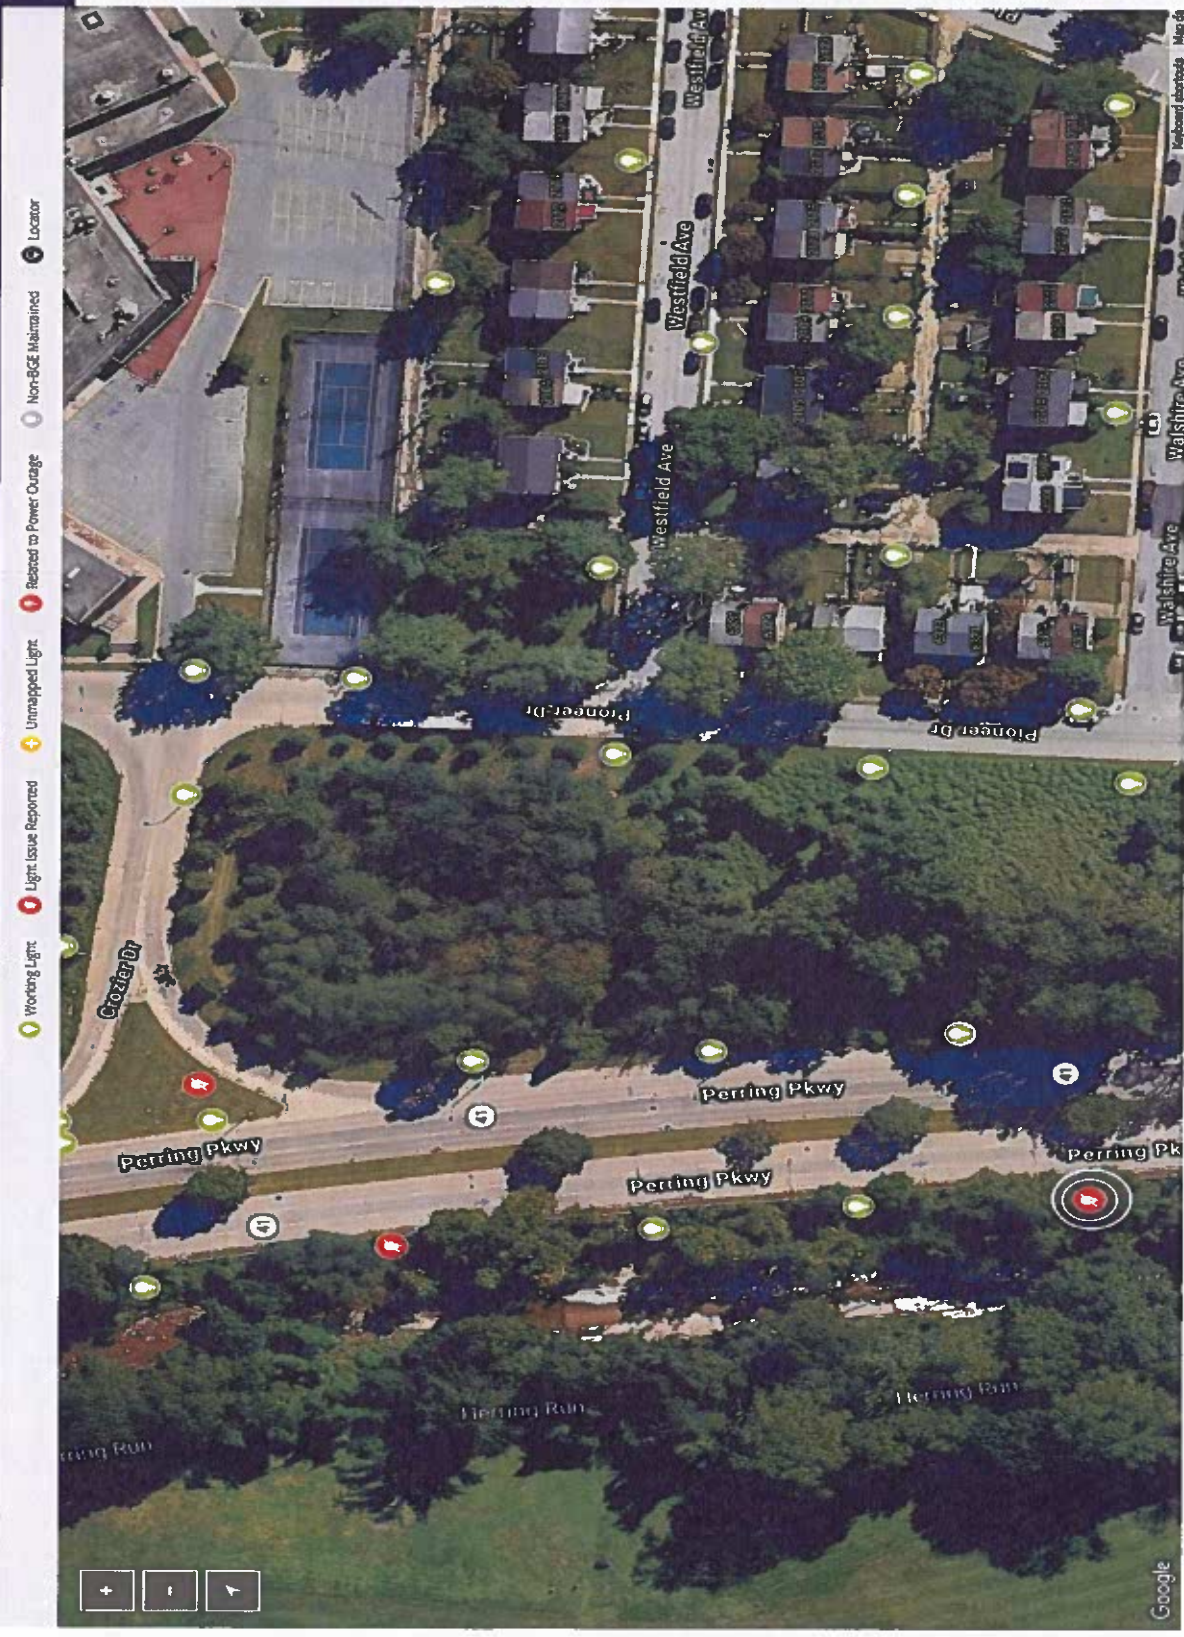
Missing ✓

DOWNED POLE & EXPOSED WIRES

Pending Repair
