# Inspections: Damaged Pole Report

Service Request: 26-00 897985 Sector: \_\_\_\_\_ Gateway: \_\_\_\_\_ Primary: \_\_\_\_\_  
 Location on Service Request: 5801 Pulaski Hwy  
 Grid : 2010440 LLC: 7060

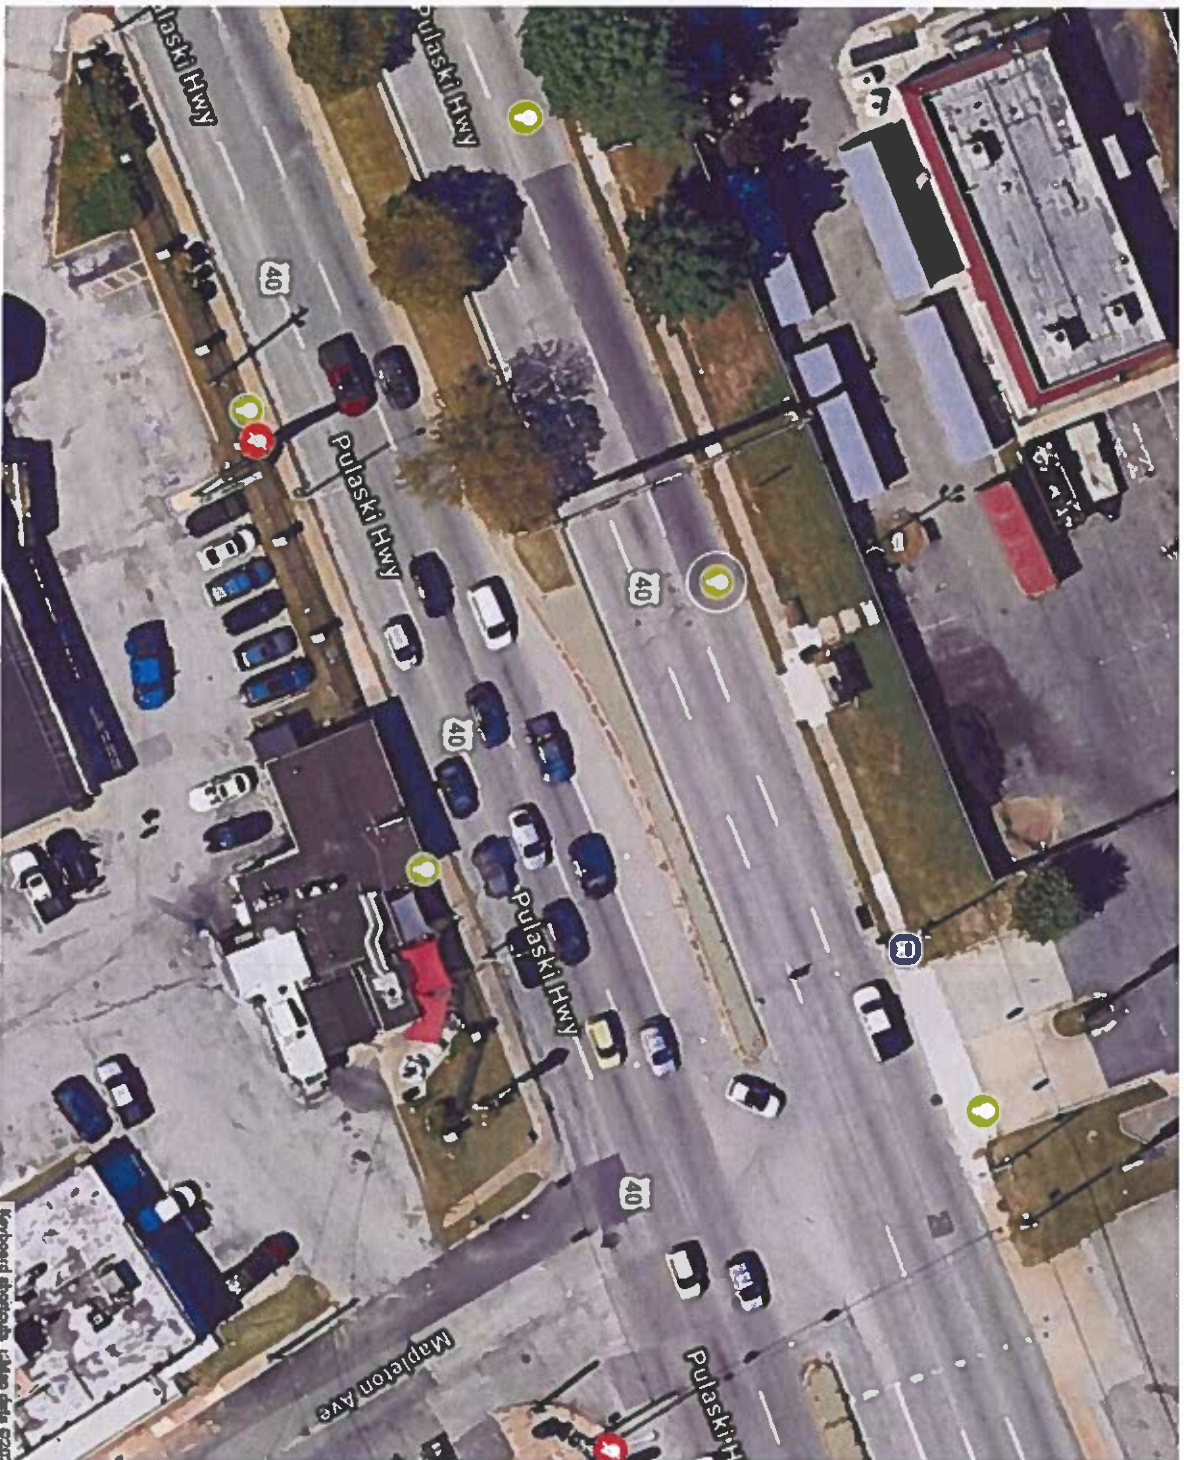
Deteriorated ☒  
 Missing ☒  
 Damaged \_\_\_\_\_  
 Arm/Fixture Missing \_\_\_\_\_  
 Other \_\_\_\_\_

Need new base
