# Inspections: Damaged Pole Report

Service Request 26-00935215 Sector \_\_\_\_\_ Gateway \_\_\_\_\_ Primary \_\_\_\_\_  
 Location on Service Request: 2012 Kennedy Ave  
 Grid : 2020140 LLC: 7223

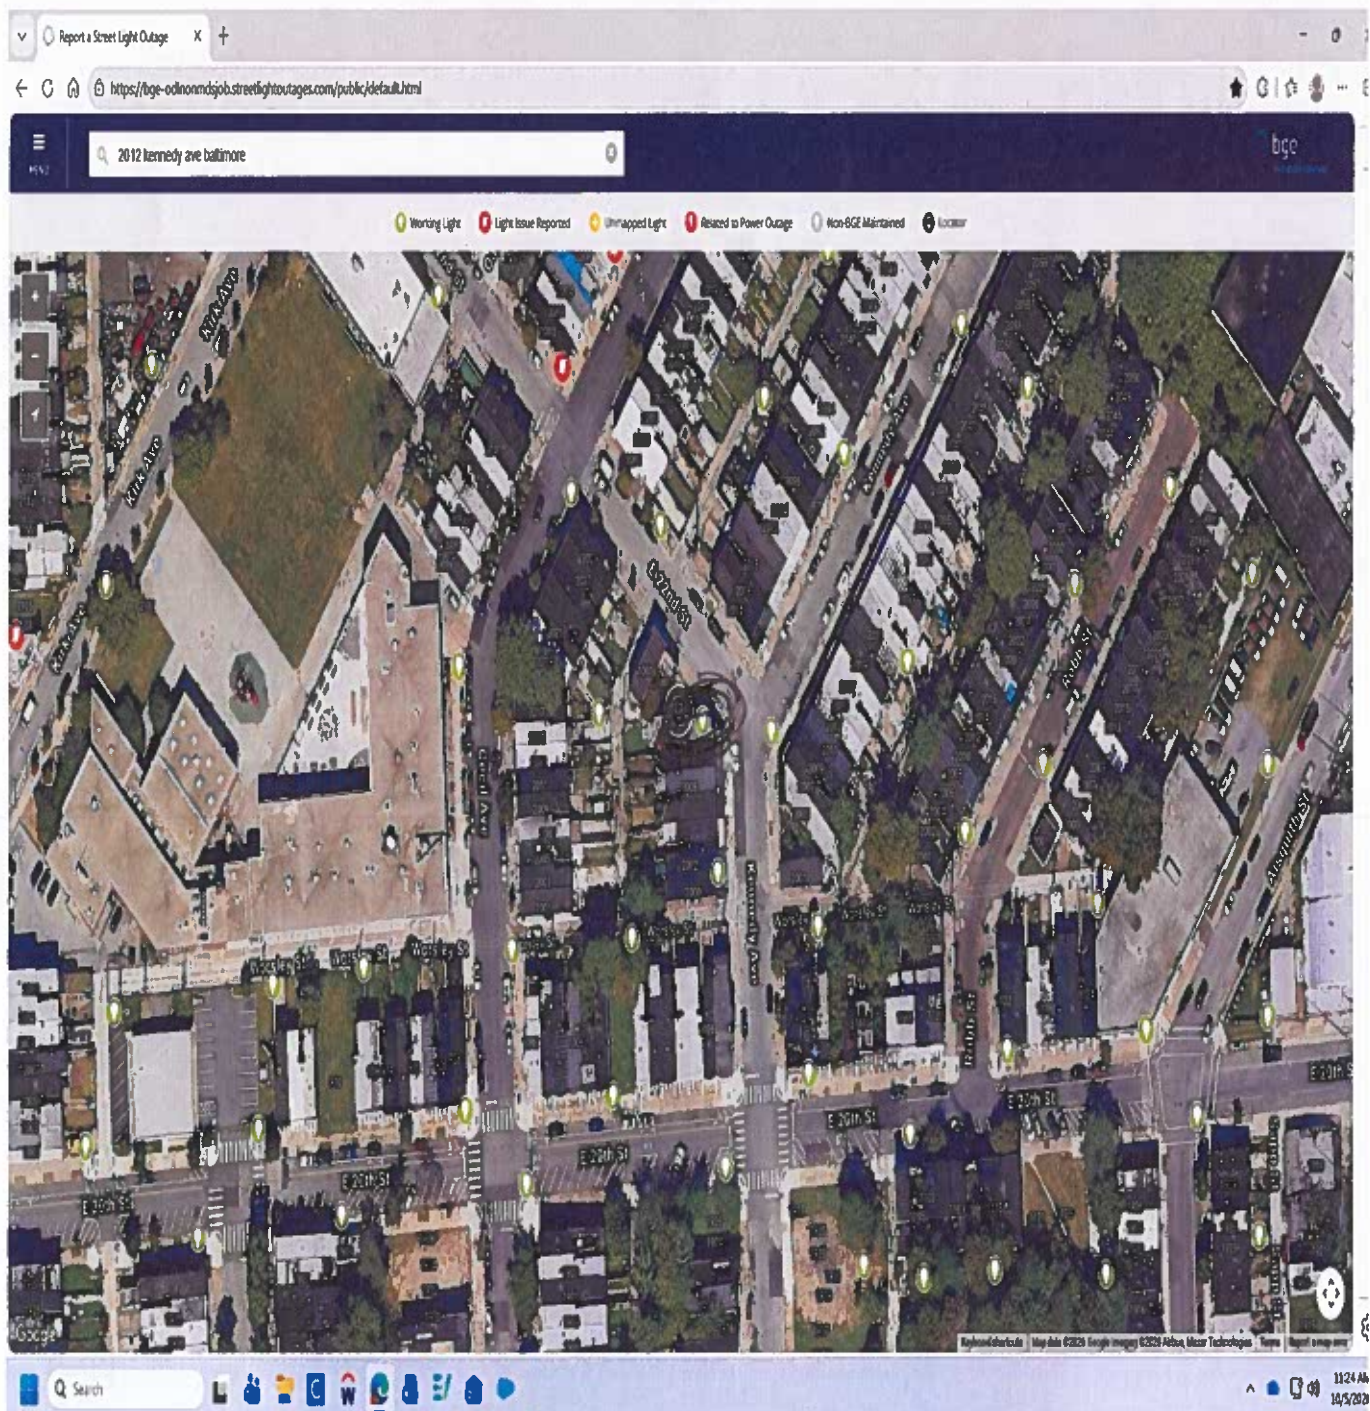
Deteriorated \_\_\_\_\_  
 Missing ☒  
 Damaged \_\_\_\_\_  
 Arm/Fixture Missing \_\_\_\_\_  
 Other \_\_\_\_\_

Damaged \_\_\_\_\_  
 Missing ☒

Bolts ☒  
 Wires ☒  
 Conduit ☒

**NEEDS  
New  
Base**
