# Inspections Damaged Pole Report

Service Request 26-00937823 ctor Gateway Primary           
 Location on Service Request. 600 Guilford Ave  
 Grid : 4010110 LLC: 7163

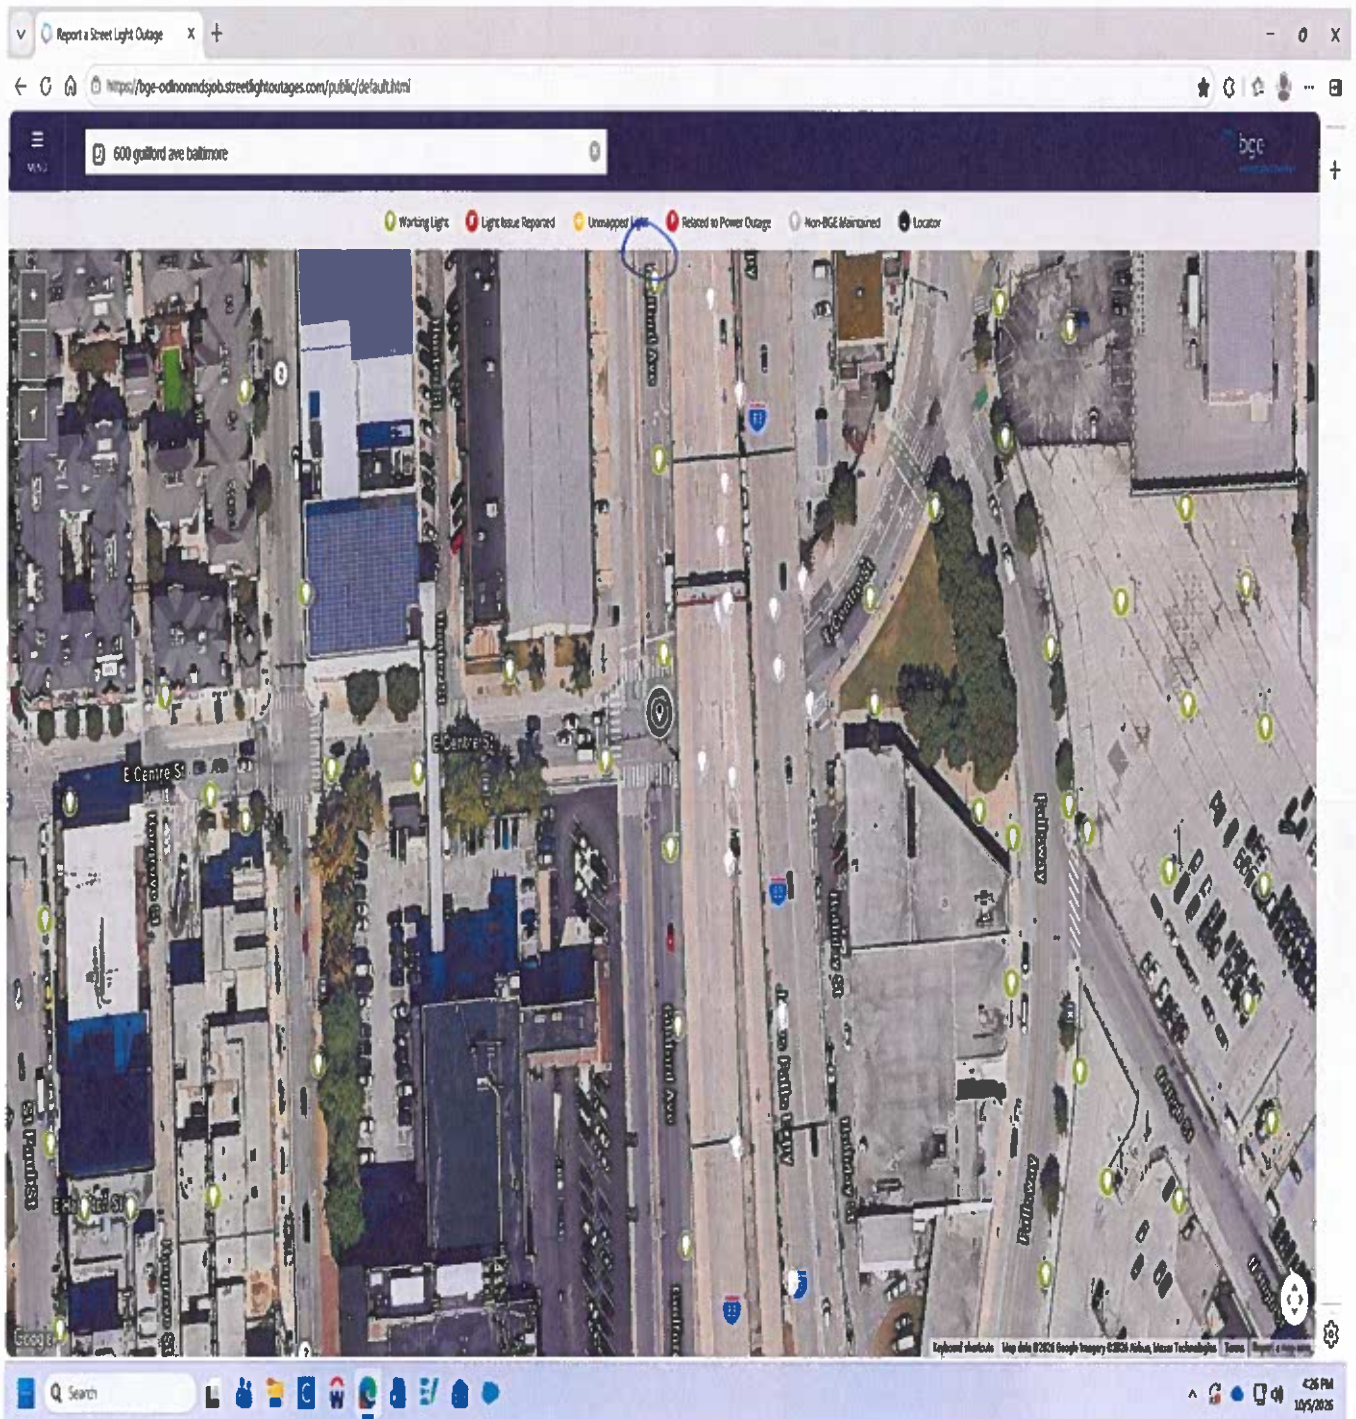
30 Foot  
Aluminum  
pole  
cobra mini  
LED
