# Inspections: Damaged Pole Report

Service Request 26-00944060 Gateway Primary

Location on Service Request: 5200 EASTBURY AVE

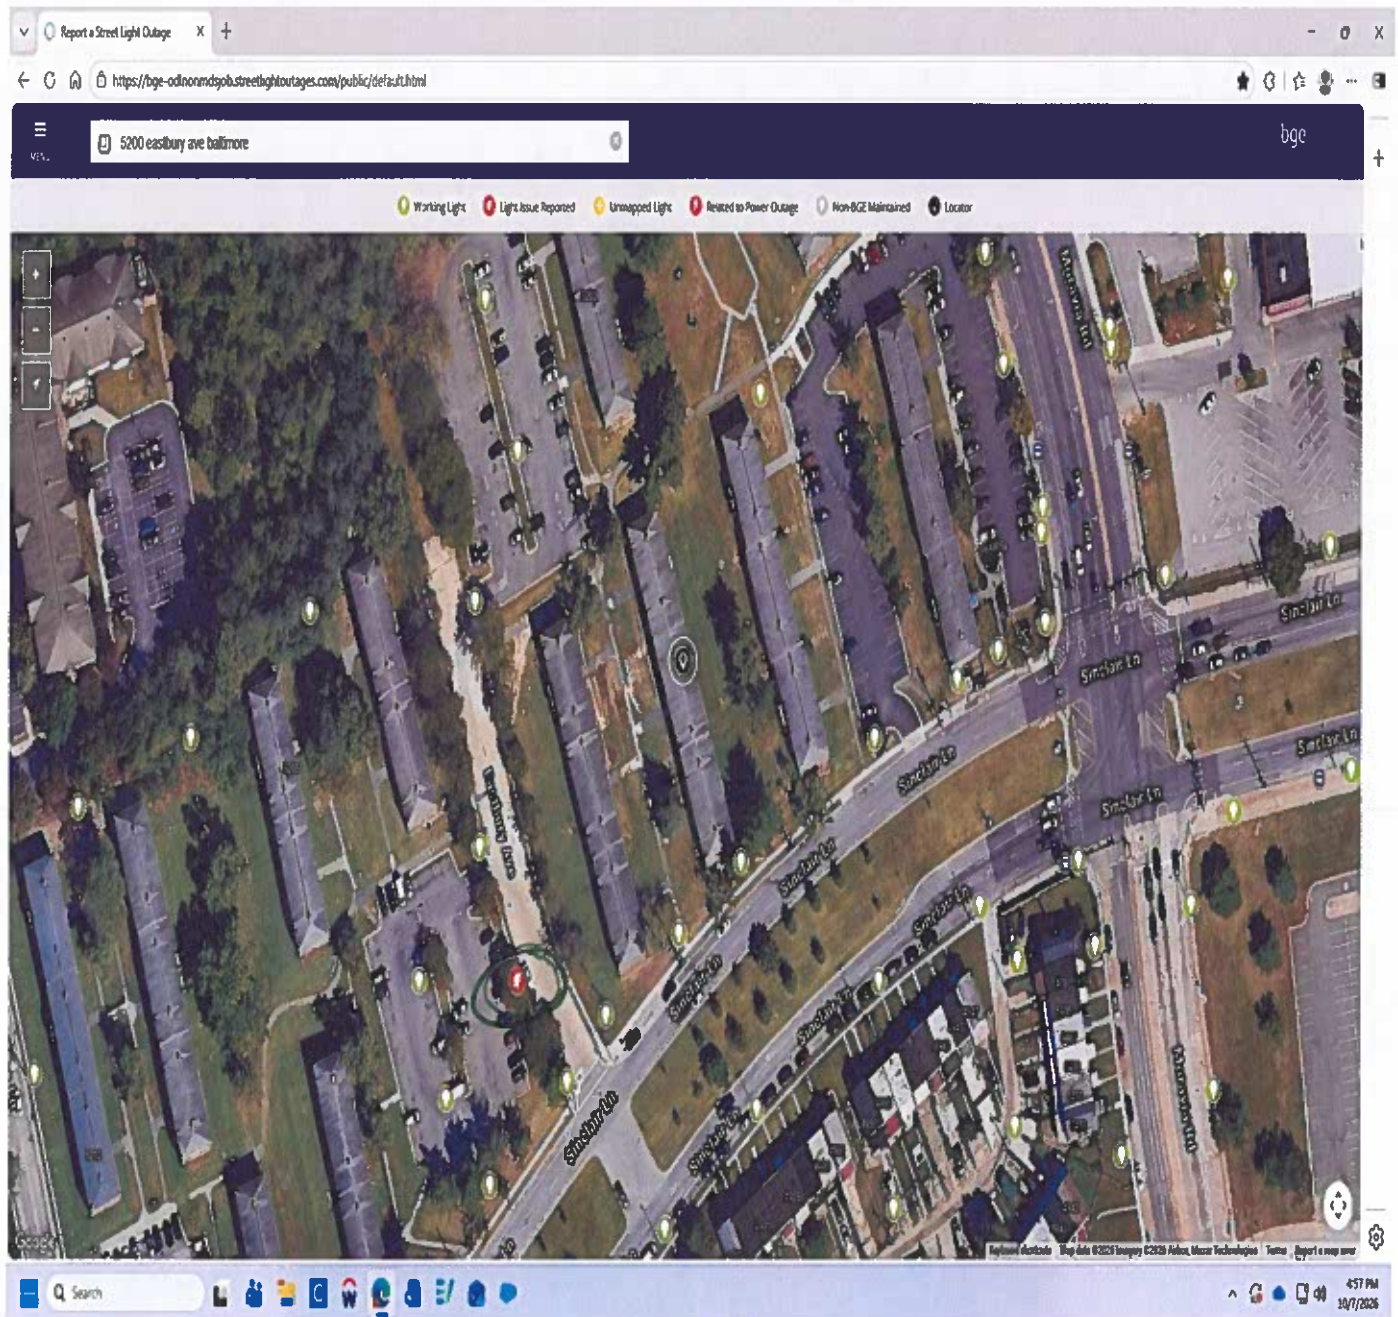
NEEDS  
NEW  
BASE

25 Foot  
Aluminum  
pole  
Cobon Thread  
LED

WORK ORDER #  
20260250
