Inspections: Damaged Pole Report

Service Request 210-00952988 Sector Dillon St & S. Fagley St Gateway Primary  
 Location on Service Request: Dillon St & S. Fagley St  
 Grid: 4020320 LLC: 7009

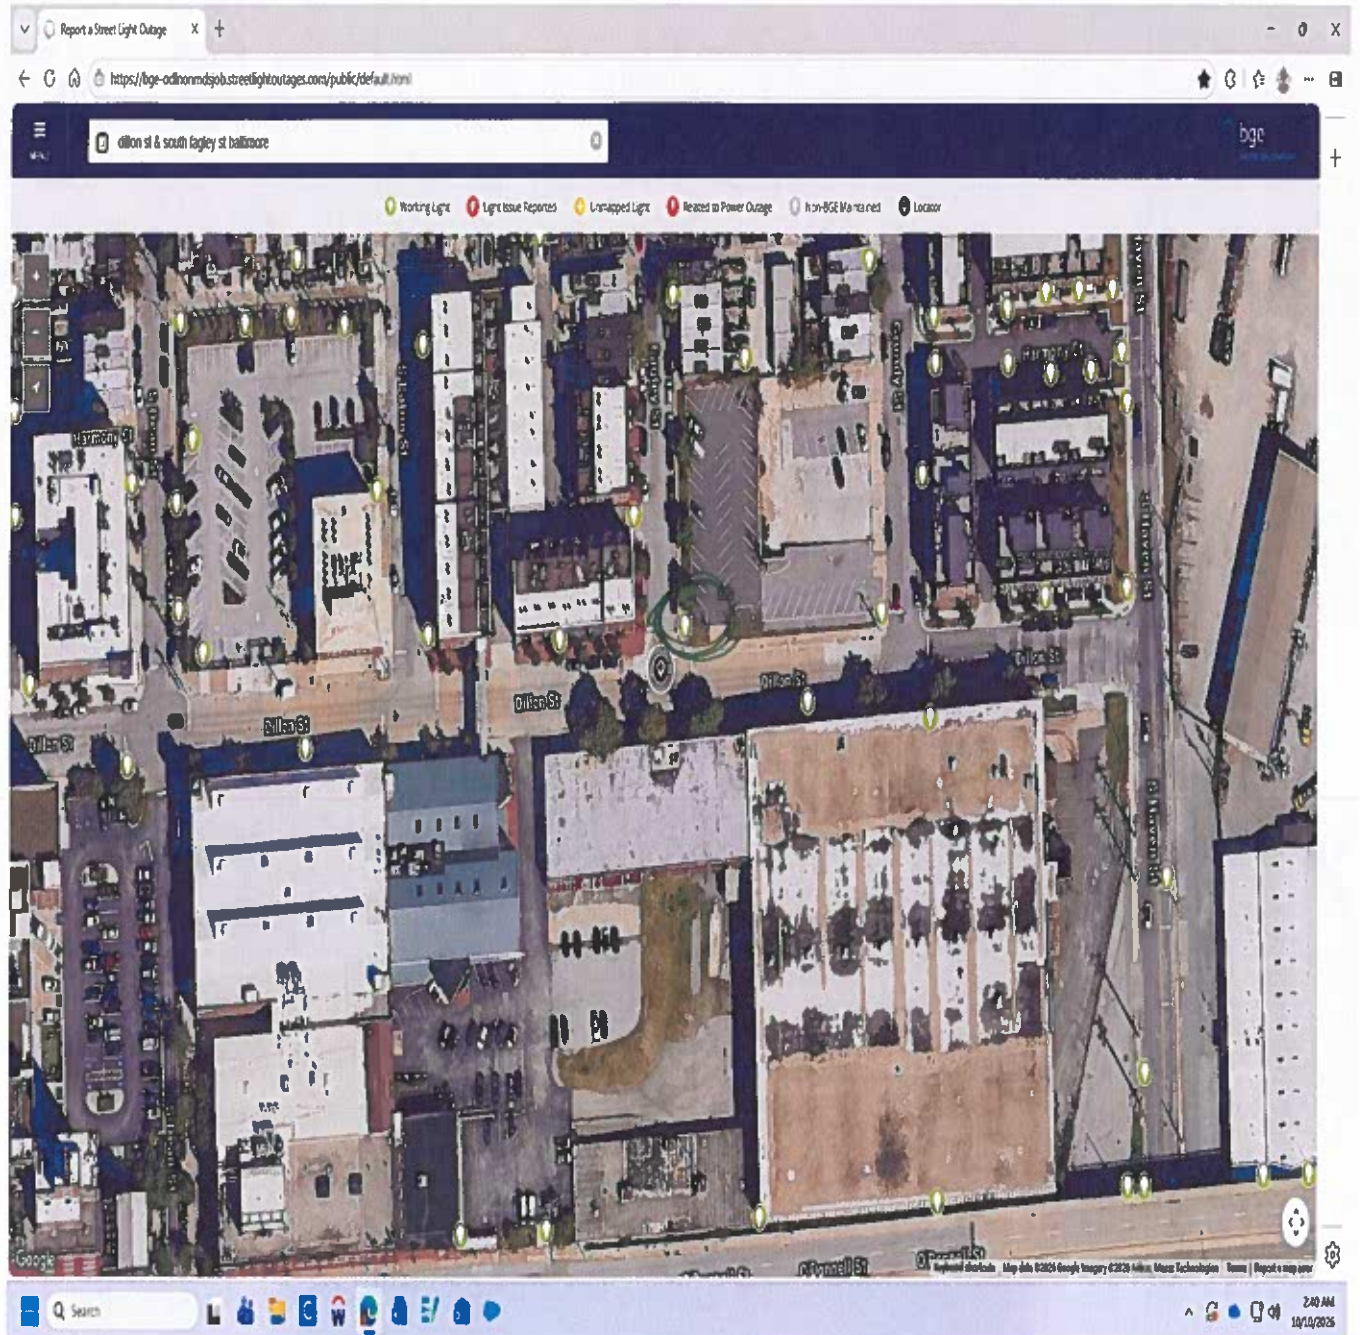
**NEEDS  
NEW  
BASE**

25 Foot  
Aluminum  
pole  
cobra head  
LED
