# Inspections Damaged Pole Report

Service Request 26-00957836 Sector            Gateway            Primary

Location on Service Request: 5100 Eastern Ave

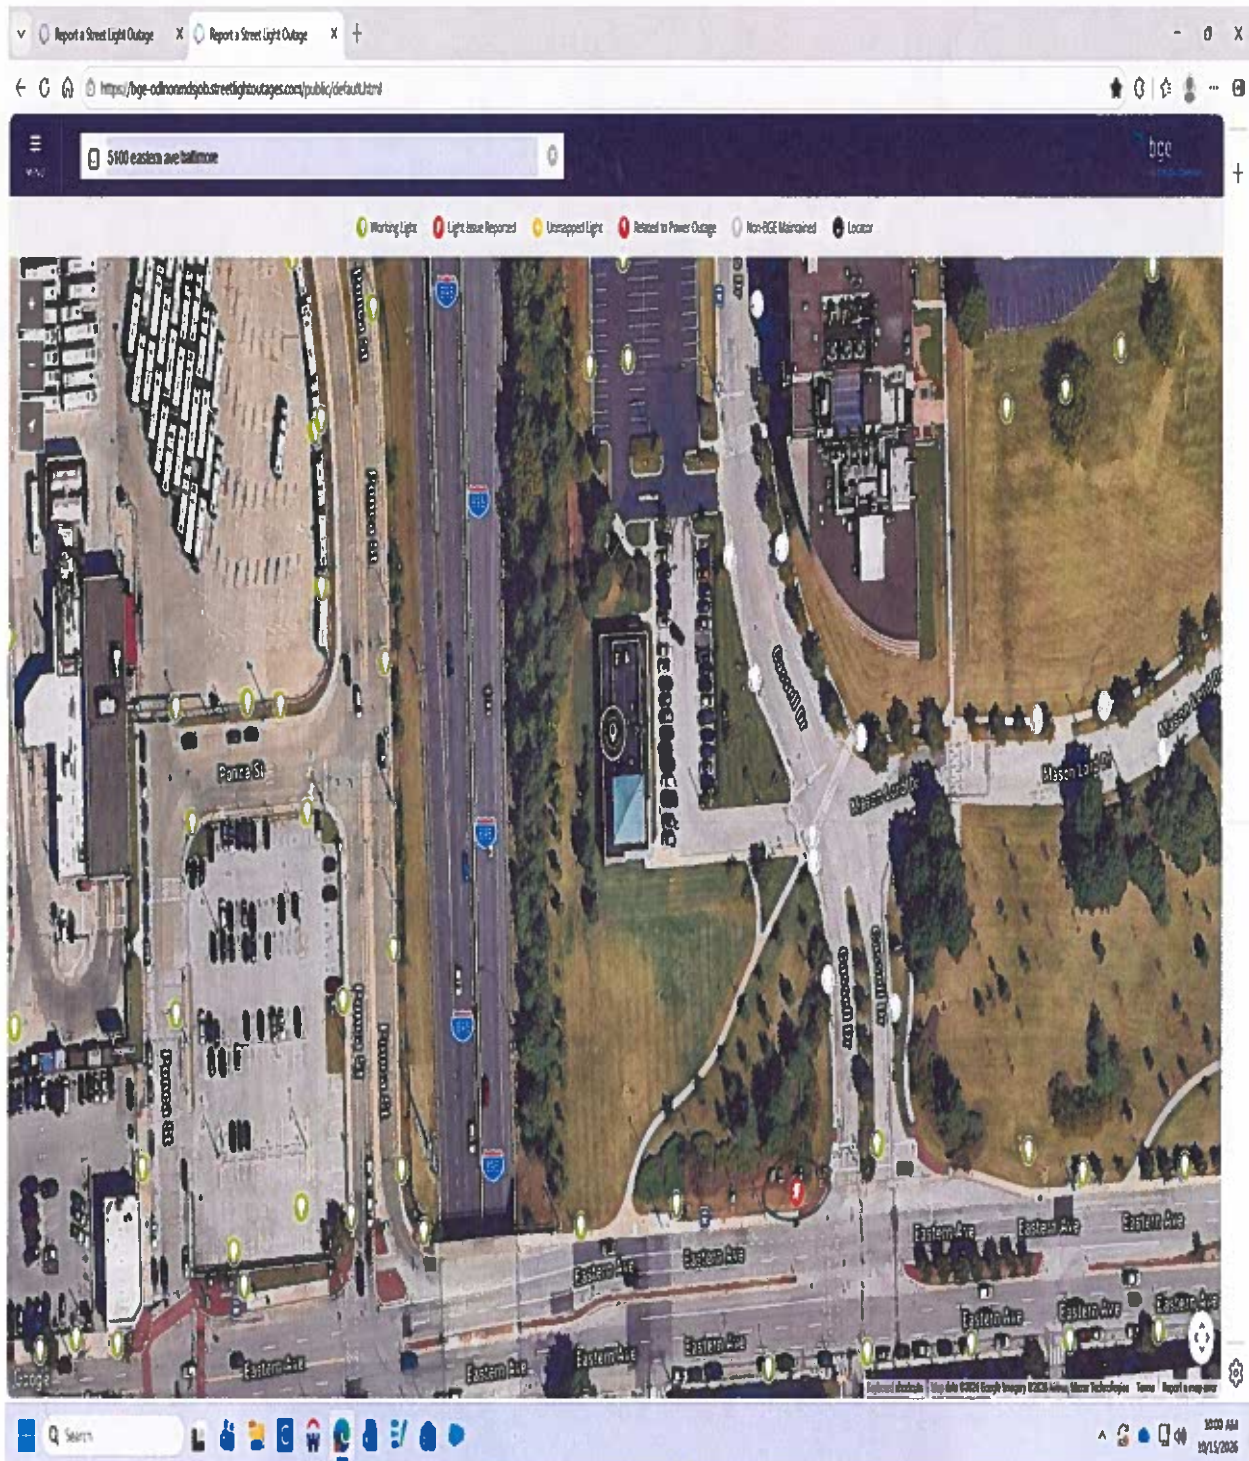
Deteriorated ☒

Missing ☒

30 Foot  
Aluminum  
pole  
cobrahead  
LED
