Inspections: Damaged Pole Report

Service Request: 26-00967862 Sector: \_\_\_\_\_ Gateway: \_\_\_\_\_ Primary: \_\_\_\_\_

Location on Service Request: 17 Mercer St

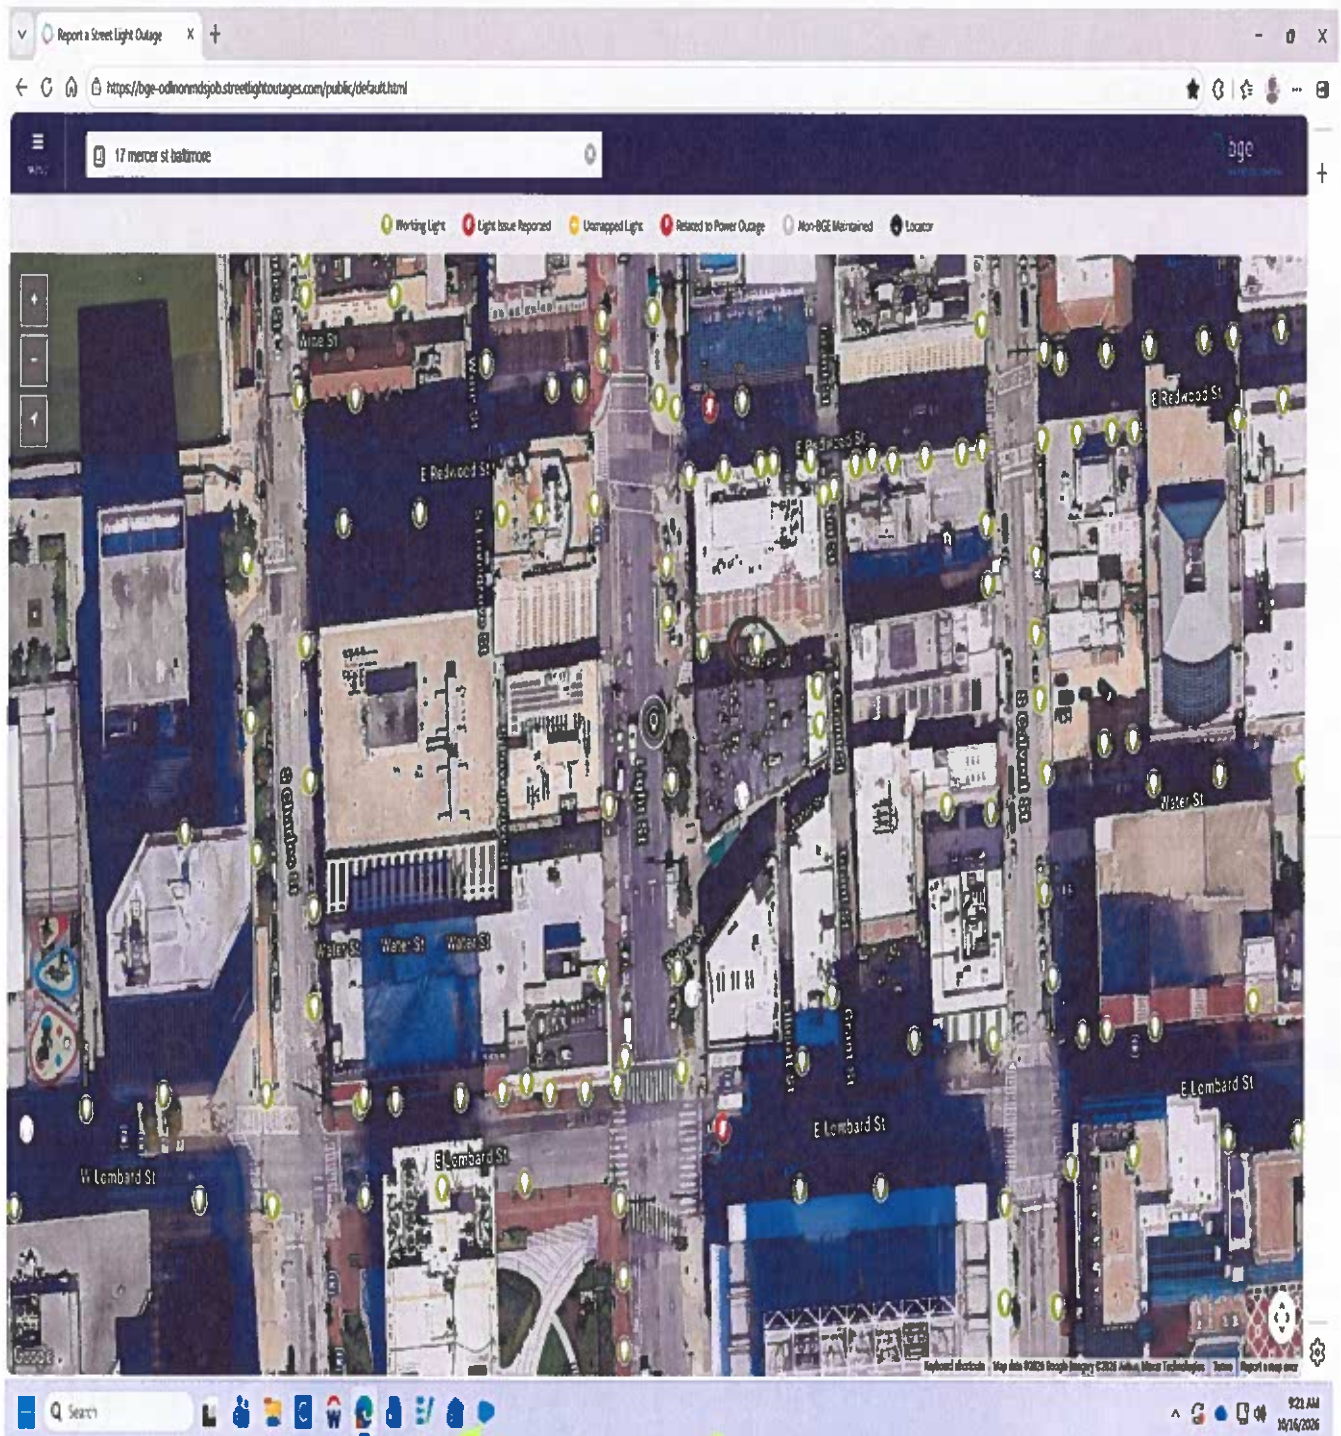
Missing ☒

Ottenbein  
Acorn Fixture
