## Inspection Report (Bulldozer)

Year	2004
Make	Caterpillar
Model	D5N XL
Serial Number	AGG00760
Hour Meter Reading	10032

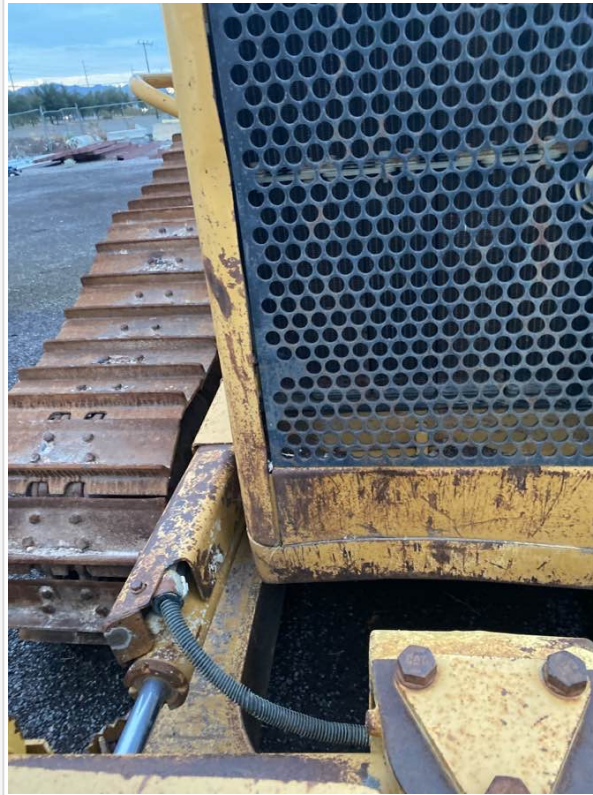
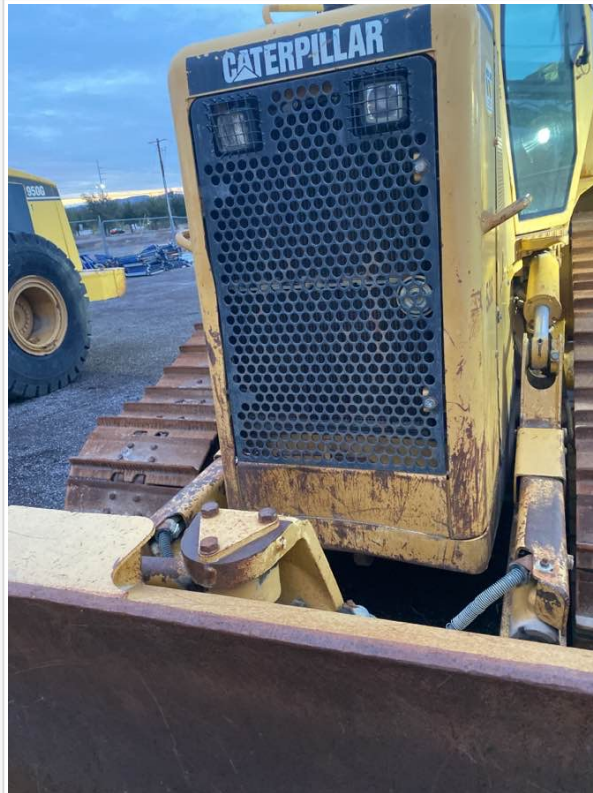
<b>Instructions</b>	<p>Evaluate the following on a 4 point scale (leave comments where an explanation is appropriate):</p> <p>4 = Like New, Recently Replaced 3 = Normal Wear &amp; Tear 2 = Above Average Wear 1 = Service Required</p> <p>Things to look for:</p> <ul style="list-style-type: none"> <li>- cosmetic damage</li> <li>- minor surface rust</li> <li>- repaint (and overspray)</li> <li>- cracked or damage glass</li> <li>- major rust (cancer)</li> <li>- cracks / visible welds</li> </ul>
<b>Front</b>	<p>3 - Normal Wear &amp; Tear</p>
<b>Comments</b>	<p>Normal wear, surface rust on blade, light scratches on front of hard nose</p>
<b>Front Photos</b>

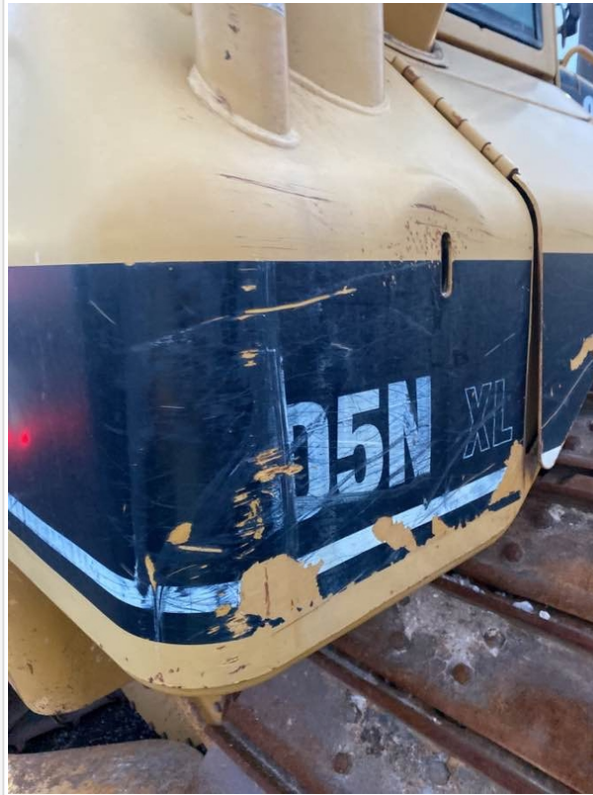
Normal wear, light scratching on paint. Tracks and track frames have surface rust

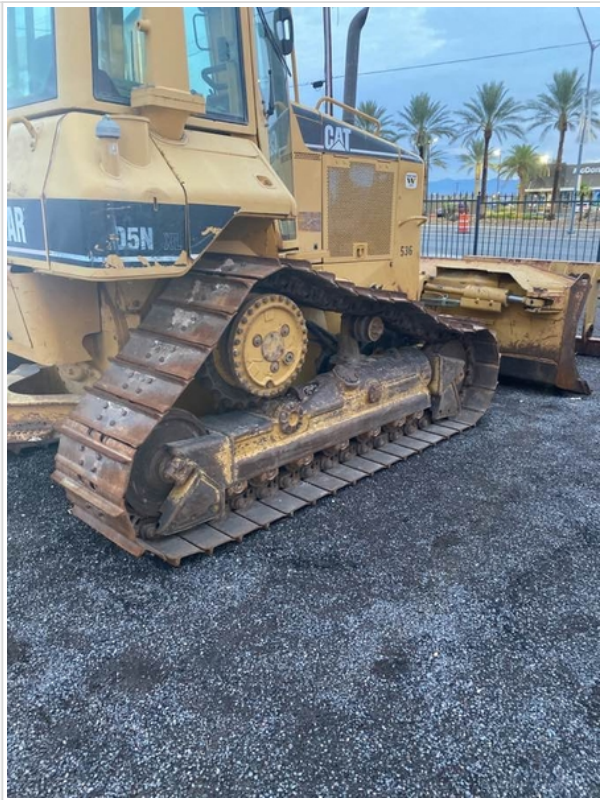
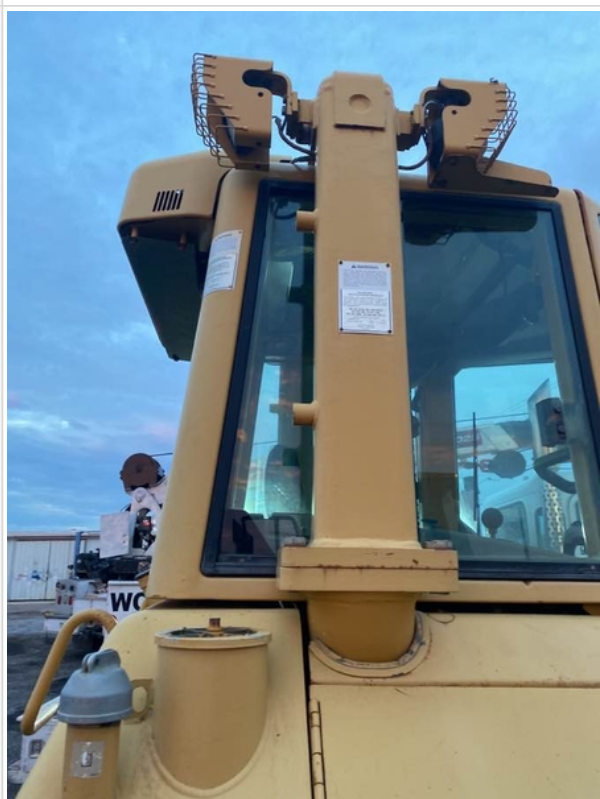
Upper	3 - Normal Wear & Tear	
Comments	Glass is good, no cracks. Wipers present. ROPS has a few spots of surface rust	
Upper Photos

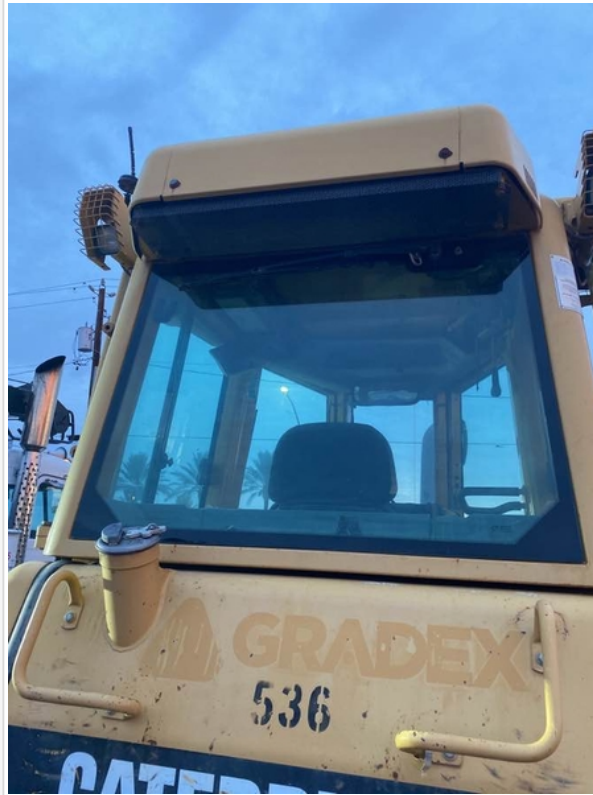
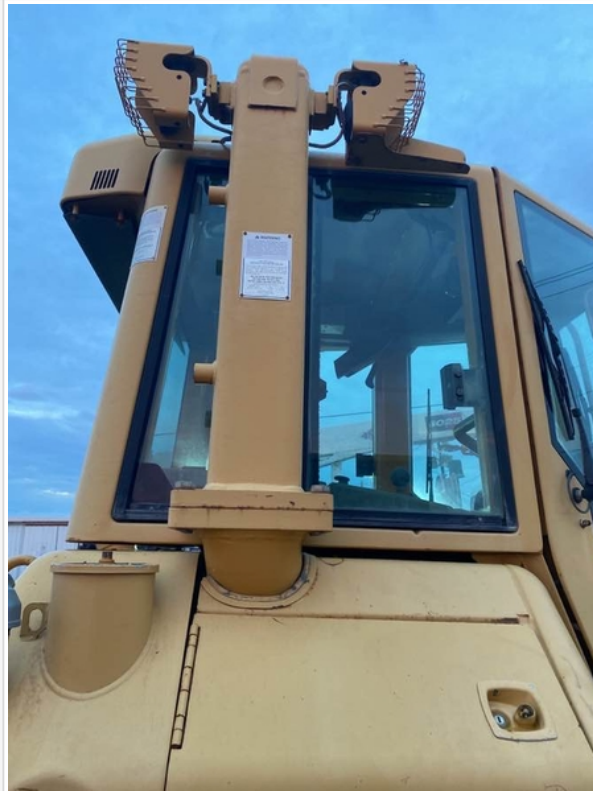
Glass Condition Photos

Glass Condition	3 - Normal Wear & Tear
Comments	Glass has no cracks.

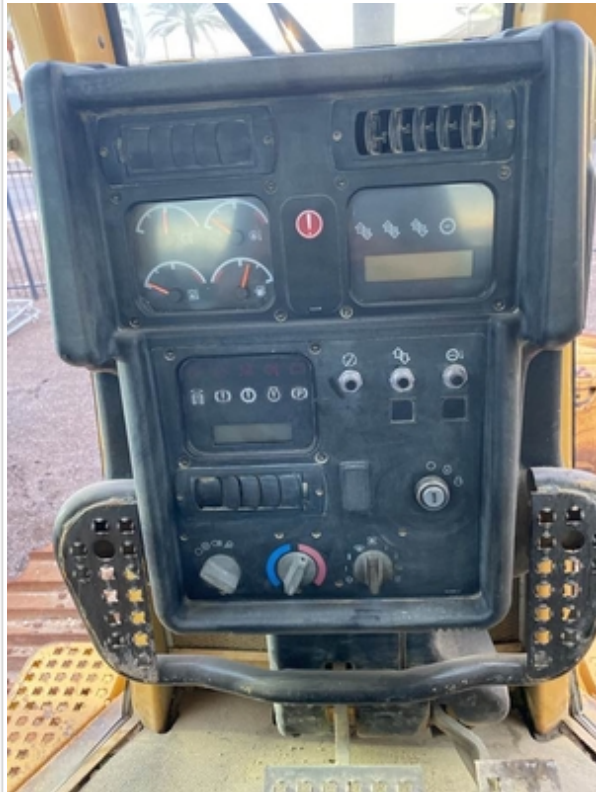
Controls & Switches	3 - Normal Wear & Tear
Comments	Controls and switches look ok. Normal wear.
Controls & Switches Photos

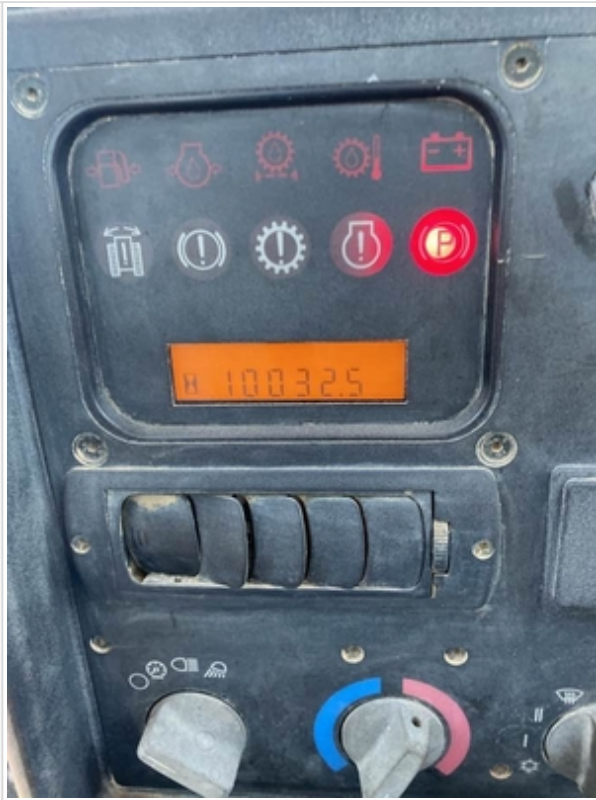
<p>Other Gauge Activity</p>	<p>3 - Normal Wear &amp; Tear</p>
<p>Comments</p>	<p>Gauges functional</p>
<p>Other Gauge Activity Photos</p>

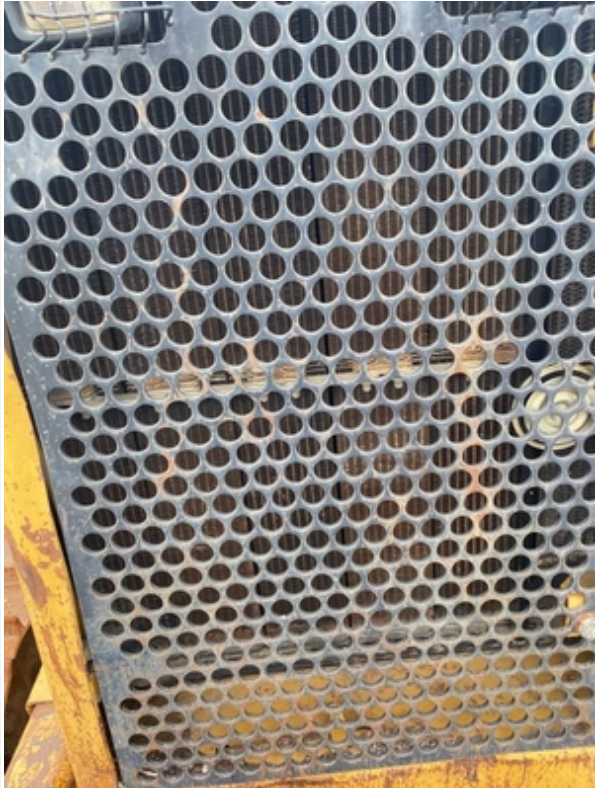
<b>Instructions</b>	Assess the condition of the engine / power unit.  For items on a 4 point scale, evaluate using the following criteria:  4 = Like New, Recently Replaced 3 = Normal Wear & Tear 2 = Above Average Wear 1 = Service Required
<b>Blow-by (Visual Observation Check)</b>	No
<b>Unusual Noises (Upon Start-up, Idle, Shutdown)</b>	No
<b>Comments</b>	Batteries were weak had to jump start.
<b>Engine Smoke (Upon Start-up, Idle, Shutdown)</b>	No
<b>Engine Exhaust Color</b>	Black
<b>Comments</b>	Slight black on start up but ran very clean
<b>Oil Color / Appearance</b>	3 - Normal Wear & Tear
<b>Comments</b>	Oil black
<b>Coolant Color / Appearance</b>	3 - Normal Wear & Tear
<b>Comments</b>	Light green
<b>Radiator</b>	1 - Service Required
<b>Comments</b>	Radiator light surface rust
<b>Radiator Photos</b>

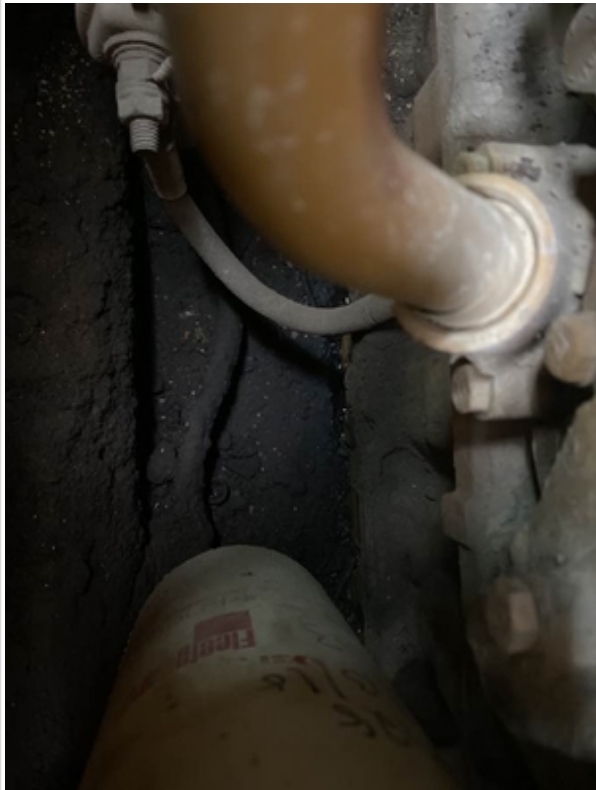
<p>Belts &amp; Hoses</p>	<p>3 - Normal Wear &amp; Tear</p>
<p>Oil Leaks</p>	<p>Yes</p>
<p>Comments</p>	<p>Oil present in belly pan</p>
<p>Oil Leaks Photos</p>

Fuel Leaks	No
Cooling System Leaks	No
Overall Engine Appearance	Wet
Overall Engine Comments	Corrosion at electrical connections on relay. Oil leaks on engine. Not major. But oil present in belly pan. High pressure oil hose going to head wet. Hoses for coolant not leaking. But soft.

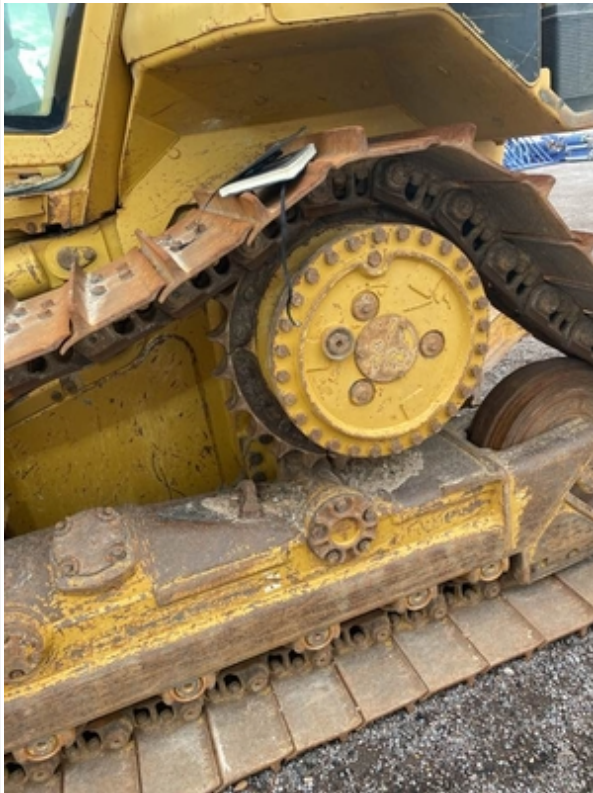
Instructions	Evaluate the following on a 4 point scale (leave comments where an explanation is appropriate):  4 = Like New, Recently Replaced 3 = Normal Wear & Tear 2 = Above Average Wear 1 = Service Required
Clutch	0
Left Drive Motor	0
Left Final Drive	3 - Normal Wear & Tear
Comments	Ok. No visible leaks
Left Final Drive Photos

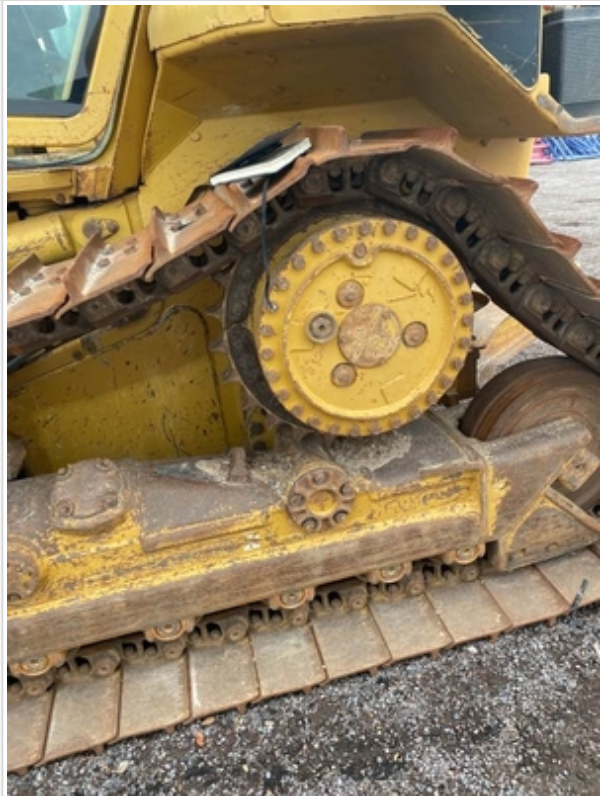
<p>Left High Drive Photos</p>

Left High Drive	3 - Normal Wear & Tear
Comments	Ok. No visible leaks

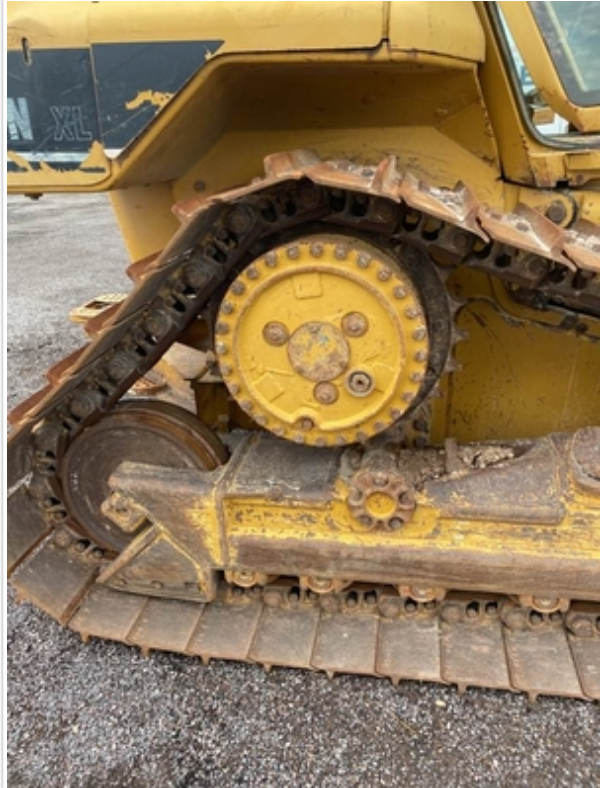
<p>Right Drive Motor</p>	<p>0</p>	
<p>Right Final Drive</p>	<p>3 - Normal Wear &amp; Tear</p>	
<p>Comments</p>	<p>Ok. No visible leaks</p>	
<p>Right Final Drive Photos</p>

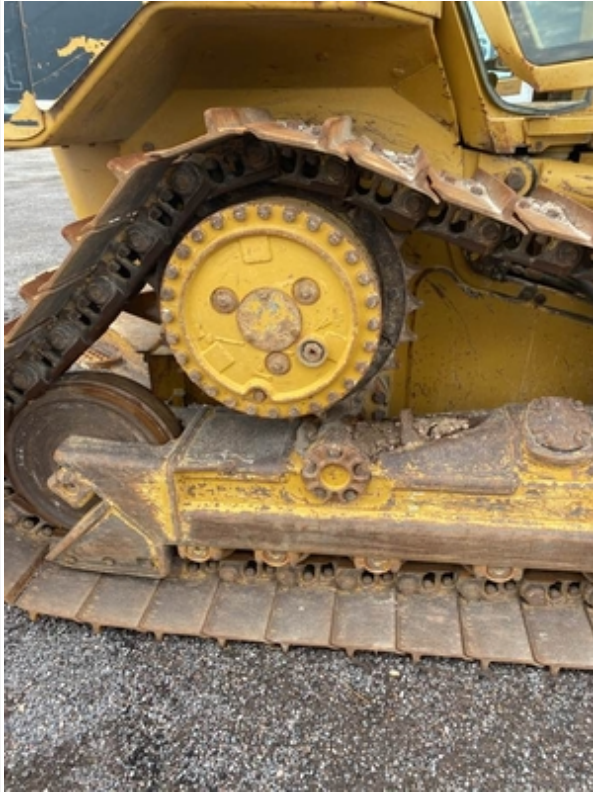
Right High Drive	3 - Normal Wear & Tear
Comments	Ok. No visible leaks
Right High Drive Photos

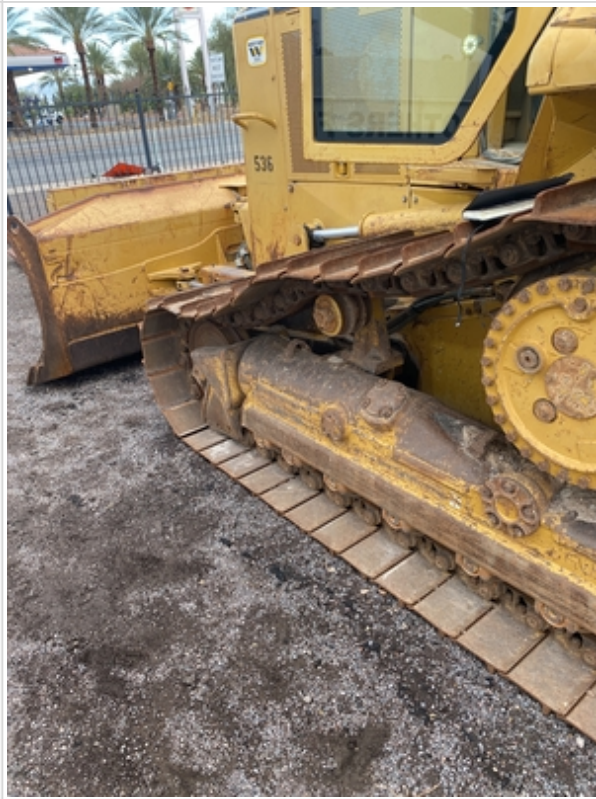
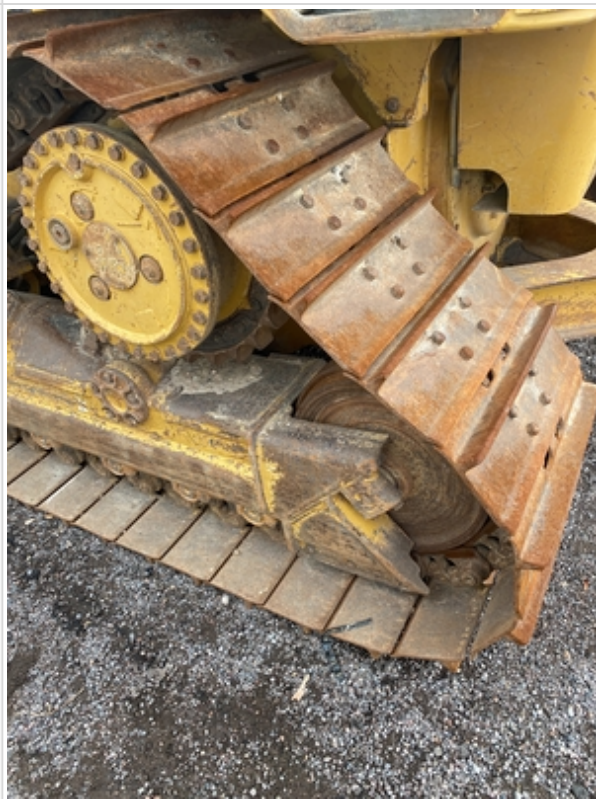
Comments	Tracks are a bit loose but still have 50-60% wear left.
Tracks Photos

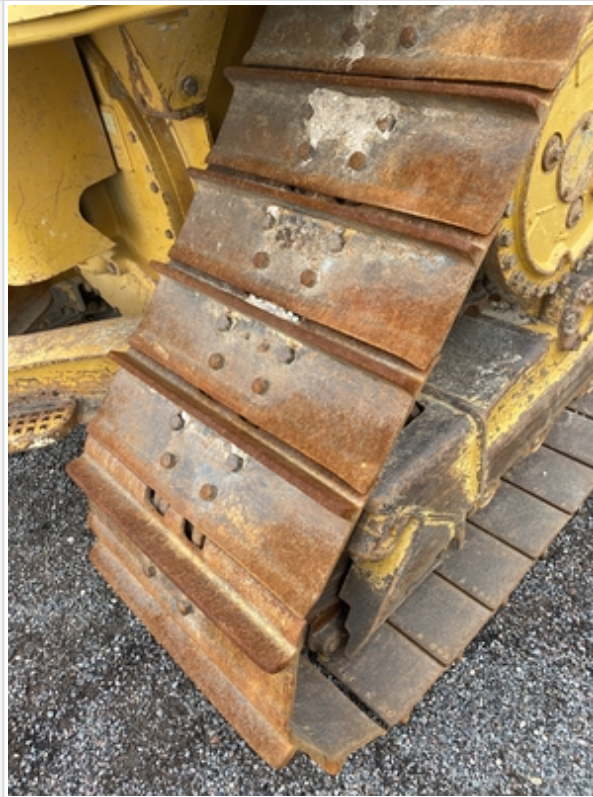
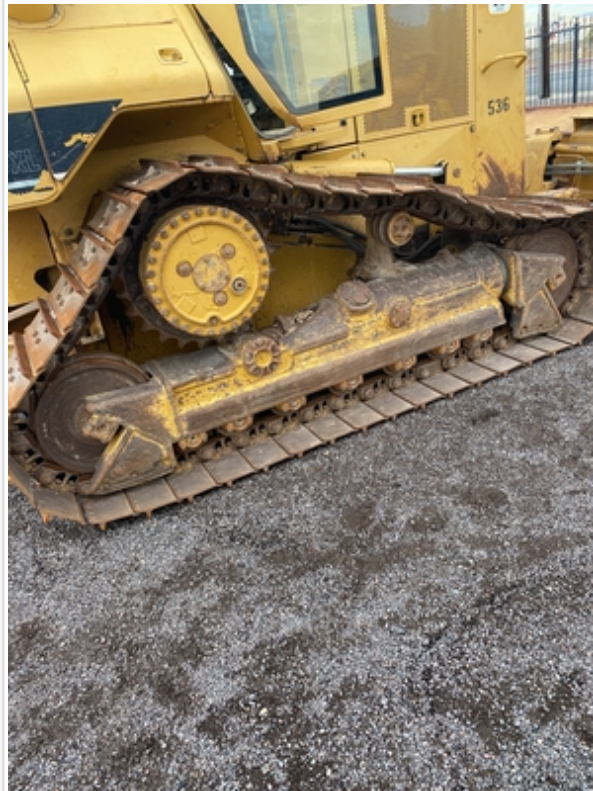
Shoes in decent shape good grouser life. Sprocket segments still have life left in them.

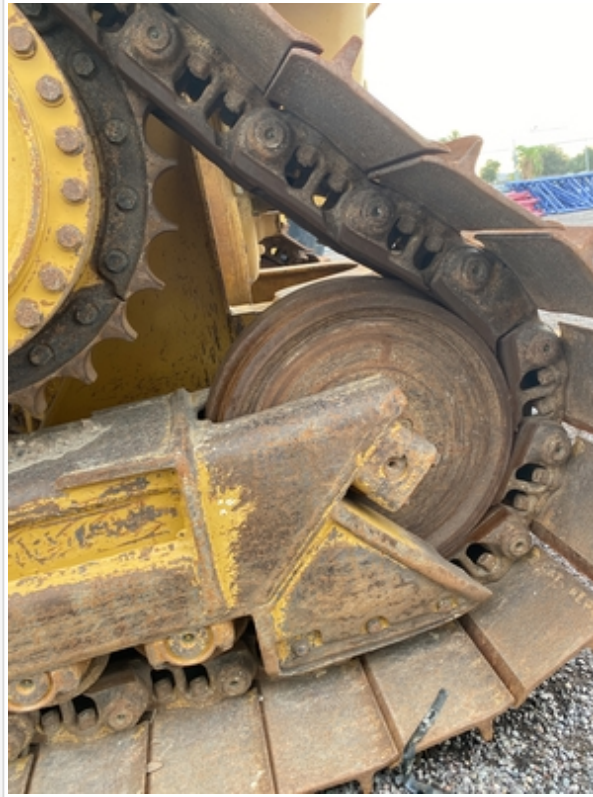
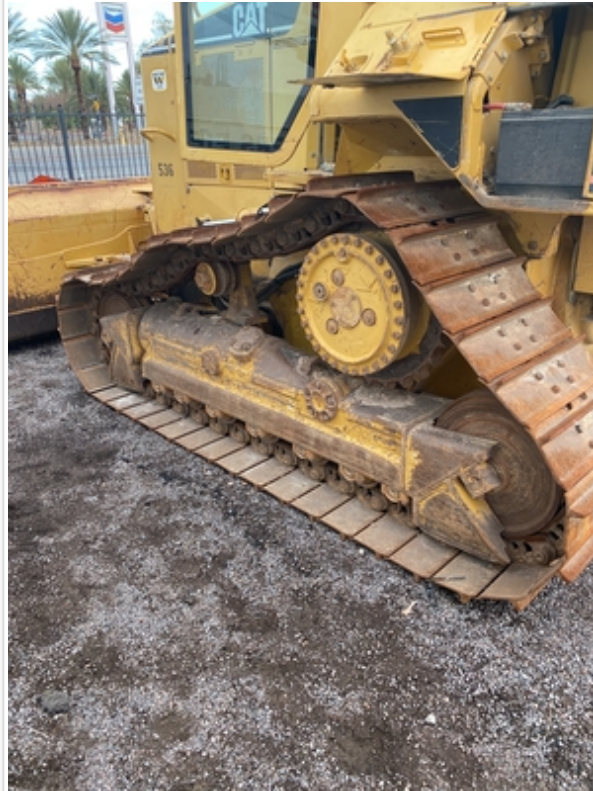
<p><b>Right Side: Link Bushings / Drive Sprocket / Shoe Condition</b></p>	<p>3 - Normal Wear &amp; Tear</p>
<p><b>Comments</b></p>	<p>Bushings can feel wear but probably 50-60% wear left.</p>

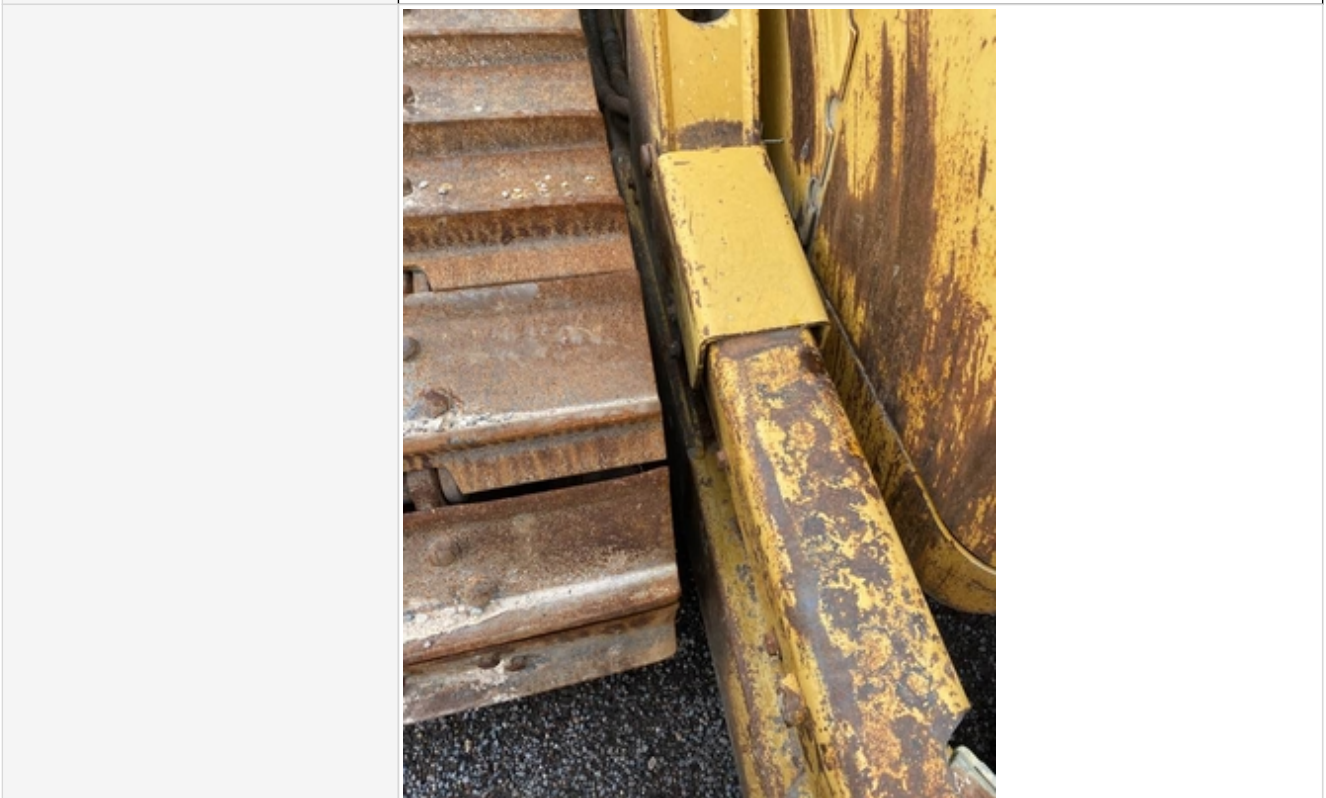
<b>Instructions</b>	<p>Evaluate the following on a 4 point scale (leave comments where an explanation is appropriate):</p> <p>4 = Like New, Recently Replaced          3 = Normal Wear &amp; Tear          2 = Above Average Wear          1 = Service Required</p>
<b>Push Arm / C-Frame Condition</b>	3 - Normal Wear & Tear
<b>Comments</b>	No visible cracks
<b>Push Arm / C-Frame Photos</b>

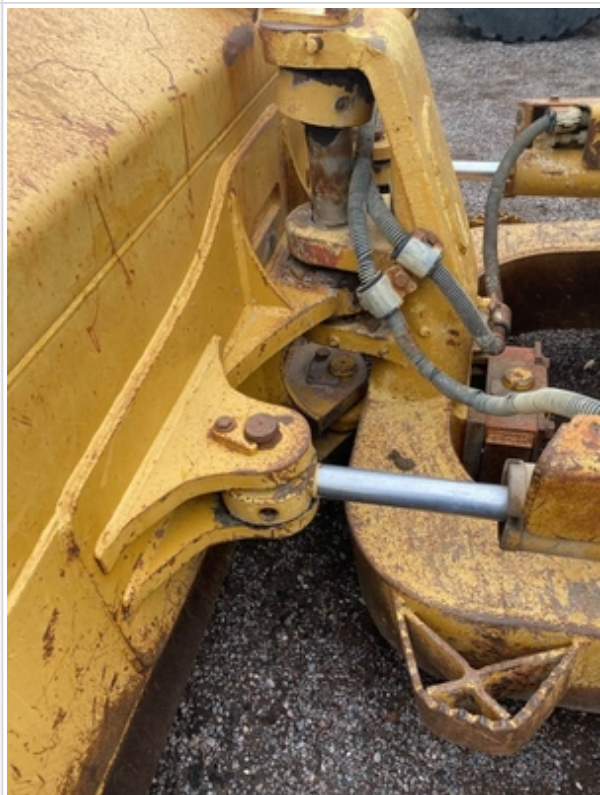
<b>Push Arm Pivot / C-Frame Trunnions Condition</b>	3 - Normal Wear & Tear	
<b>Comments</b>	No appreciable movement. Or cracks	
<b>Push Arm Pivot / C-Frame Trunnions Photos</b>

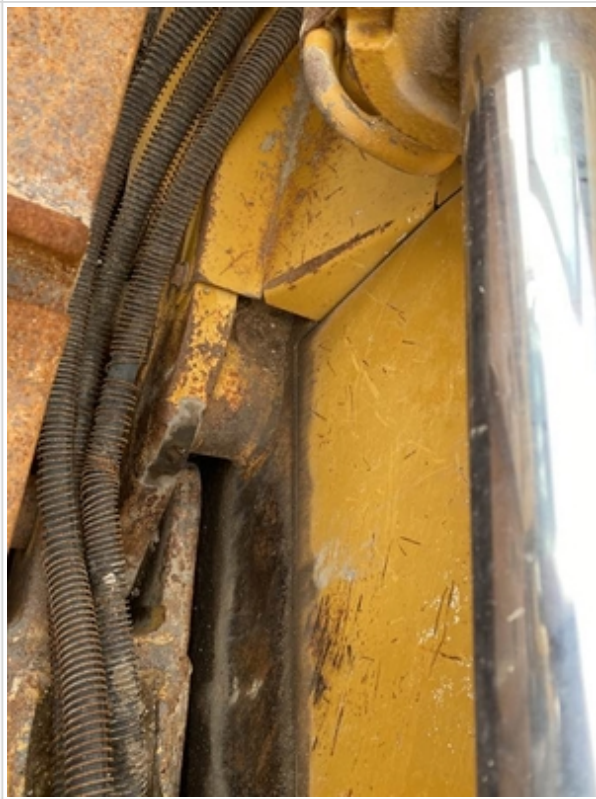
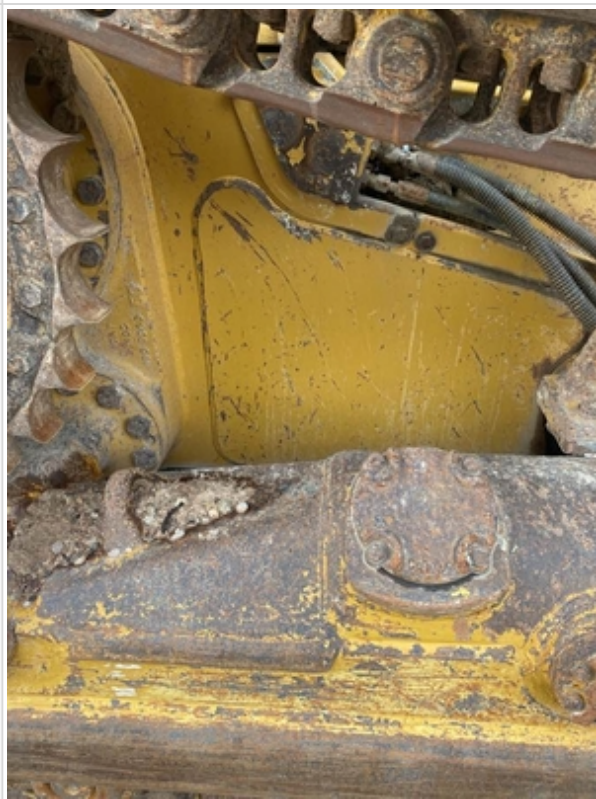
Comments	Ok. No cracks visible
Frame Photos

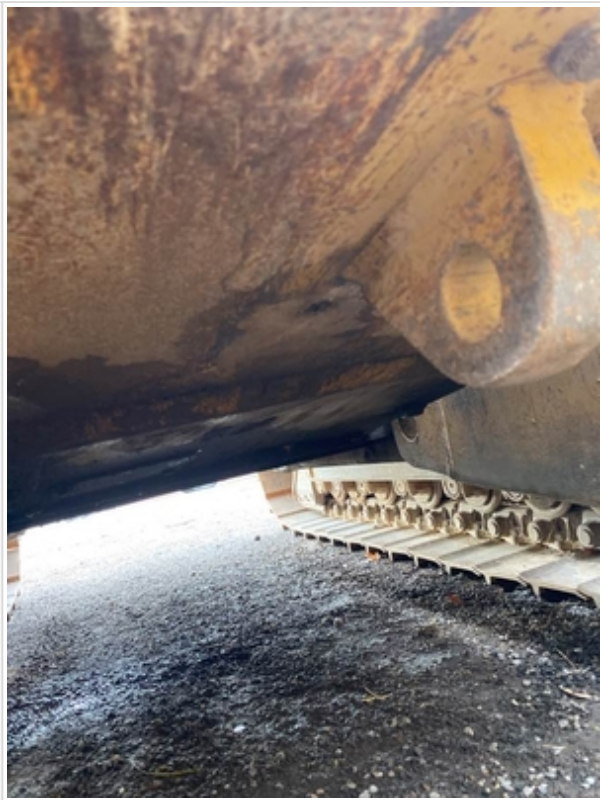
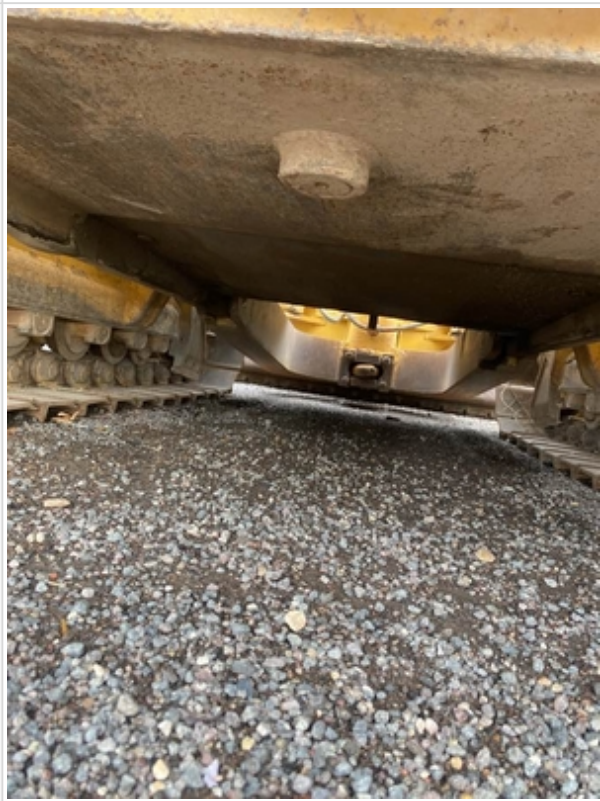
<p>Belly Pans Photos</p>

<p><b>Belly Pans</b></p>	<p>3 - Normal Wear &amp; Tear</p>	
<p><b>Comments</b></p>	<p>Belly pans present</p>

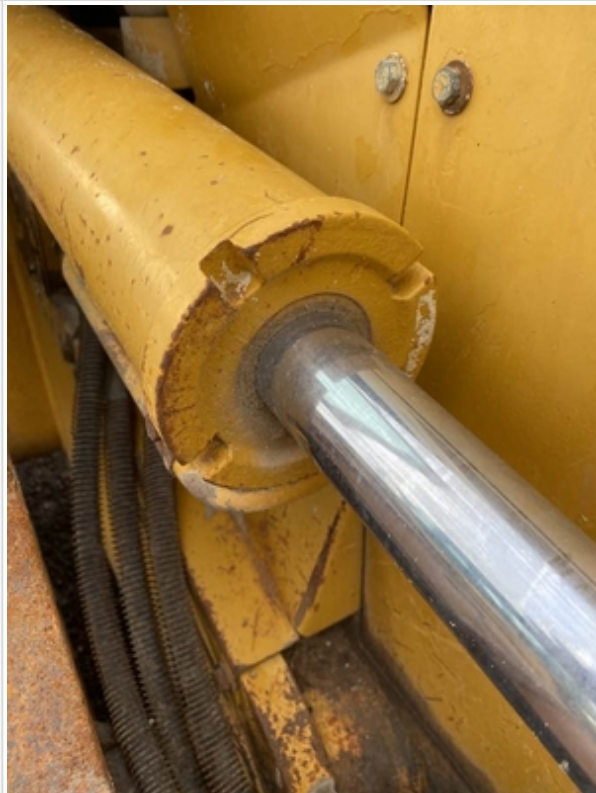
<b>Instructions</b>	<p>Evaluate the following on a 4 point scale (leave comments where an explanation is appropriate):</p> <p>4 = Like New, Recently Replaced  3 = Normal Wear &amp; Tear  2 = Above Average Wear  1 = Service Required</p> <p>Things to look for:  - All hydraulic lines  - All hydraulic cylinders  - All mounting pins  - Leaks  - Wet/damp lines</p> <p>Take close-up photos and leave comments.</p>
<b>Overall Appearance of Hydraulic Lines / Fittings</b>	<p>3</p>
<b>Comments</b>	<p>Ok. Light dust around seals on cylinders. No major leaks</p>
<b>Hydraulic Lines Photos</b>

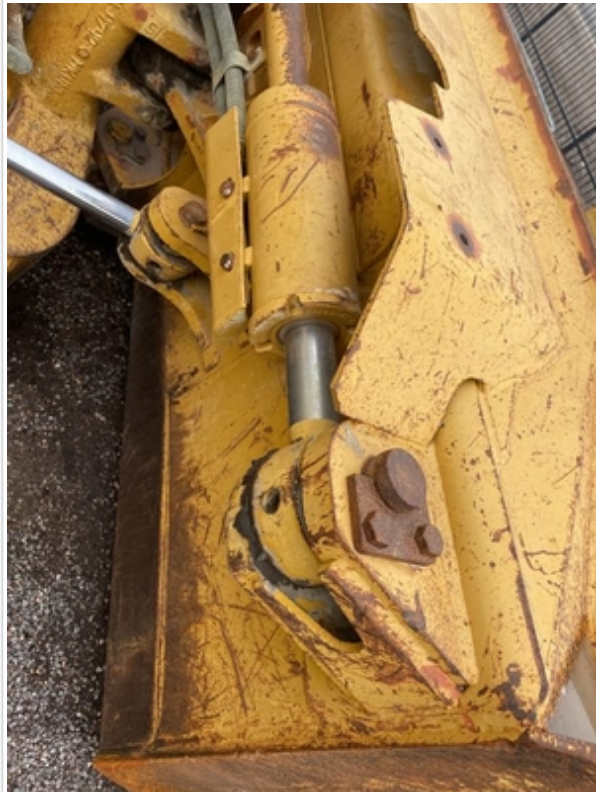
<p>Tilt Cylinder Photos</p>

<b>Tilt Cylinder</b>	Check the tilt cylinder. Note any wear, pitting, discoloration, etc. Take photos.
<b>Tilt Cylinder: Mounting Pin</b>	3
<b>Tilt Cylinder: Oil Leaks</b>	No
<b>Comments</b>	No leaks

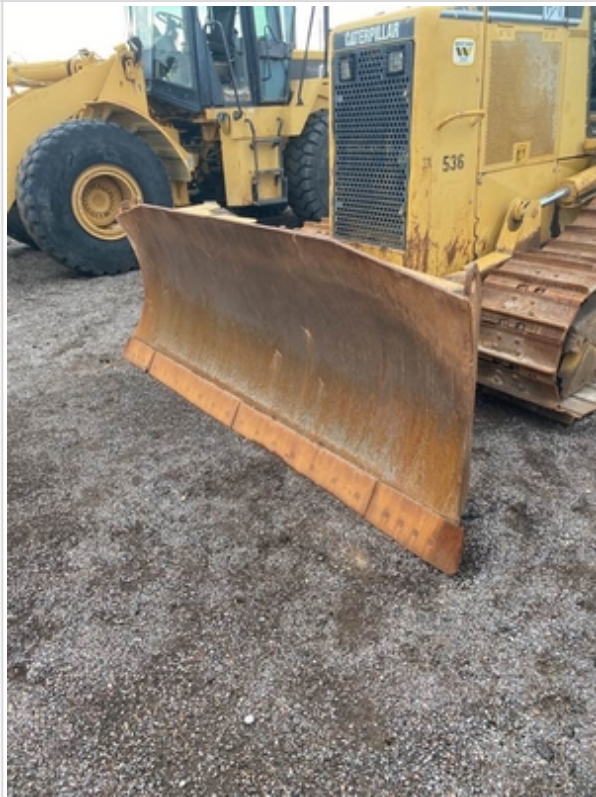
<b>Instructions</b>	<p>Evaluate the following on a 4 point scale (leave comments where an explanation is appropriate):</p> <p>4 = Like New, Recently Replaced          3 = Normal Wear &amp; Tear          2 = Above Average Wear          1 = Service Required</p>
<b>Blade Condition</b>	<p>3 - Normal Wear &amp; Tear</p>
<b>Comments</b>	<p>Normal wear.</p>
<b>Blade Photos</b>
