## Inspection Report (Excavator)

Year	2007
Make	Caterpillar
Model	320C
Serial Number	CAT0320CVPAC01289
Hour Meter Reading	7763
Previous Application (e.g., earth moving, mining, demolition, etc)	general construction

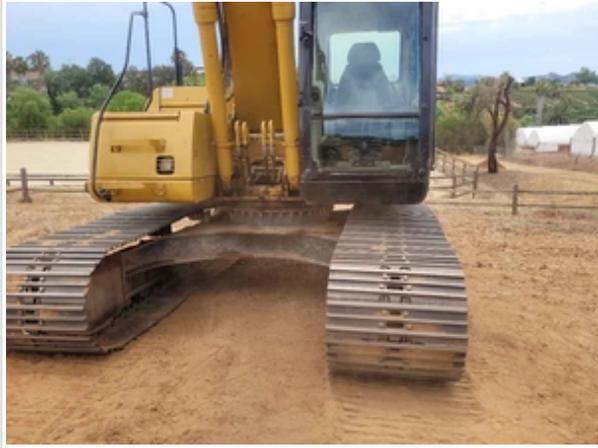
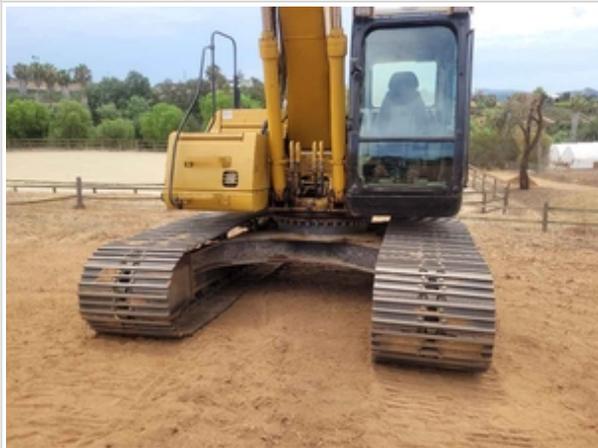
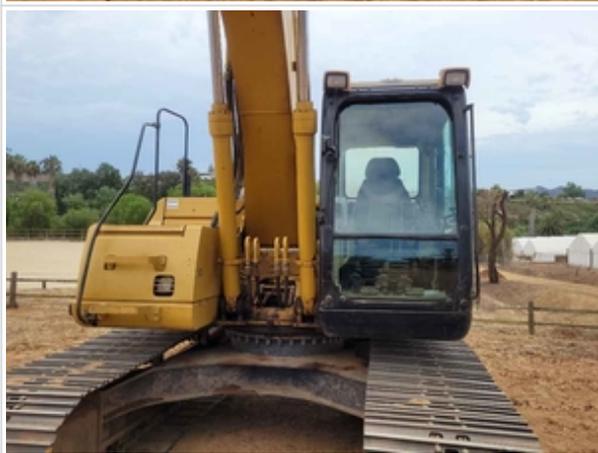
Front	3 - Normal Wear & Tear
Front Condition	No visible damage
Front Photos

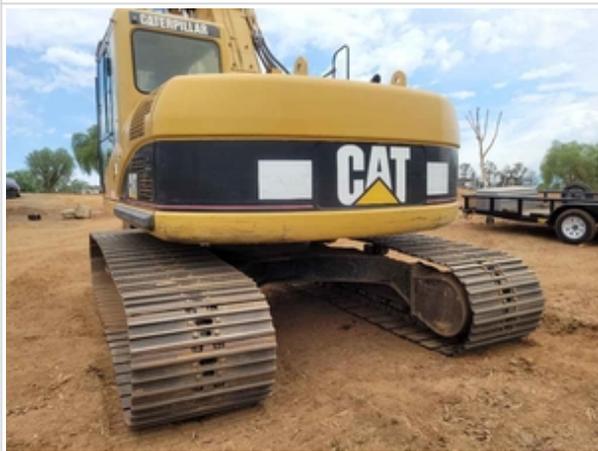
<p><b>Rear</b></p>	<p>4 - Like New, Recently Replaced</p>
<p><b>Rear Condition</b></p>	<p>No visible damage</p>
<p><b>Rear Photos</b></p>

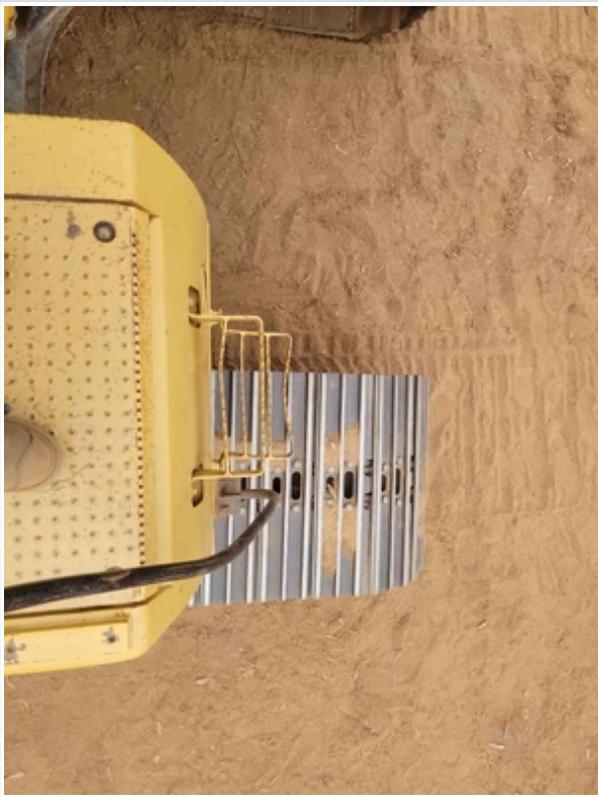
Upper	3 - Normal Wear & Tear	
Upper Condition	No visible damage, Other (see comments)	
Comments	a few seps a bit bent but okay	
Upper Photos

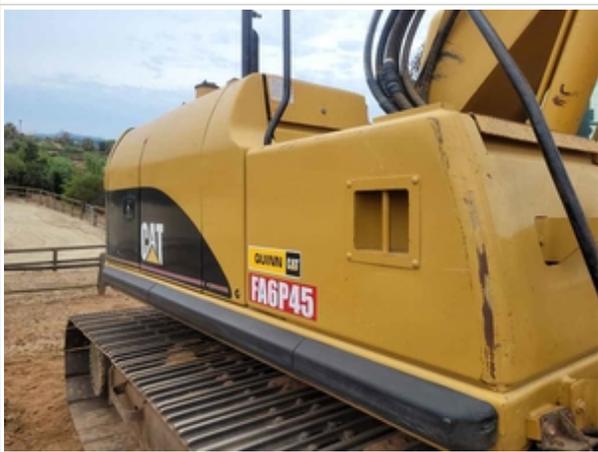
<p><b>Body Panels (Any Rust Damage?)</b></p>	<p>3 - Normal Wear &amp; Tear</p>
<p><b>Body Panel Condition</b></p>	<p>No visible damage, good paint condition and panel fitment</p>
<p><b>Body Panels Photos</b></p>

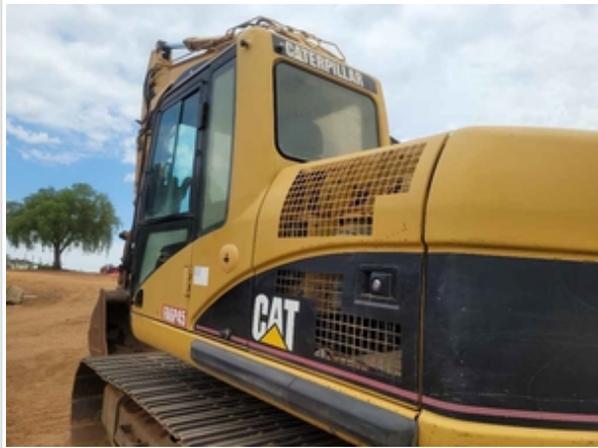
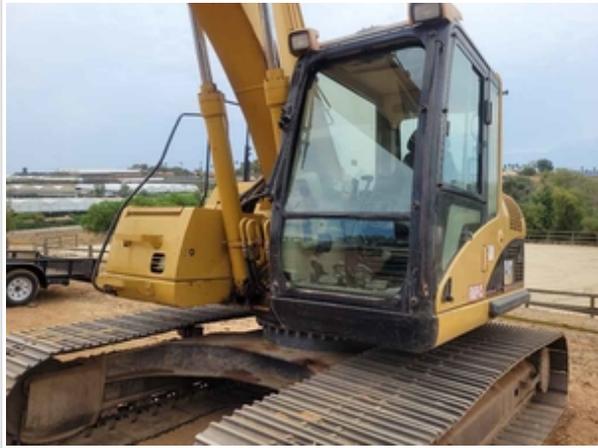
<p><b>Doors / Canopy Latches</b></p>	<p>4 - Like New, Recently Replaced</p>
<p><b>Doors / Canopy Latches Condition</b></p>	<p>No visible damage</p>
<p><b>Doors / Canopy Latches Photos</b></p>

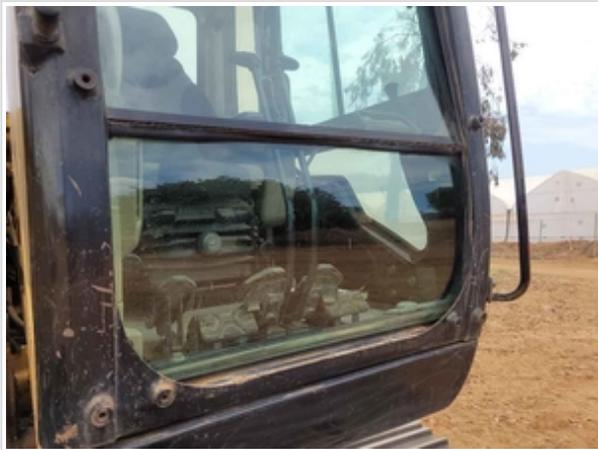
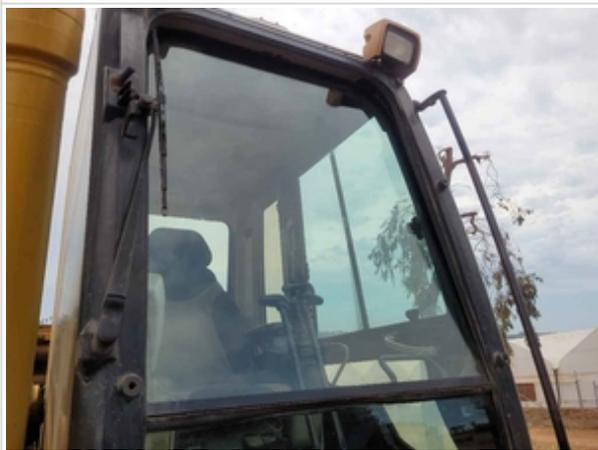
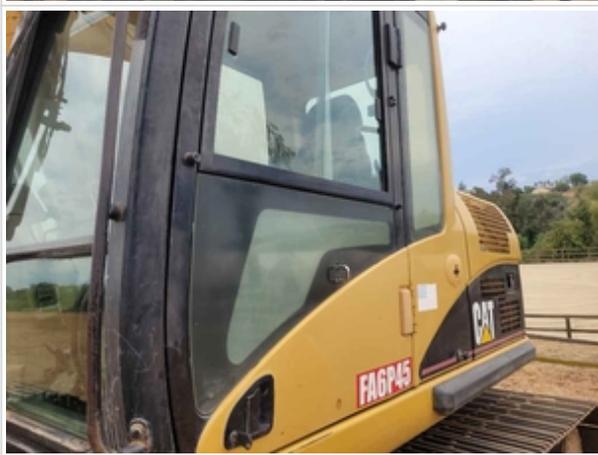
<p>Glass Condition Photos</p>

<b>Glass Condition</b>	3 - Normal Wear & Tear
<b>Glass Condition Notes</b>	Other (see comments)
<b>Comments</b>	front cab window slider needs repair to slide up properly

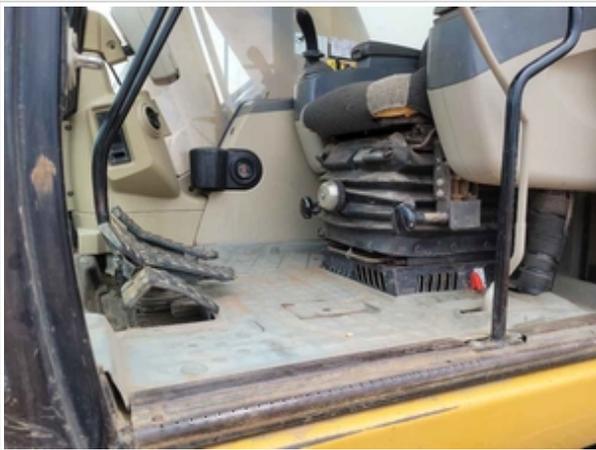
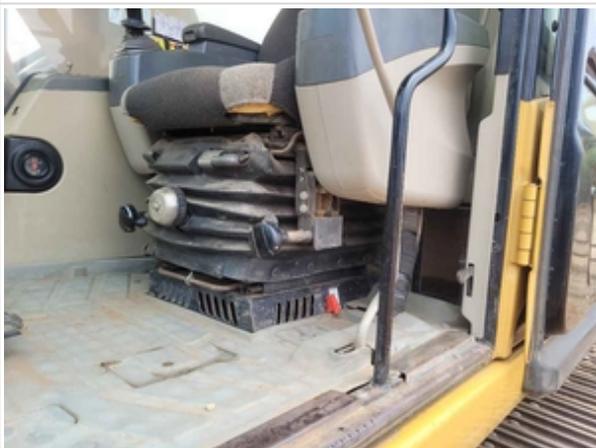
<p>Operator Cabin Overall</p>	<p>3 - Normal Wear &amp; Tear</p>
<p>Operator Cabin Overall Condition</p>	<p>Good cabin appearance, solid floors, panels, and ceiling</p>
<p>Operator Cabin Photos</p>

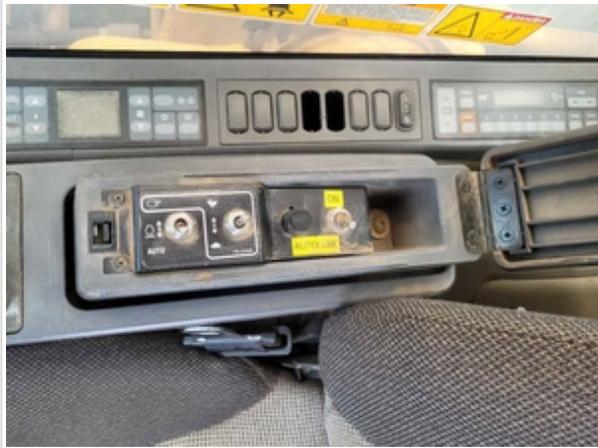
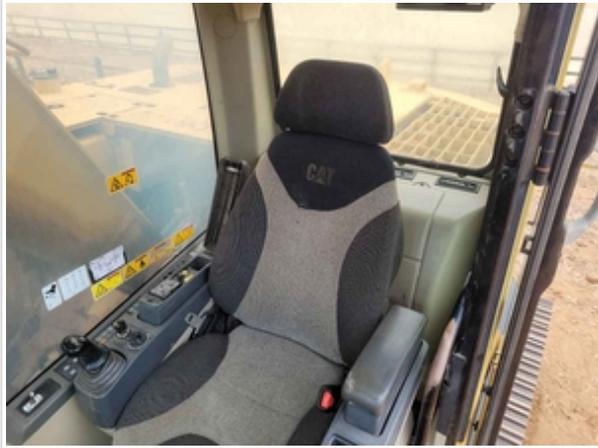
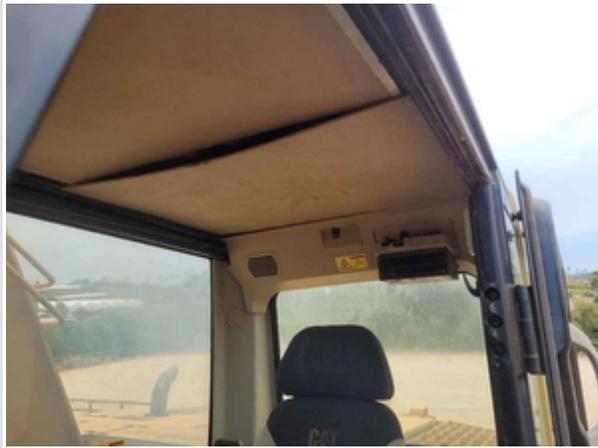
Operator's Seat & Arm Rests  
Photos

<b>Operator's Seat &amp; Arm Rests</b>	3 - Normal Wear & Tear
<b>Operator's Seat &amp; Arm Rests Condition</b>	Seat(s) have minor surface staining or small tears

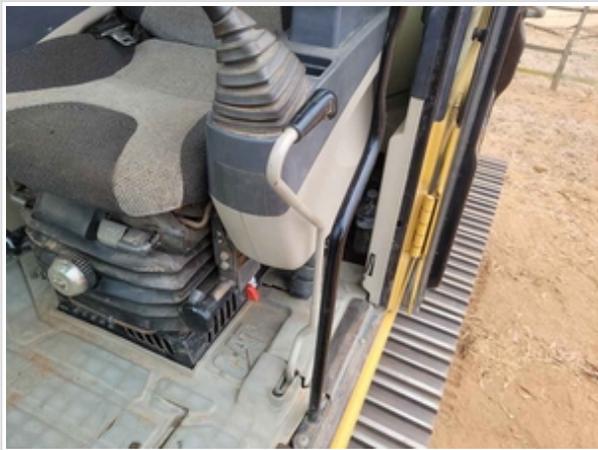
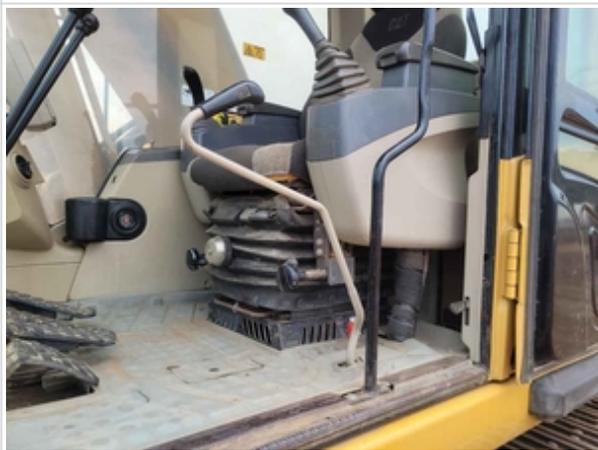
<p>Safety Lock Out / Stop Photos</p>

<b>Safety Lock Out / Stop</b>	4 - Like New, Recently Replaced
<b>Safety Lock Out / Stop Condition</b>	Safety lock out device is present, in good condition, and functional

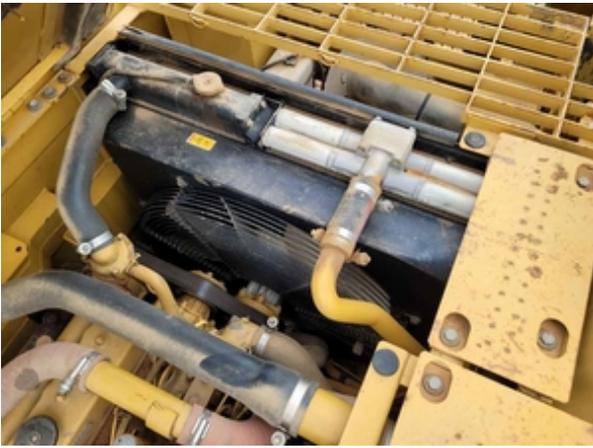
<b>Radiator Photos</b>

<b>Blow-by (Visual Observation Check)</b>	No	
<b>Unusual Noises (Upon Start-up, Idle, Shutdown)</b>	No	
<b>Unusual Noise Notes</b>	No unusual noises heard	
<b>Engine Smoke (Upon Start-up, Idle, Shutdown)</b>	No	
<b>Engine Smoke Notes</b>	No engine smoke issues observed	
<b>Engine Exhaust Color</b>	Clear	
<b>Battery</b>	3 - Normal Wear & Tear	
<b>Battery Condition</b>	Clean & dry appearance, tight connections, Other (see comments)	
<b>Comments</b>	machine started right up after sitting for a week	
<b>Radiator</b>	3 - Normal Wear & Tear	
<b>Radiator Condition</b>	Radiator fins & components appear to be in good working order, no signs of damage or leaks

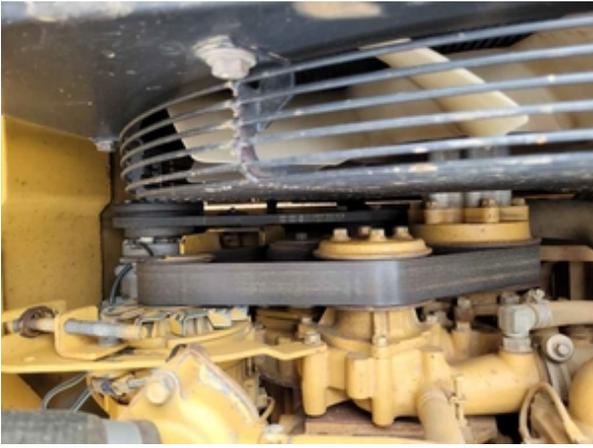
<b>Belts</b>	3 - Normal Wear & Tear
<b>Belt Condition</b>	Belts appear in good condition & alignment with proper tension
<b>Belt Photos</b>

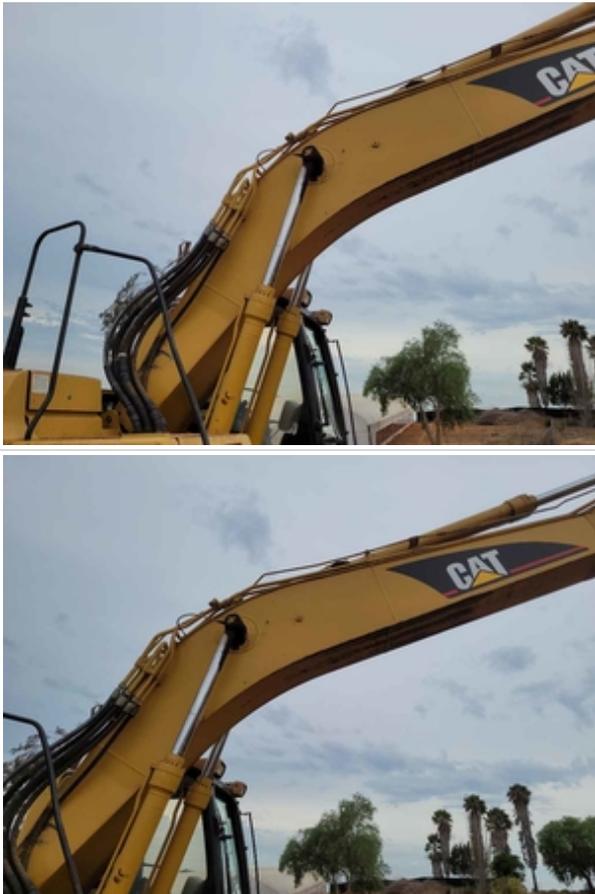
Instructions	<p>Evaluate the following on a 4 point scale (leave comments where an explanation is appropriate):</p> <p>4 = Like New, Recently Replaced  3 = Normal Wear &amp; Tear  2 = Above Average Wear  1 = Service Required</p>
Boom Condition	4 - Like New, Recently Replaced
Boom Photos

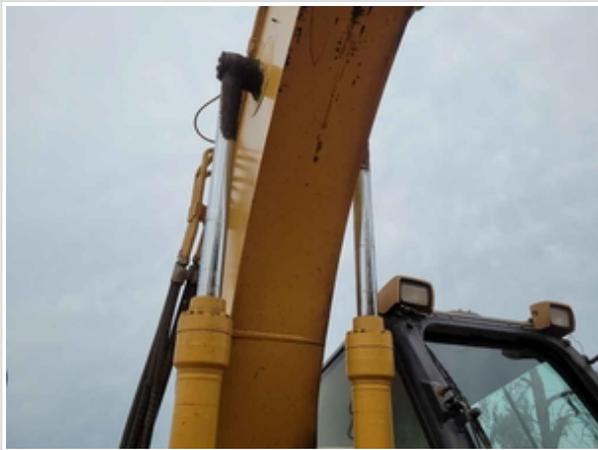
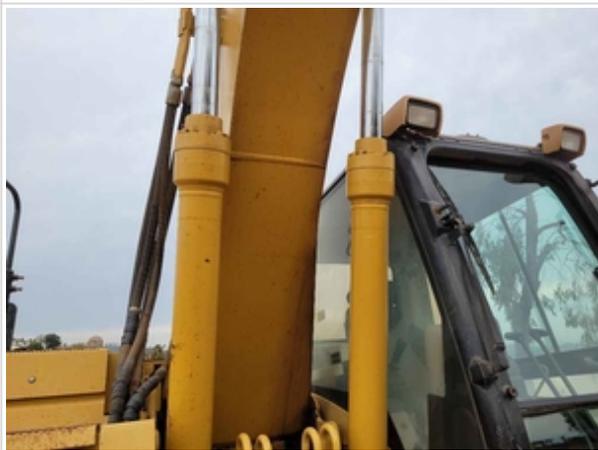
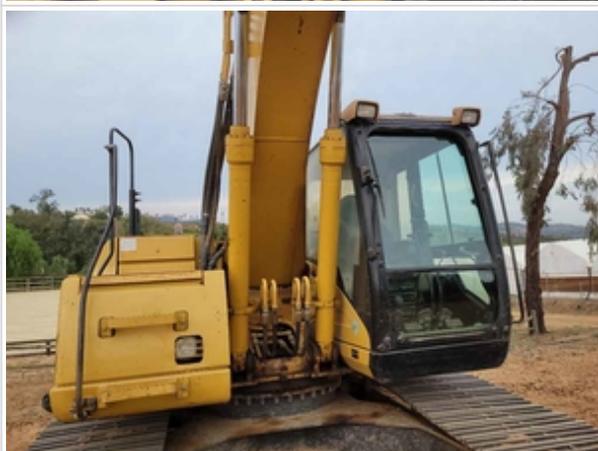
<p>Boom Cylinder Photos</p>

Boom Cylinder	Check the boom cylinder. Note any wear, pitting, discoloration, etc. Take photos.
Boom Cylinder: Mounting Pin	3
Boom Cylinder: Oil Leaks	No

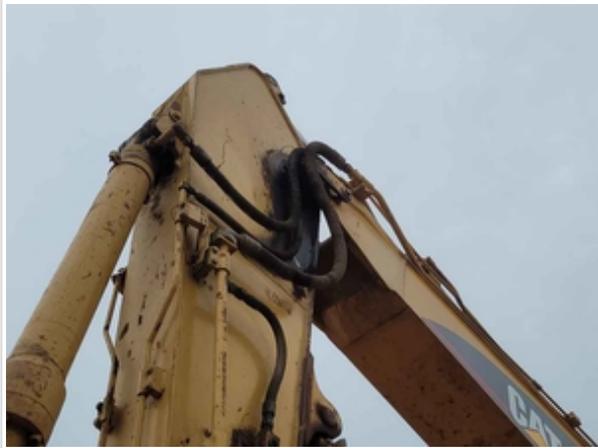
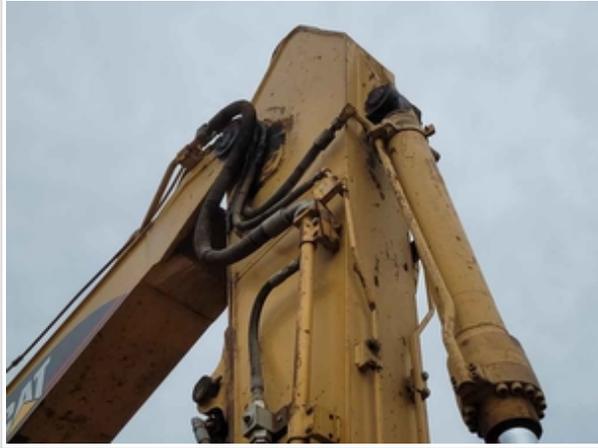
<b>Bucket Hose &amp; Fittings Photos</b>

<p><b>Bucket Hose &amp; Fittings</b></p>	<p>3 - Normal Wear &amp; Tear</p>

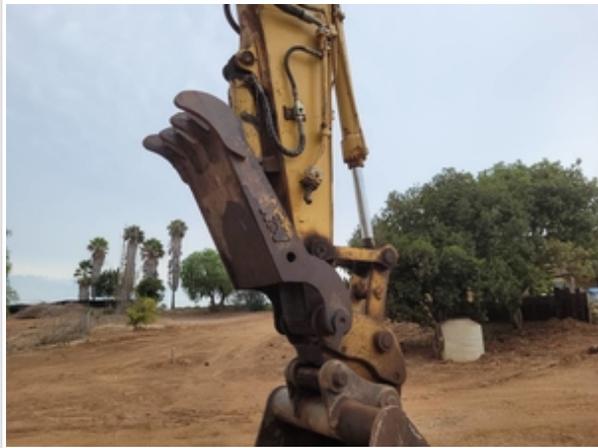
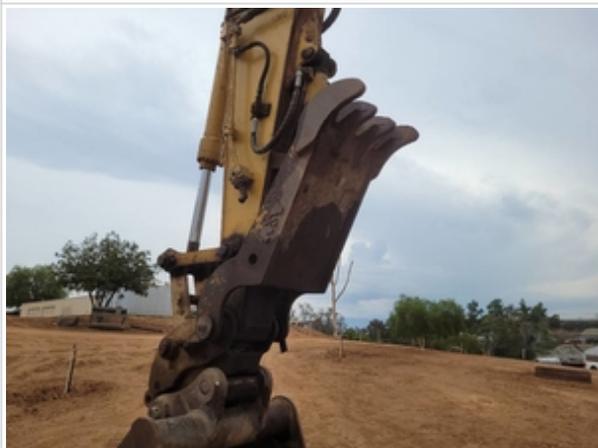
Attachment Photos

<b>Attachment Type</b>	hydraulic thumb
<b>Attachment Make</b>	M & W
<b>Attachment Size / Specs</b>	24"
<b>Attachment Condition</b>	3 - Normal Wear & Tear
