Inspection Report (Excavator)

Year	2014
Make	Takeuchi
Model	TB240
Serial Number	124000138
Hour Meter Reading	2519.7
Previous Application (e.g., earth moving, mining, demolition, etc)	Demolition

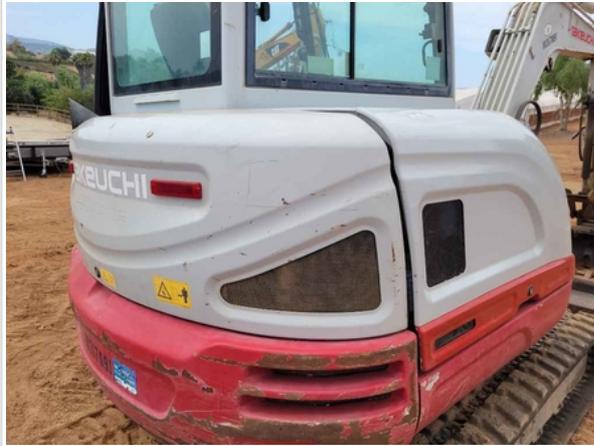
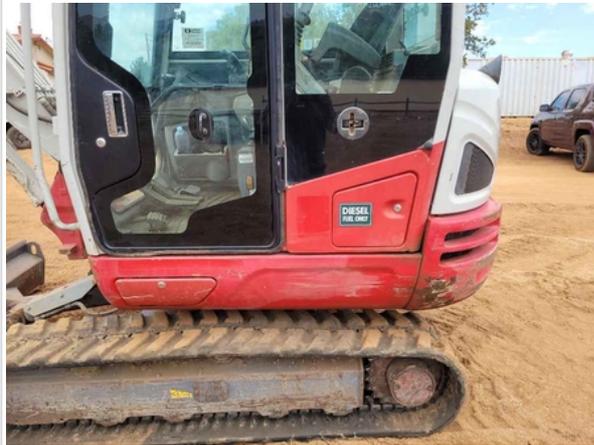
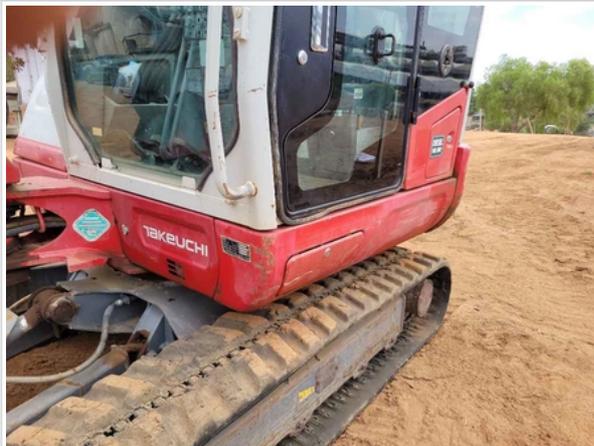
Body Panels (Any Rust Damage?)	3 - Normal Wear & Tear	
Body Panel Condition	No visible damage, good paint condition and panel fitment, Other (see comments)	
Comments	minor scuff marks all the way around	
Body Panels Photos

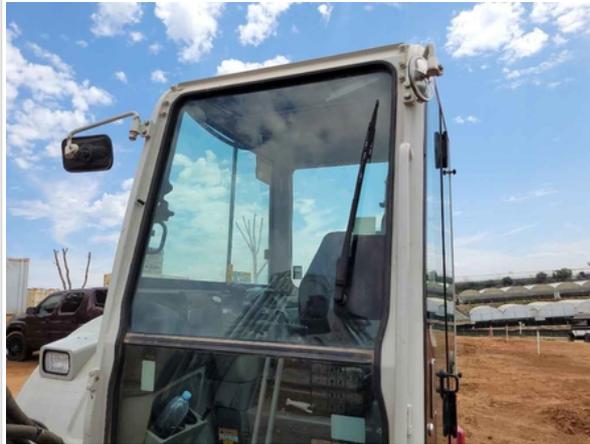
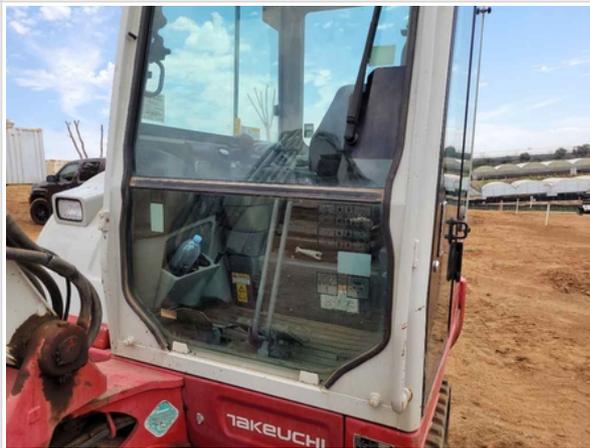
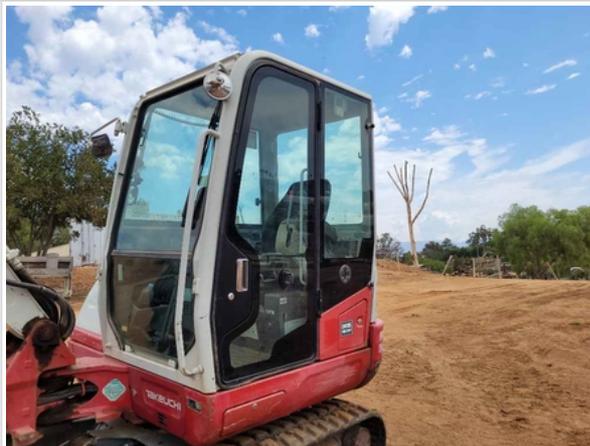
Glass Condition Photos

<p>Glass Condition</p>	<p>3 - Normal Wear & Tear</p>
<p>Glass Condition Notes</p>	<p>Glass intact, no visible damage, Other (see comments)</p>
<p>Comments</p>	<p>small scratches</p>

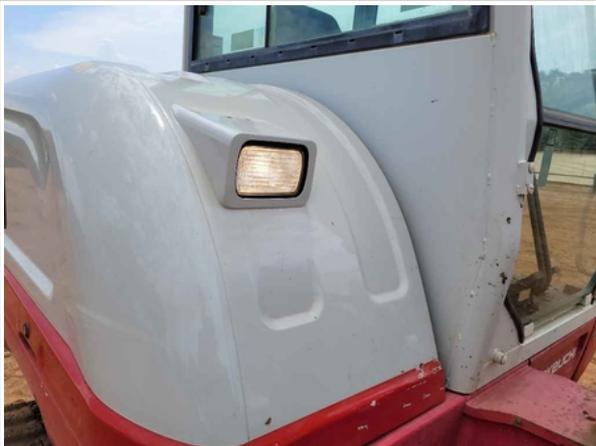
Lighting System	3 - Normal Wear & Tear	
Lighting System Condition	One or more exterior lights are non-operational, Other (see comments)	
Comments	cab light ok boom light not working	
Lighting System Photos

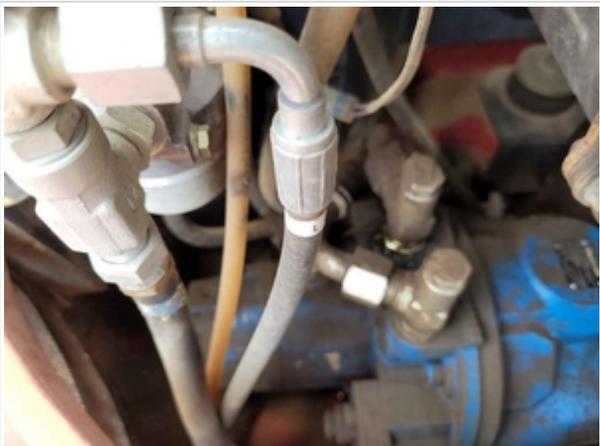
Water Pump	4 - Like New, Recently Replaced	
Water Pump Condition	No unusual pump noises heard	
Cooling System Leaks	No	
Coolant Color / Appearance	3 - Normal Wear & Tear	
Coolant Color/Appearance Notes	Normal Translucent appearance, no visual signs of contamination	
Oil Leaks	Yes	
Oil Leak Notes	No oil leaks seen, Other (see comments)	
Comments	no engine oil leaks present, oil leaks are present on hyd. pump that connects to engine	
Oil Leak Photos

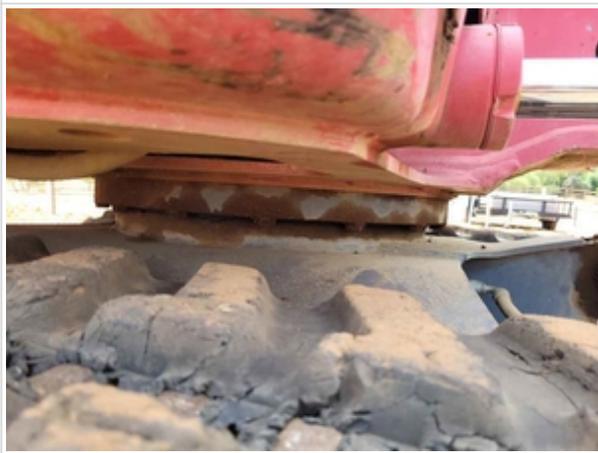
<p>Turntable Bearing</p>	<p>3 - Normal Wear & Tear</p>
<p>Comments</p>	<p>all hardware intact with no signs of excessive play</p>
<p>Turntable Bearing Photos</p>

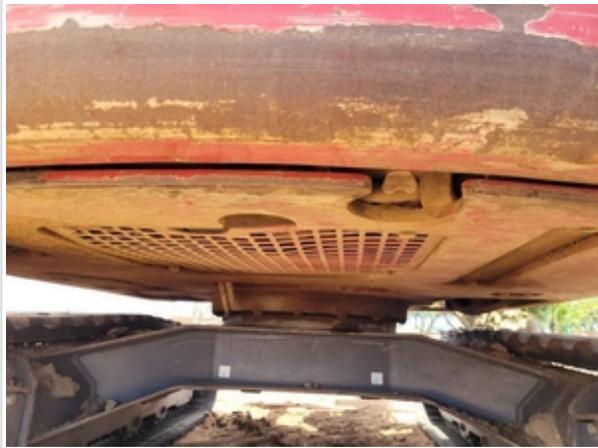
Bottom Covers Photos

<p>Bottom Covers</p>	<p>3 - Normal Wear & Tear</p>
<p>Comments</p>	<p>normal wear and tear, all cover present</p>

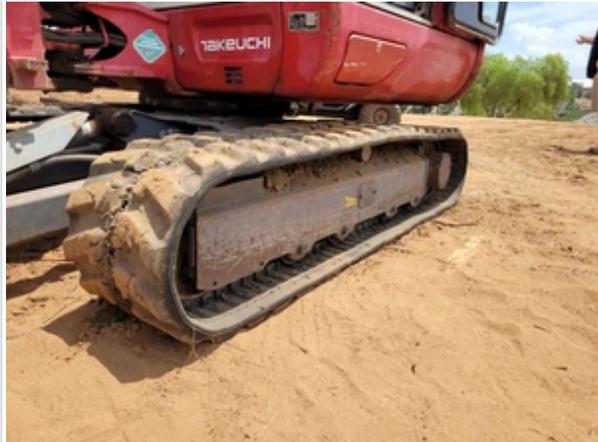
Instructions	<p>Evaluate the following on a 4 point scale (leave comments where an explanation is appropriate):</p> <p>4 = Like New, Recently Replaced 3 = Normal Wear & Tear 2 = Above Average Wear 1 = Service Required</p>
Undercarriage Overall Condition	3 - Normal Wear & Tear
Comments	l/s track on backwards possibly
Undercarriage Overall Photos

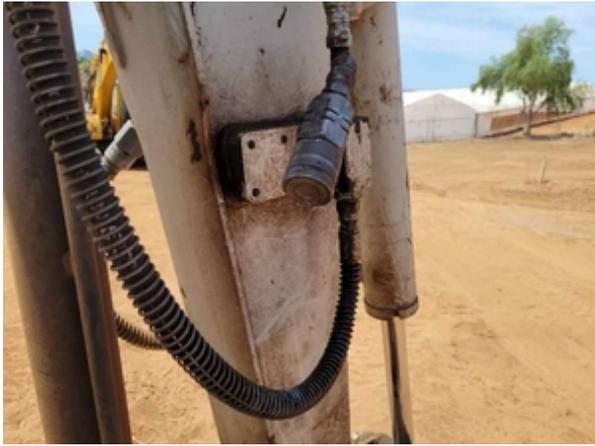
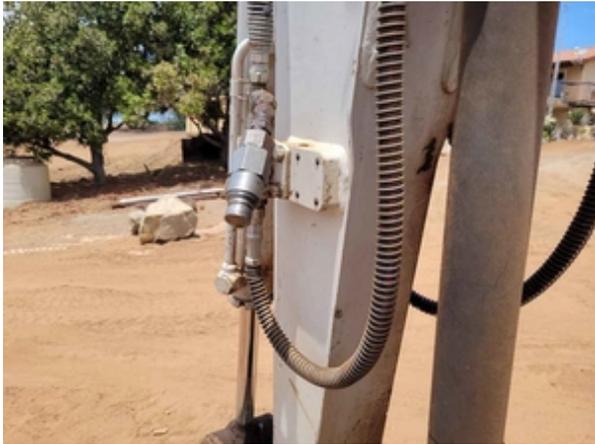
Appearance of Hydraulic Lines / Fittings	3
Hydraulic Lines / Fittings Condition	Dried seepages observed, Active leaks in hoses or fittings observed, Other (see comments)
Comments	hyd. leaks present at quick coupler fittings and at rear main hyd. pump elbow fitting
Appearance of Hydraulic Lines / Fittings Photos

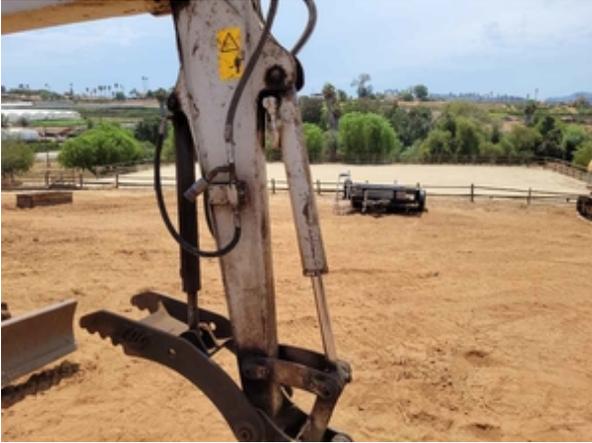
Bucket Cylinder	Check the bucket cylinder. Note any wear, pitting, discoloration, etc. Take photos.	
Bucket Cylinder: Mounting Pin	3	
Bucket Cylinder: Oil Leaks	No	
Comments	bucket cylinder in good condition	
Bucket Cylinder Photos

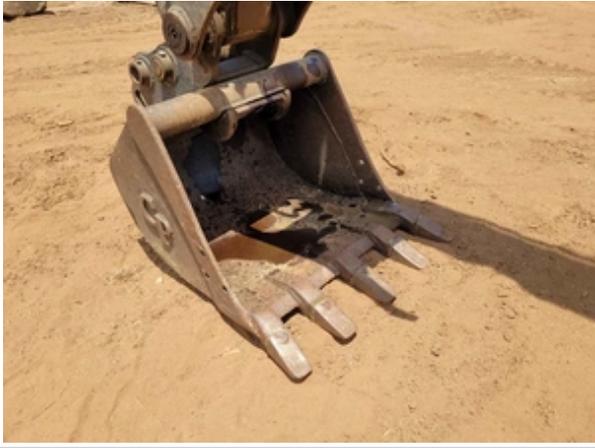
Instructions	<p>Evaluate the following on a 4 point scale (leave comments where an explanation is appropriate):</p> <p>4 = Like New, Recently Replaced 3 = Normal Wear & Tear 2 = Above Average Wear 1 = Service Required</p>
Bucket Condition	<p>3 - Normal Wear & Tear</p>
Comments	<p>24" bucket currently on machine with thumb attachment</p>
Bucket Photos
