## Inspection Report (Telehandler)

Year	2022
Make	JLG/Skytrak
Model	10054
Serial Number	0160111934
Hour Meter Reading	25.0 Hours
Previous Application (e.g., earth moving, mining, demolition, etc)	Warehouse/Yard Material Handling

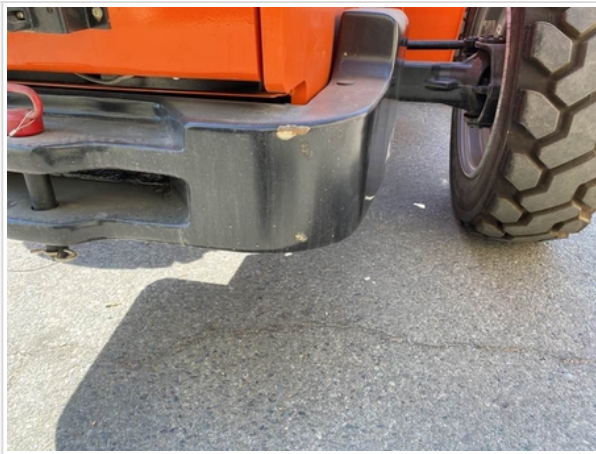
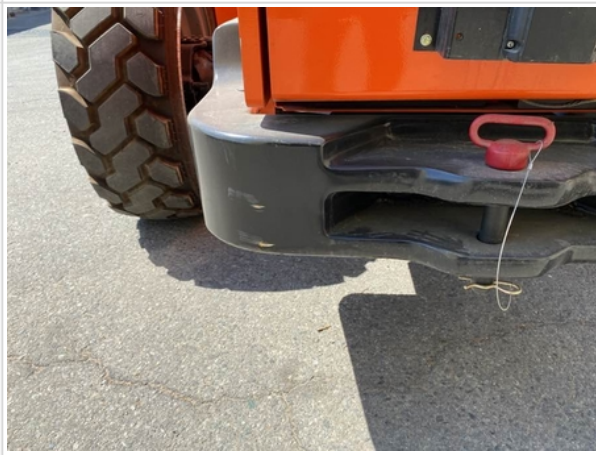
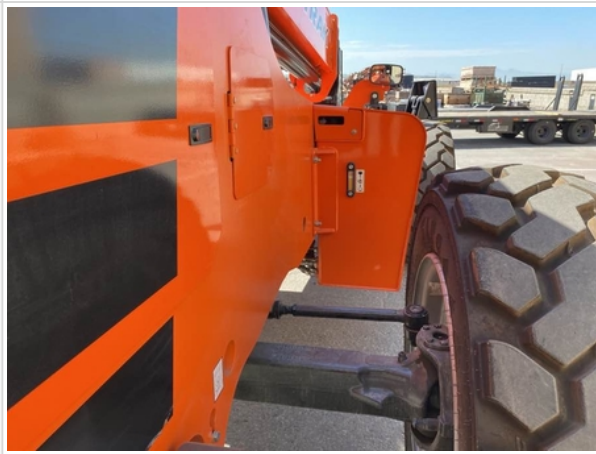
<b>Rear</b>	4 - Like New, Recently Replaced
<b>Rear Condition</b>	No visible damage, Other (see comments)
<b>Comments</b>	Very minor scuff marks on counter weight/bumper
<b>Rear Photos</b>

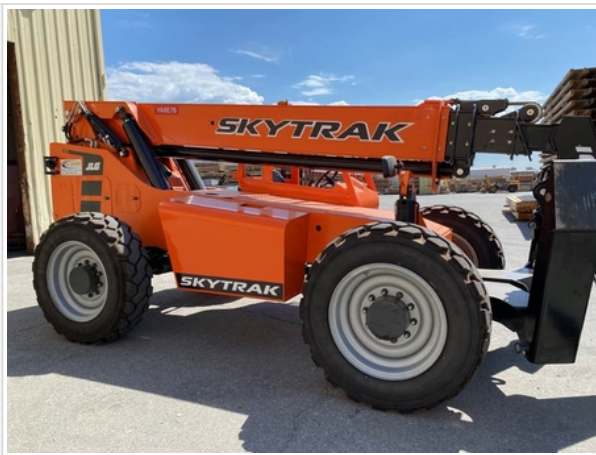
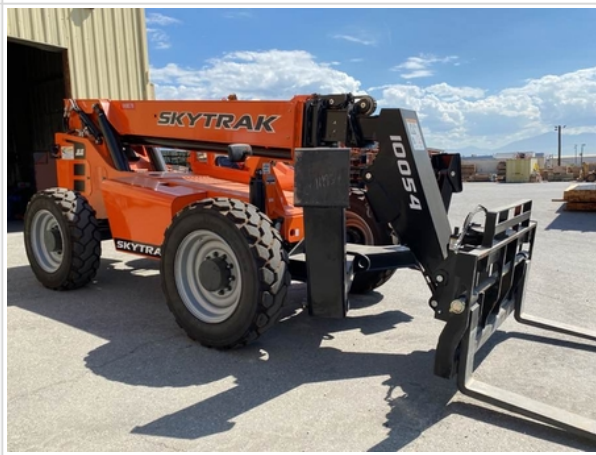
<b>Right</b>	4 - Like New, Recently Replaced	
<b>Right Condition</b>	No visible damage	
<b>Right Photos</b>

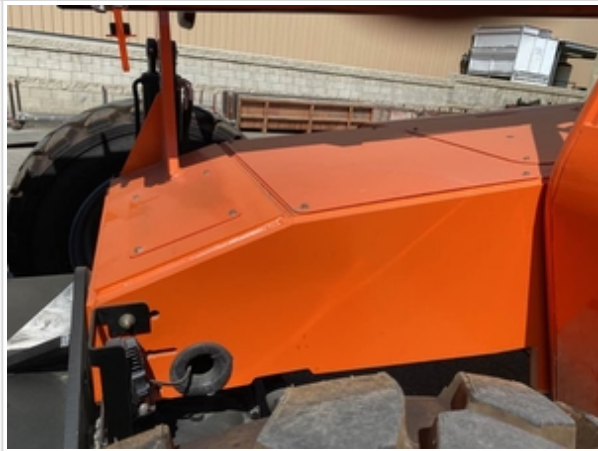
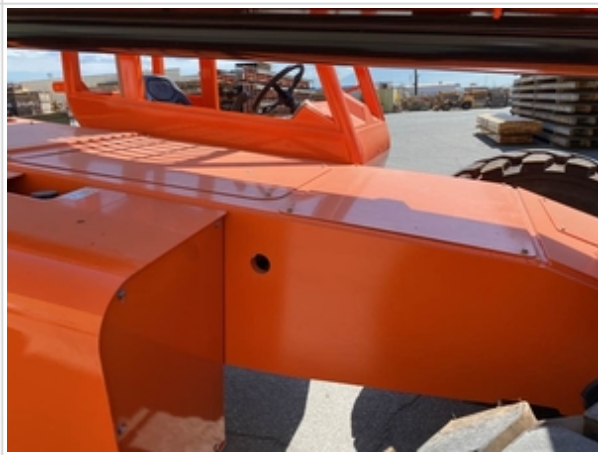
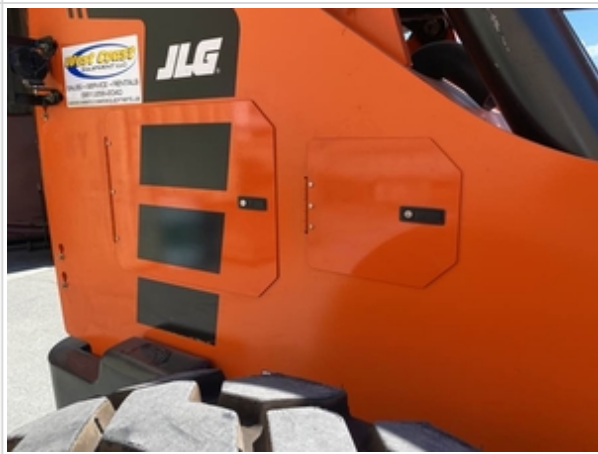
<b>Body Panels (Any Rust Damage?)</b>	4 - Like New, Recently Replaced
<b>Body Panel Condition</b>	No visible damage, good paint condition and panel fitment
<b>Body Panels Photos</b>

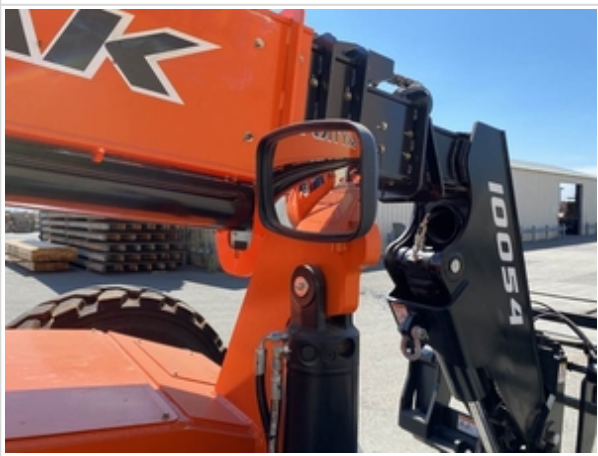
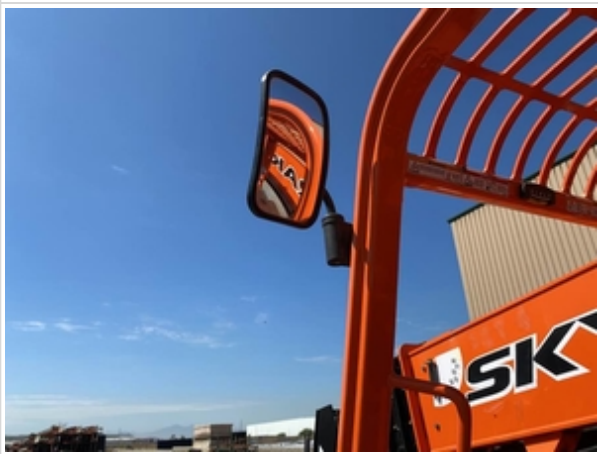
<b>Glass Condition</b>	0	
<b>Mirrors</b>	4 - Like New, Recently Replaced	
<b>Mirror Condition Notes</b>	Mirrors present and intact, no visible damage	
<b>Mirrors Photos</b>

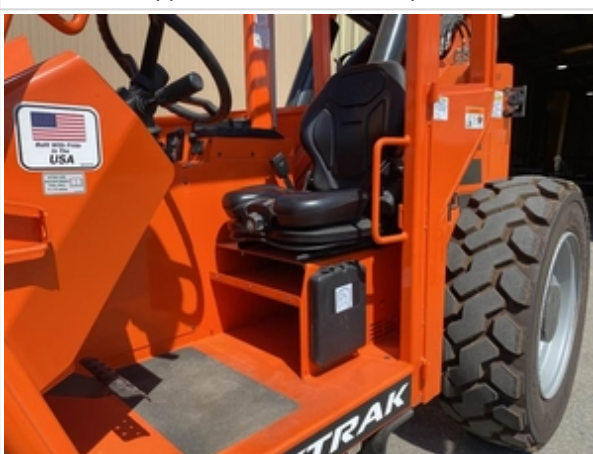
Operator Cabin Overall	4 - Like New, Recently Replaced
Operator Cabin Overall Condition	Good cabin appearance, solid floors, panels, and ceiling
Operator Cabin Photos

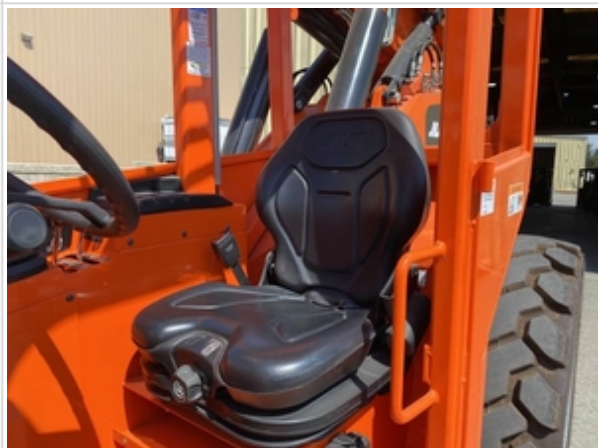
<b>Operator's Seat &amp; Arm Rests</b>	4 - Like New, Recently Replaced	
<b>Operator's Seat &amp; Arm Rests Condition</b>	Seat(s) in good condition, no stains or tears in upholstery	
<b>Operator's Seat &amp; Arm Rests Photos</b>

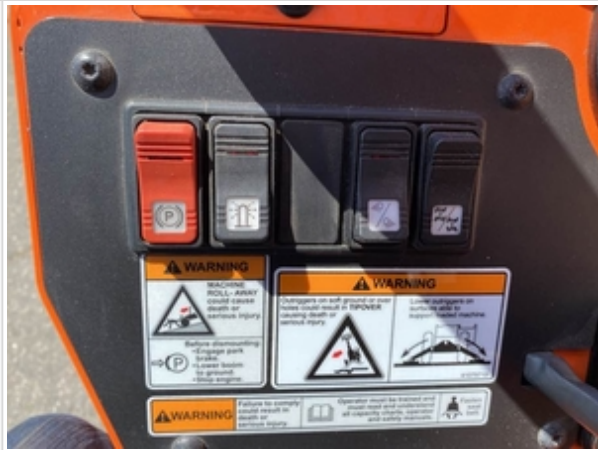
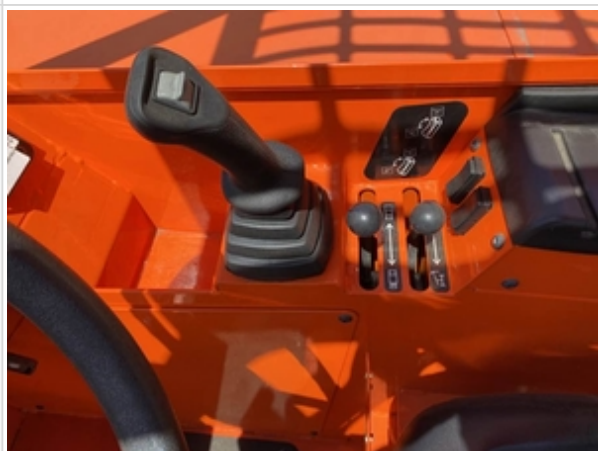
<b>Cabin Lights</b>	0	
<b>Safety Lock Out / Stop</b>	0	
<b>Controls &amp; Switches</b>	4 - Like New, Recently Replaced	
<b>Controls &amp; Switches Condition</b>	All switches are installed and functional	
<b>Controls &amp; Switches Photos</b>

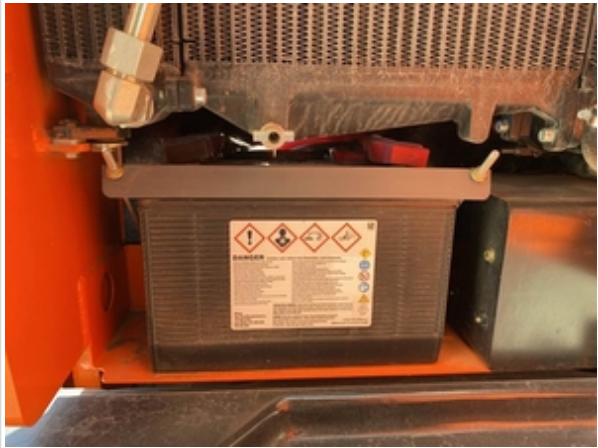
<b>Blow-by (Visual Observation Check)</b>	No
<b>Unusual Noises (Upon Start-up, Idle, Shutdown)</b>	No
<b>Unusual Noise Notes</b>	No unusual noises heard
<b>Engine Smoke (Upon Start-up, Idle, Shutdown)</b>	No
<b>Engine Smoke Notes</b>	No engine smoke issues observed
<b>Engine Exhaust Color</b>	Clear
<b>Battery</b>	4 - Like New, Recently Replaced
<b>Battery Condition</b>	Like new, recently replaced

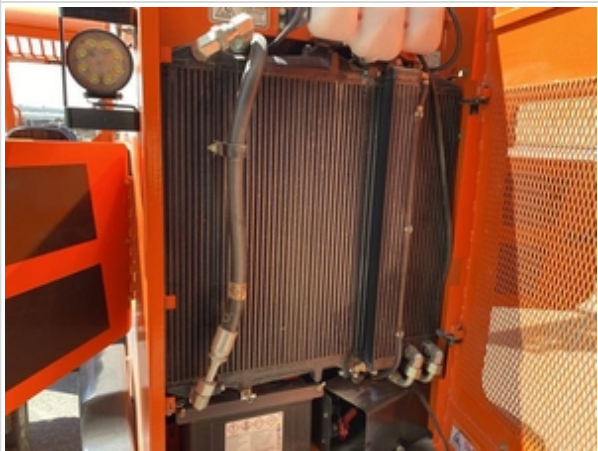
<b>Radiator</b>	4 - Like New, Recently Replaced	
<b>Radiator Condition</b>	Radiator fins & components appear to be in good working order, no signs of damage or leaks	
<b>Radiator Photos</b>

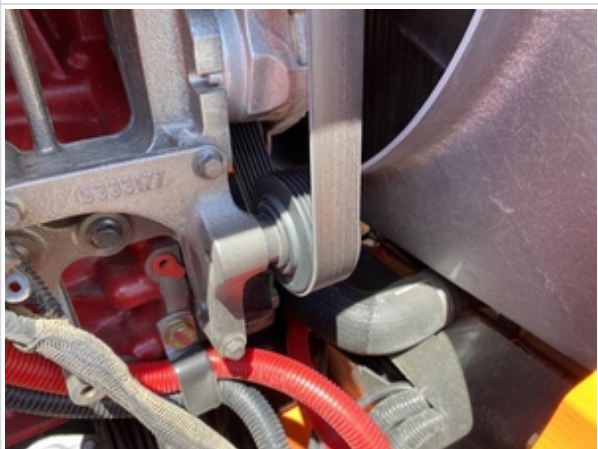
<b>Belts</b>	4 - Like New, Recently Replaced	
<b>Belt Condition</b>	Belts appear in good condition & alignment with proper tension	
<b>Belt Photos</b>

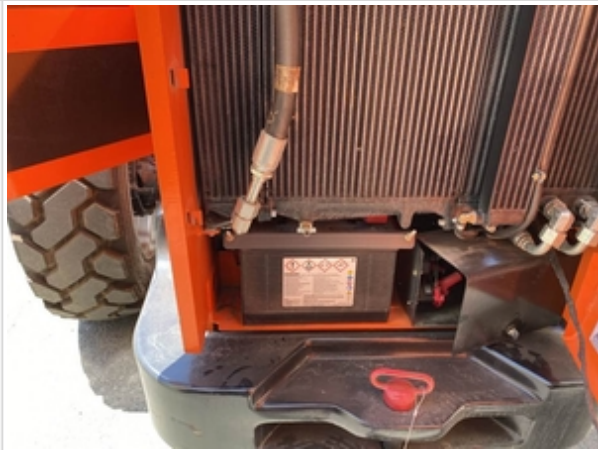
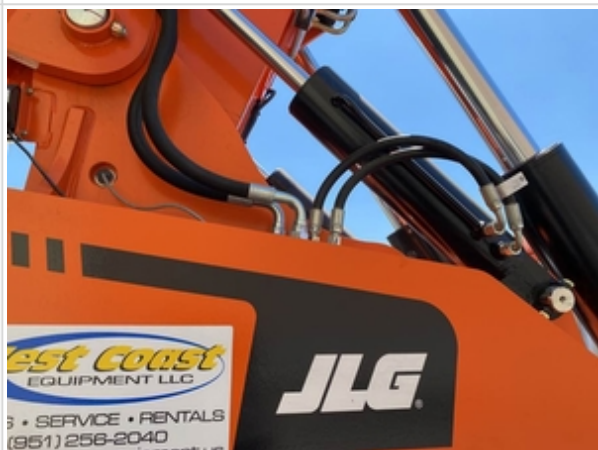
<b>Hoses</b>	4 - Like New, Recently Replaced	
<b>Hose Condition</b>	Firm, pliant hoses with no signs of wear or leaks	
<b>Hose Photos</b>

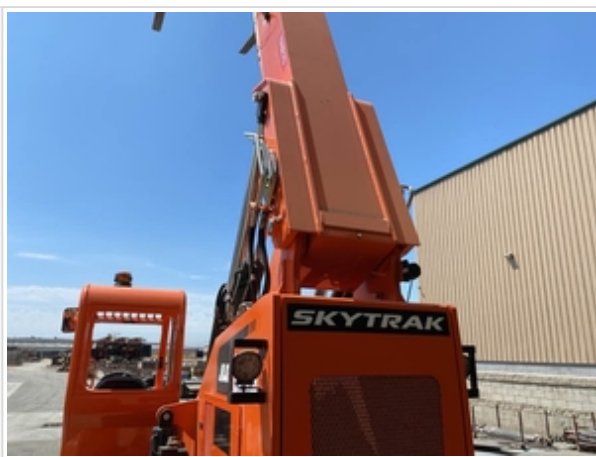
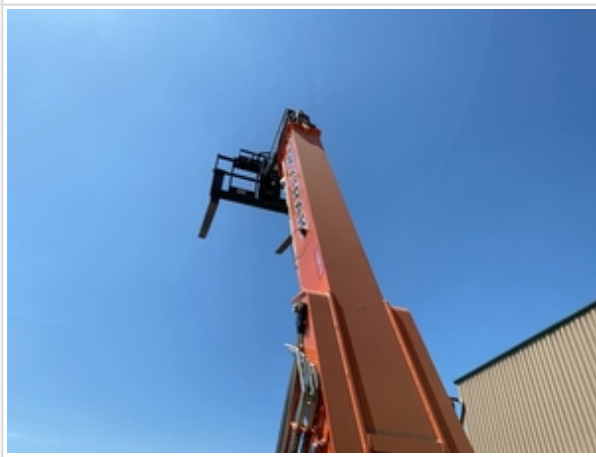
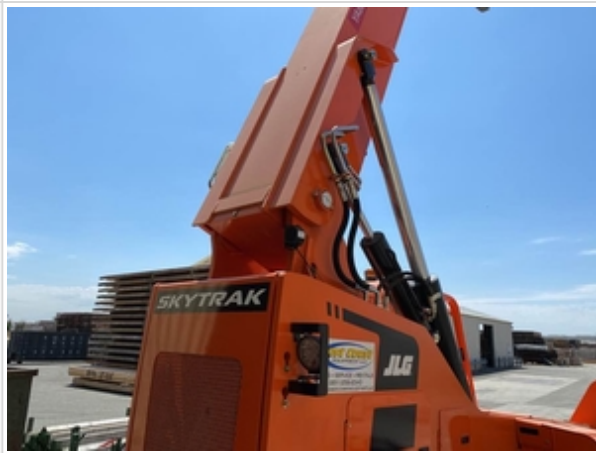
<p>Boom Condition Photos</p>

<b>Tire Brand</b>	Firestone Duraforce MH
<b>Tire Size</b>	400/75 -28
<b>Front Left Tire - Ratio Remaining</b>	90%
<b>Rear Left Tire - Ratio Remaining</b>	90%
<b>Front Right Tire - Ratio Remaining</b>	90%
<b>Rear Right Tire - Ratio Remaining</b>	90%
<b>Boom Condition</b>	4 - Like New, Recently Replaced
<b>Comments</b>	Tires above 90%
