Inspection Report (Boom Lift)

Year	2015
Make	JLG
Model	660sj
Serial Number	0300197865
Hour Meter Reading	2804
Previous Application (e.g., earth moving, mining, demolition, etc)	General Construction Rentals

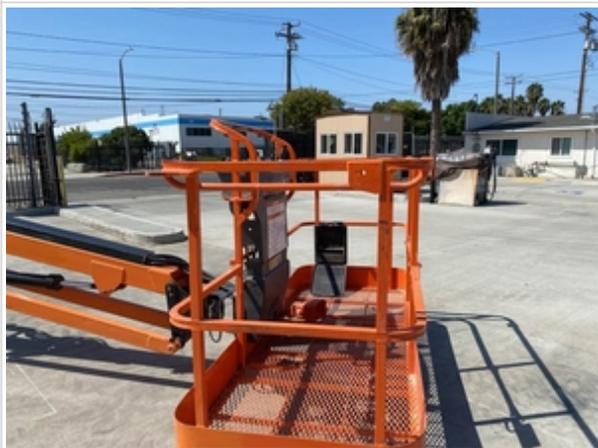
<p>Right</p>	<p>3 - Normal Wear & Tear</p>
<p>Right Photos</p>

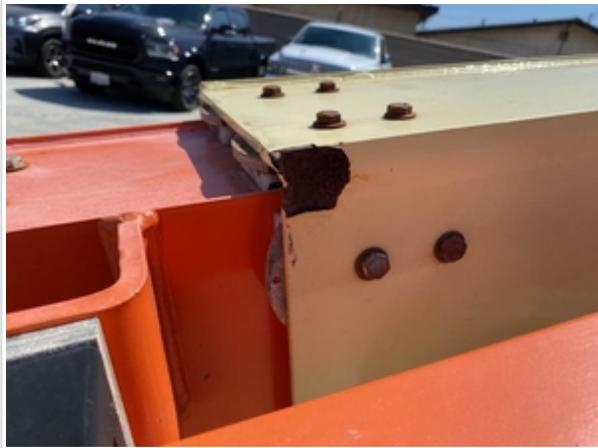
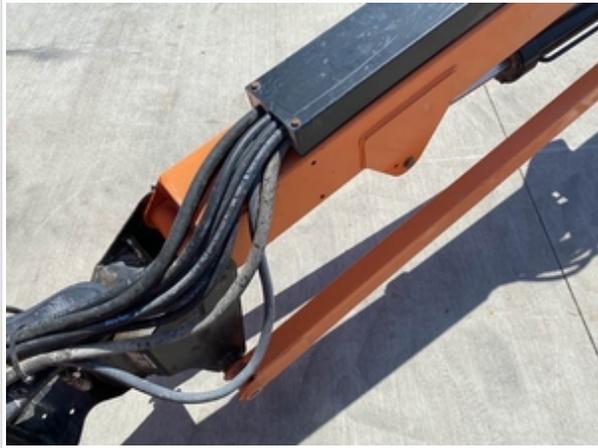
Upper	3 - Normal Wear & Tear
Upper Photos

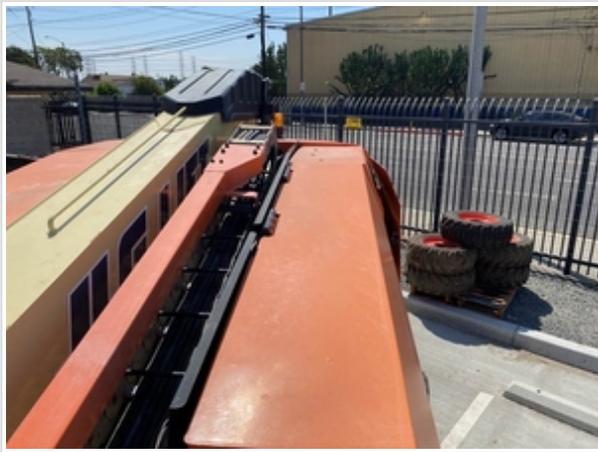
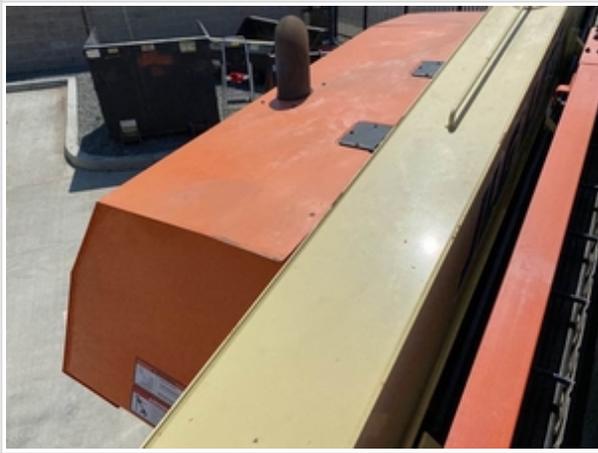
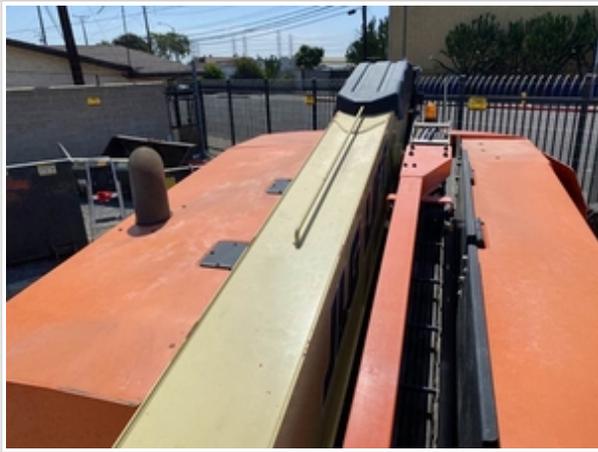
<p>Body Panels (Any Damage?)</p>	<p>3 - Normal Wear & Tear</p>

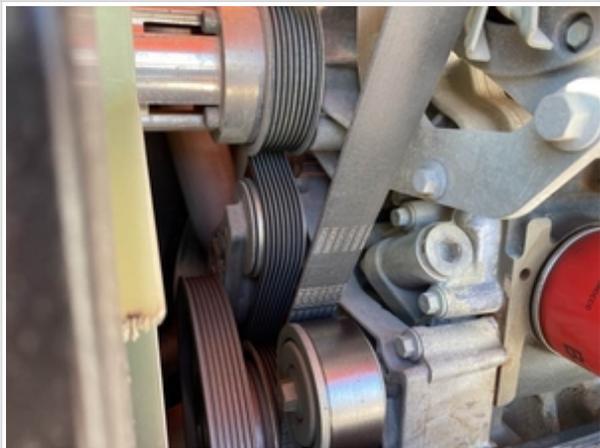
Belts	4 - Like New, Recently Replaced	
Belt Condition	Belts appear in good condition & alignment with proper tension, Other (see comments)	
Comments	Engine belt to platform generator missing	
Belt Photos

Functionality Rating	4
Overall Rating	4
What's Great About the Machine	Machine is well kept. Services up to date and machine operating perfectly.
What Needs Work	<p>Generator not being driven by engine. (Possibly not working properly) power to platform inop. unless extension chord is directly connected to platform harness.</p> <p>Decals on side body are incorrect. This machine is a 660sj not a 600. Service manager mentioned a mistake was possibly made from another branch due to sticker damage and the decals do no reflect actual JLG id plate.</p> <p>Small rust areas found on hood panels (size of a dollar coin\$). Other panels, other areas have normal wear and tear scuff marks. Some body work recommended to eliminate rust growth. Other than that, all else considered cosmetic.</p> <p>Rear left side tire has some tread missing. Tire still safe and functional</p>
Inspector's Name	Mario Ramirez
Date/Time	08-18-2022

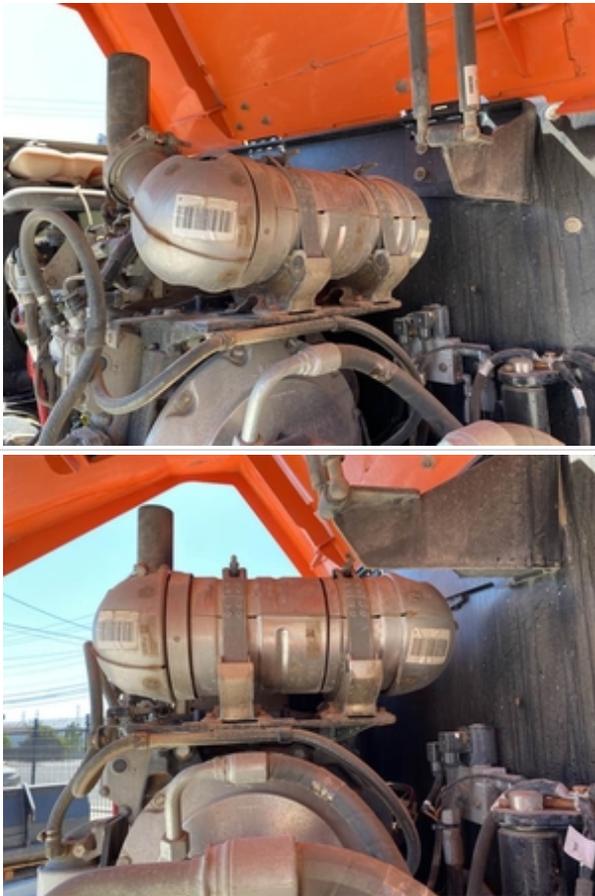
Oil Leaks	No
Oil Color / Appearance	4 - Like New, Recently Replaced
Oil Color / Appearance Notes	Clean oil appearance, no signs of cross contamination, Appropriate oil level
Fuel Leaks	No
Equipped with DPF (Diesel Particulate Filter)	Yes
DPF Condition	4 - Like New, Recently Replaced
DPF Condition Notes	Filter housing is intact with no signs of damage or malfunction, DPF indicator is not illuminated
DPF Photos

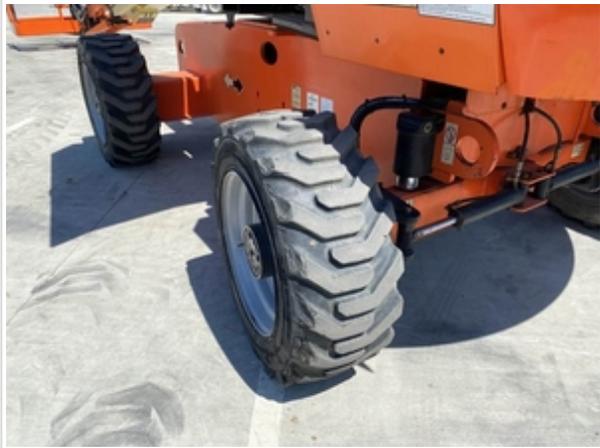
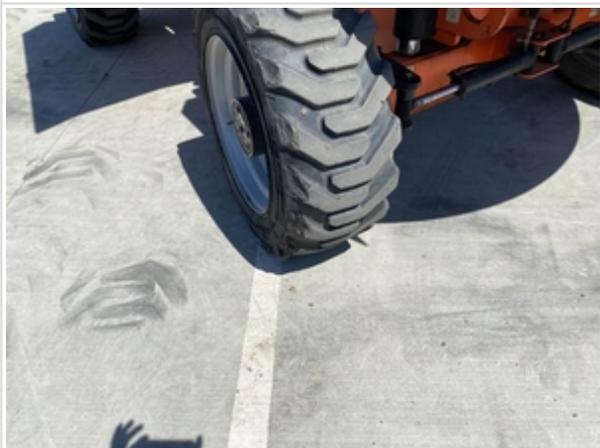
Wheels & Tires	4 - Like New, Recently Replaced	
Comments	Rear left tire has side treads cut off from impact. No major damage mostly cosmetic since top surface area is mostly relevant to machine grounds. Downgraded to 70% due to this	
Wheels & Tires Photos

Tire Brand	OTR blackstone	
Tire Size	39 x 15-22.5	
Front Left Tire - Ratio Remaining	90%	
Rear Left Tire - Ratio Remaining	70%	
Front Right Tire - Ratio Remaining	90%	
Rear Right Tire - Ratio Remaining	90%	
Swivel Bearing	4 - Like New, Recently Replaced	
Swivel Bearing Photos

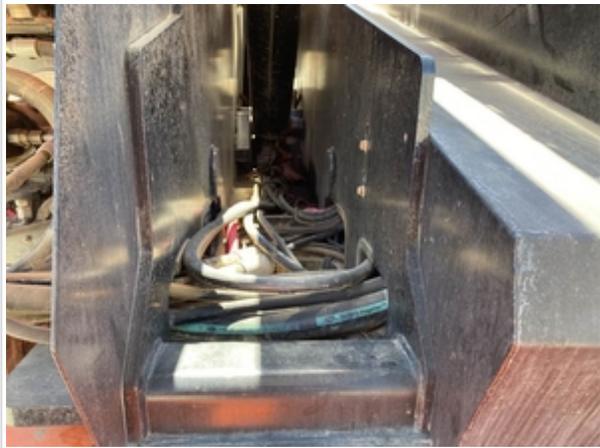
Wet or Damp Hydraulic Lines / Fittings	Yes	
Appearance of Hydraulic Lines / Fittings	4	
Hydraulic Lines / Fittings Condition	Hydraulic lines & fittings are clean and in good condition, Active leaks in hoses or fittings observed, Other (see comments)	
Comments	Only found 1 small rear hose leak at telescope cylinder valve the rest of the machine is leak free

Boom Extension Cylinder	Check the boom extension cylinder. Note any wear, pitting, discoloration, etc. Take photos.	
Boom Extension Cylinder: Mounting Pin	4	
Boom Extension Cylinder: Oil Leaks	No	
Comments	Small oil leak at rear telescope cylinder hose only
